UNDERWATER ARCHAEOLOGICAL INVESTIGATION OF THE ROOSEVELT INLET SHIPWRECK (7S-D-91A)

VOLUME 1: FINAL REPORT

State Contract No. 26-200-03
Federal Aid Project No. ETEA-2006 (10)

SOUTHEASTERN ARCHAEOLOGICAL RESEARCH, INC.

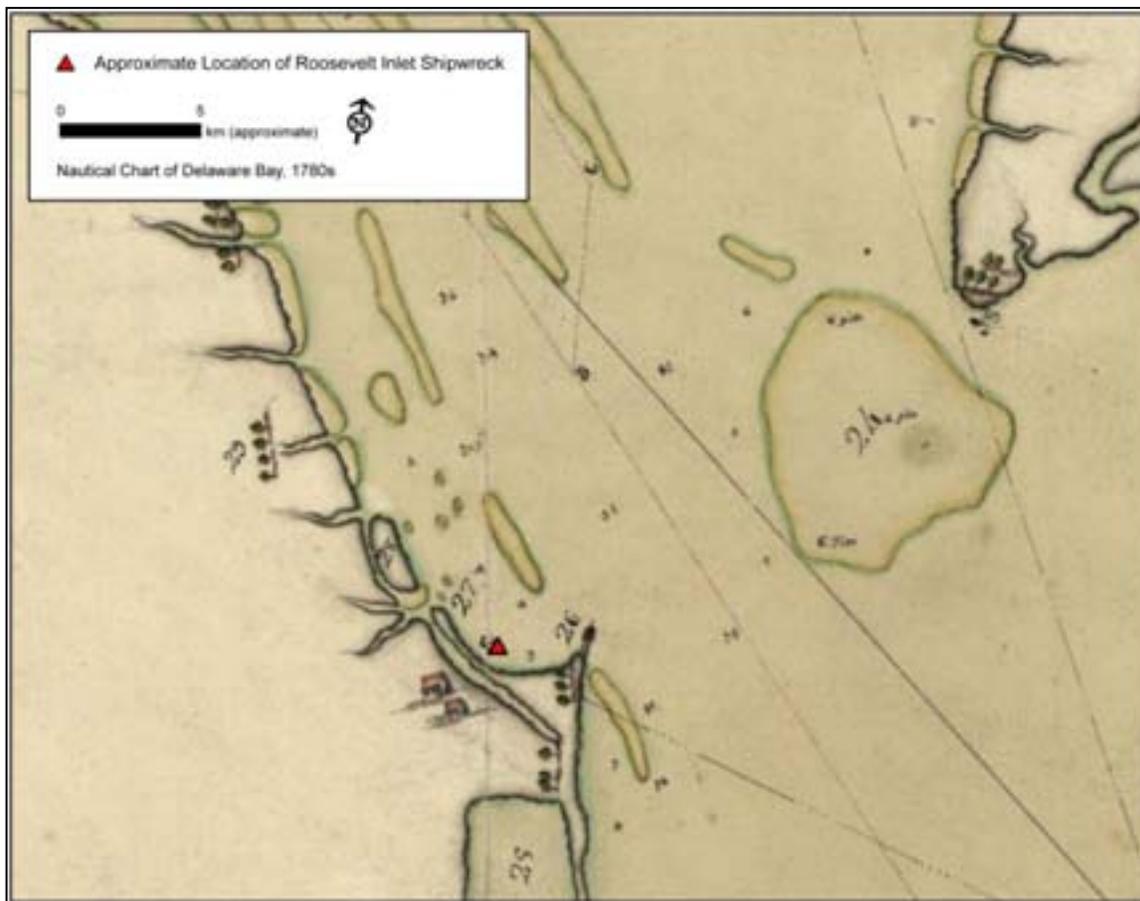
Figure 2.4. Circa 1785 del Campo chart showing the approximate location of the Roosevelt Inlet Shipwreck.

Josef del Campo's chart of Delaware Bay from the mid-1780s was very similar to that of Dury's 1776 chart, although del Campo appears to have made his own examination. Del Campo shows the lighthouse on Cape Henlopen (which he calls Cape James [point 26 on the chart]) and Lewes Creek. He notes only one suitable area for anchorage east of the Cape. The project area is located in the general vicinity of this anchorage. Point 27 refers to the "Rada de Whorekill" or (roughly) Whorekill Road (del Campo c.1785) (Figure 2.4).

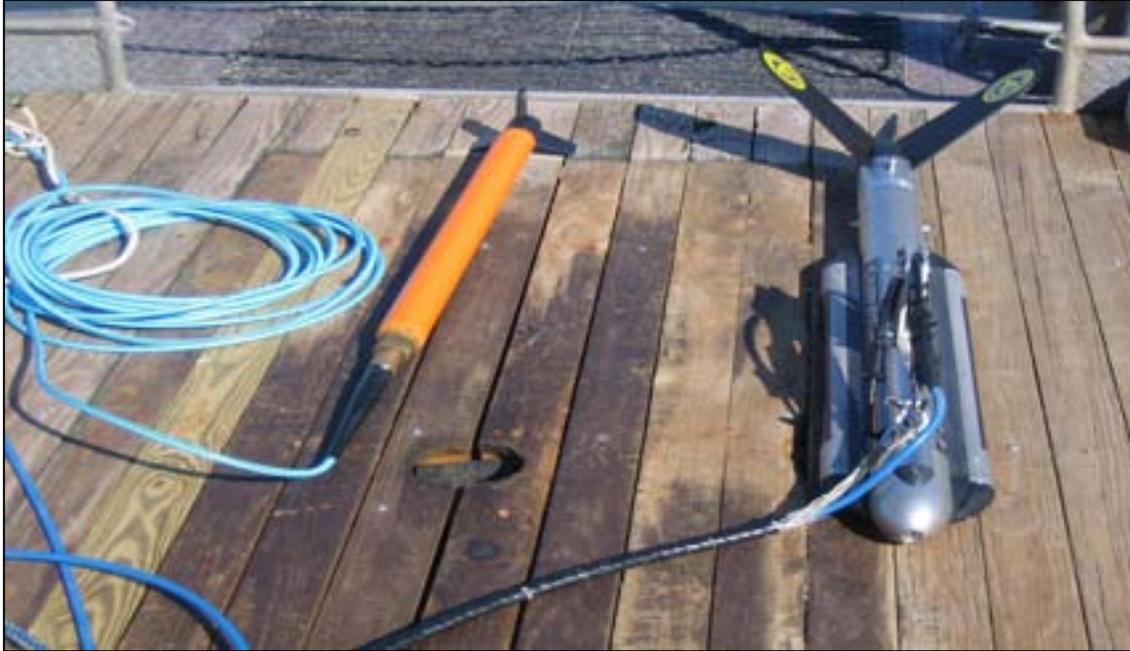
Figure 4.1. The Marine Magnetics Explorer magnetometer, left, and the Klein® 3000 side scan sonar, right, ready for deployment.

SEARCH operated a Marine Magnetics Explorer magnetometer during the preliminary remote sensing survey. This magnetometer is a lightweight, low-powered unit ideally suited for all aspects of the remote sensing survey. This magnetometer is highly sensitive, accurate, and can be easily deployed from any size survey vessel. The Explorer magnetometer is completely maintenance-free and does not degrade over time (Figure 4.1). The magnetometer collected data at a sample rate of one reading per second. The unit delivers a high-resolution output with a noise level of $0.02\text{nT}/\sqrt{\text{Hz}}$. The Explorer is entirely digital and is ideal for geophysical surveys, archaeology, wreck detection, harbor mapping, and ferrous target detection.

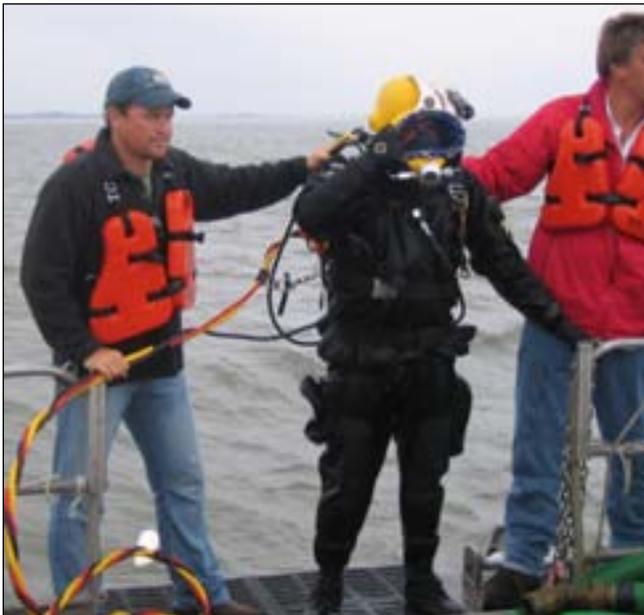
Figure 4.4. Diver outfitted with surface supplied air (including a Kirby-Morgan SuperLite®-27 helmet), preparing to excavate a portion of the Roosevelt Inlet Shipwreck.

SEARCH used both Self Contained Underwater Breathing Apparatus (SCUBA) and Surface Supplied Air (SSA) diving equipment during the current investigation. SCUBA was utilized during the preparation of the site including establishing baselines and semi-permanent moorings. SSA was then utilized for the remainder of the project during the hydro probe survey and excavation of the eleven test units. The SSA equipment included Kirby Morgan SuperLite® diving helmets (17b and 27) (Figure 4.4), Diveline floating umbilicals, and a Kirby Morgan Air Control Station-2A (KMACS-2A). The KMACS-2A, a

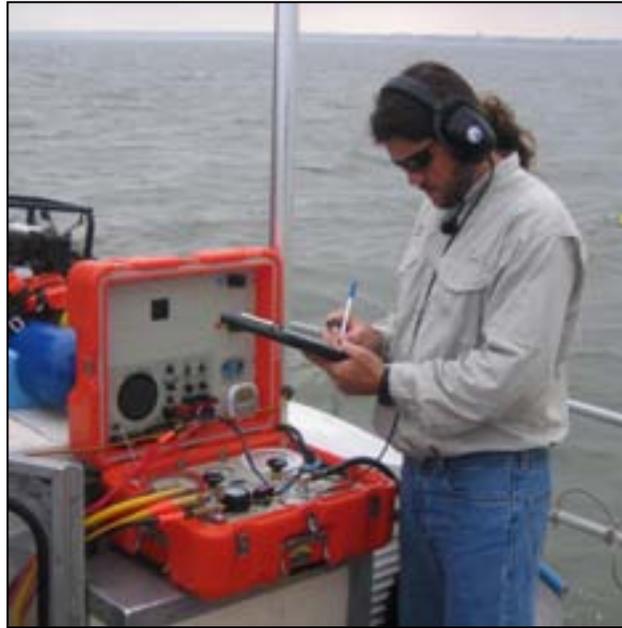
Figure 4.5. The Kirby Morgan Air Control Station-2A (KMACS-2A) allowed the Dive Supervisor to monitor the diver's air supply, dive time, and communications at all times.

portable control box for use in all SSA diving operations, controls the diver's air as well as all communications via a built-in communication system (Figure 4.5). This allows two divers to communicate via "round robin" four-wire communications in emergency situations, and it allows the Dive Supervisor total control in any situation by monitoring air supply, diver communication, and the pneumofathometer in one localized area.

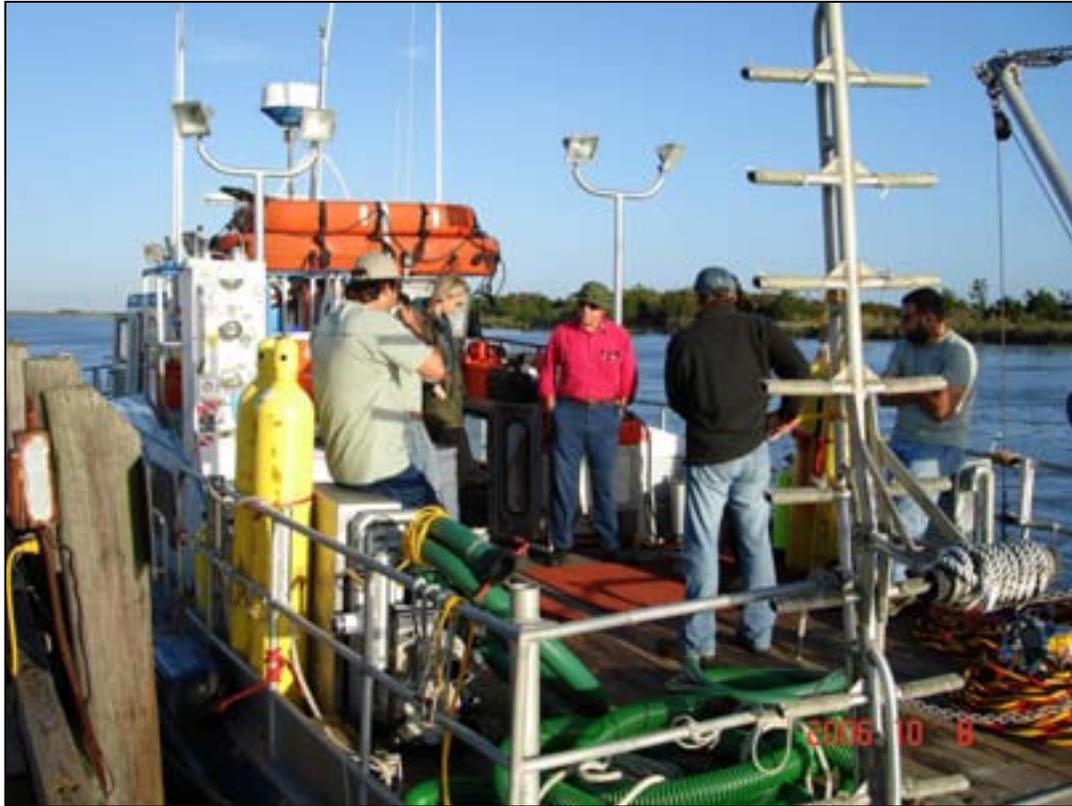
Figure 4.6 . The stern of the *Venture III* (based out of Shark River Inlet, New Jersey) had ample space for all project-related activities.

The work platform utilized during all aspects of the investigation was the 46-foot, aluminum-hulled Breaux-built crew boat *Venture III* (Figure 4.6). The vessel, operated by Captain Paul Hepler and first mate Ruth Hepler, is based out of Shark River Inlet, New Jersey. The vessel was ideally suited for all aspects of the project, including the preliminary remote sensing survey, site preparation, and excavation activities. The vessel had plenty of deck space for all equipment utilized during the project including the remote sensing equipment, SSA dive equipment, and room for daily artifact screening and storage. The *Venture III* conformed to all U.S. Coast Guard specifications according to class and had all required safety equipment including lifejackets, first aid supplies, tool kits, flare gun, and air horn.

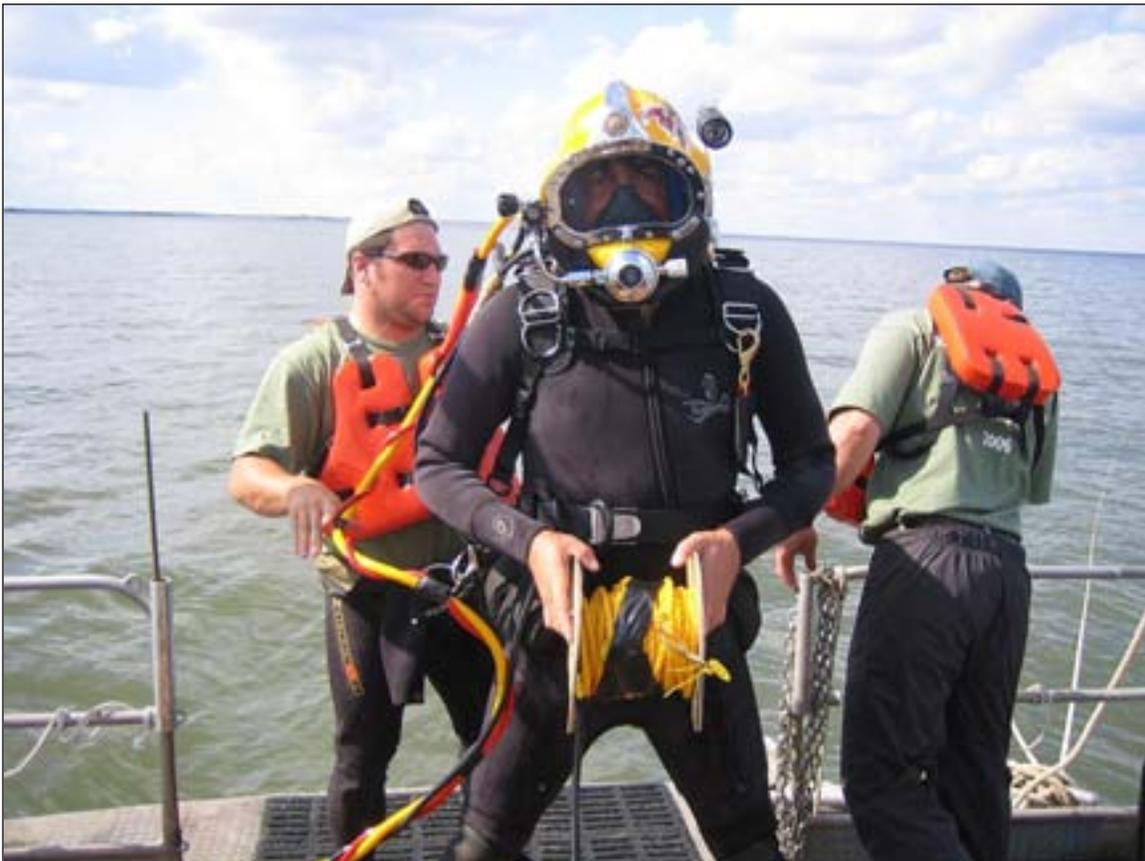
Figure 4.9. Each baseline was color coded (yellow shown) and secured with large screw anchors in the bay floor by divers using surface supplied air.

The baselines were marked with high-visibility, color-coded tags at 10-foot intervals (Figure 4.9). These colored tags assisted divers in orienting themselves to the wreck site during dive operations. The use of different colored tags for the three baselines proved an efficient means for divers to navigate across the wreck in a low-to-zero visibility work environment.

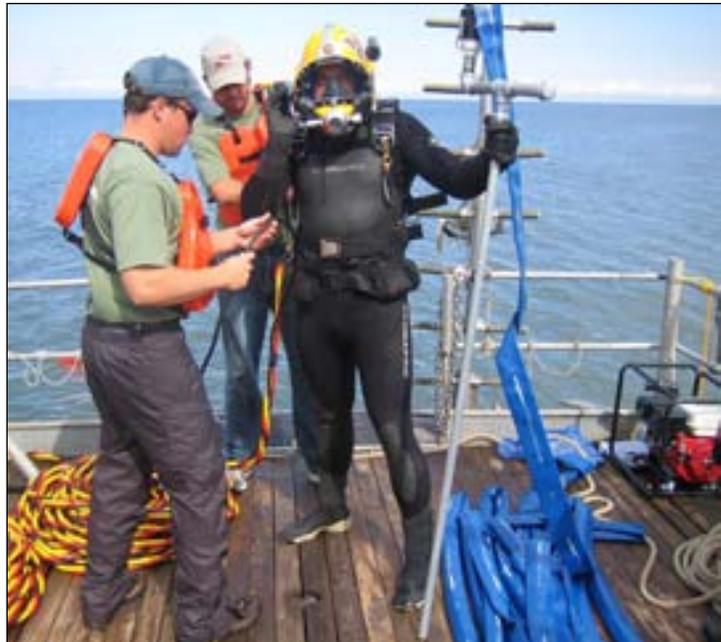
Figure 4.10. A 5-foot hydro probe was used to delineate the extant remains of the Roosevelt Inlet Shipwreck. The hydro probe is 1/2-inch in diameter and is used to probe beneath the sea floor to locate buried hull remains.

Once the two east/west-oriented, semi-permanent baselines were established the next objective was to determine the amount of extant hull remains using a 5-foot hydro probe. The hydro probe is simply a 5-foot piece of 1/2-inch galvanized pipe in which water is forced through from a centrifugal water pump located on the deck of the dive platform (Figure 4.10). This method of delineation allows divers to quickly – and in a minimally-intrusive manner – determine the extent of buried hull remains. Results of the hydro probe survey assisted archaeologists with recommendations relative to the current investigation and allowed for a better comprehension of the remaining hull structure.

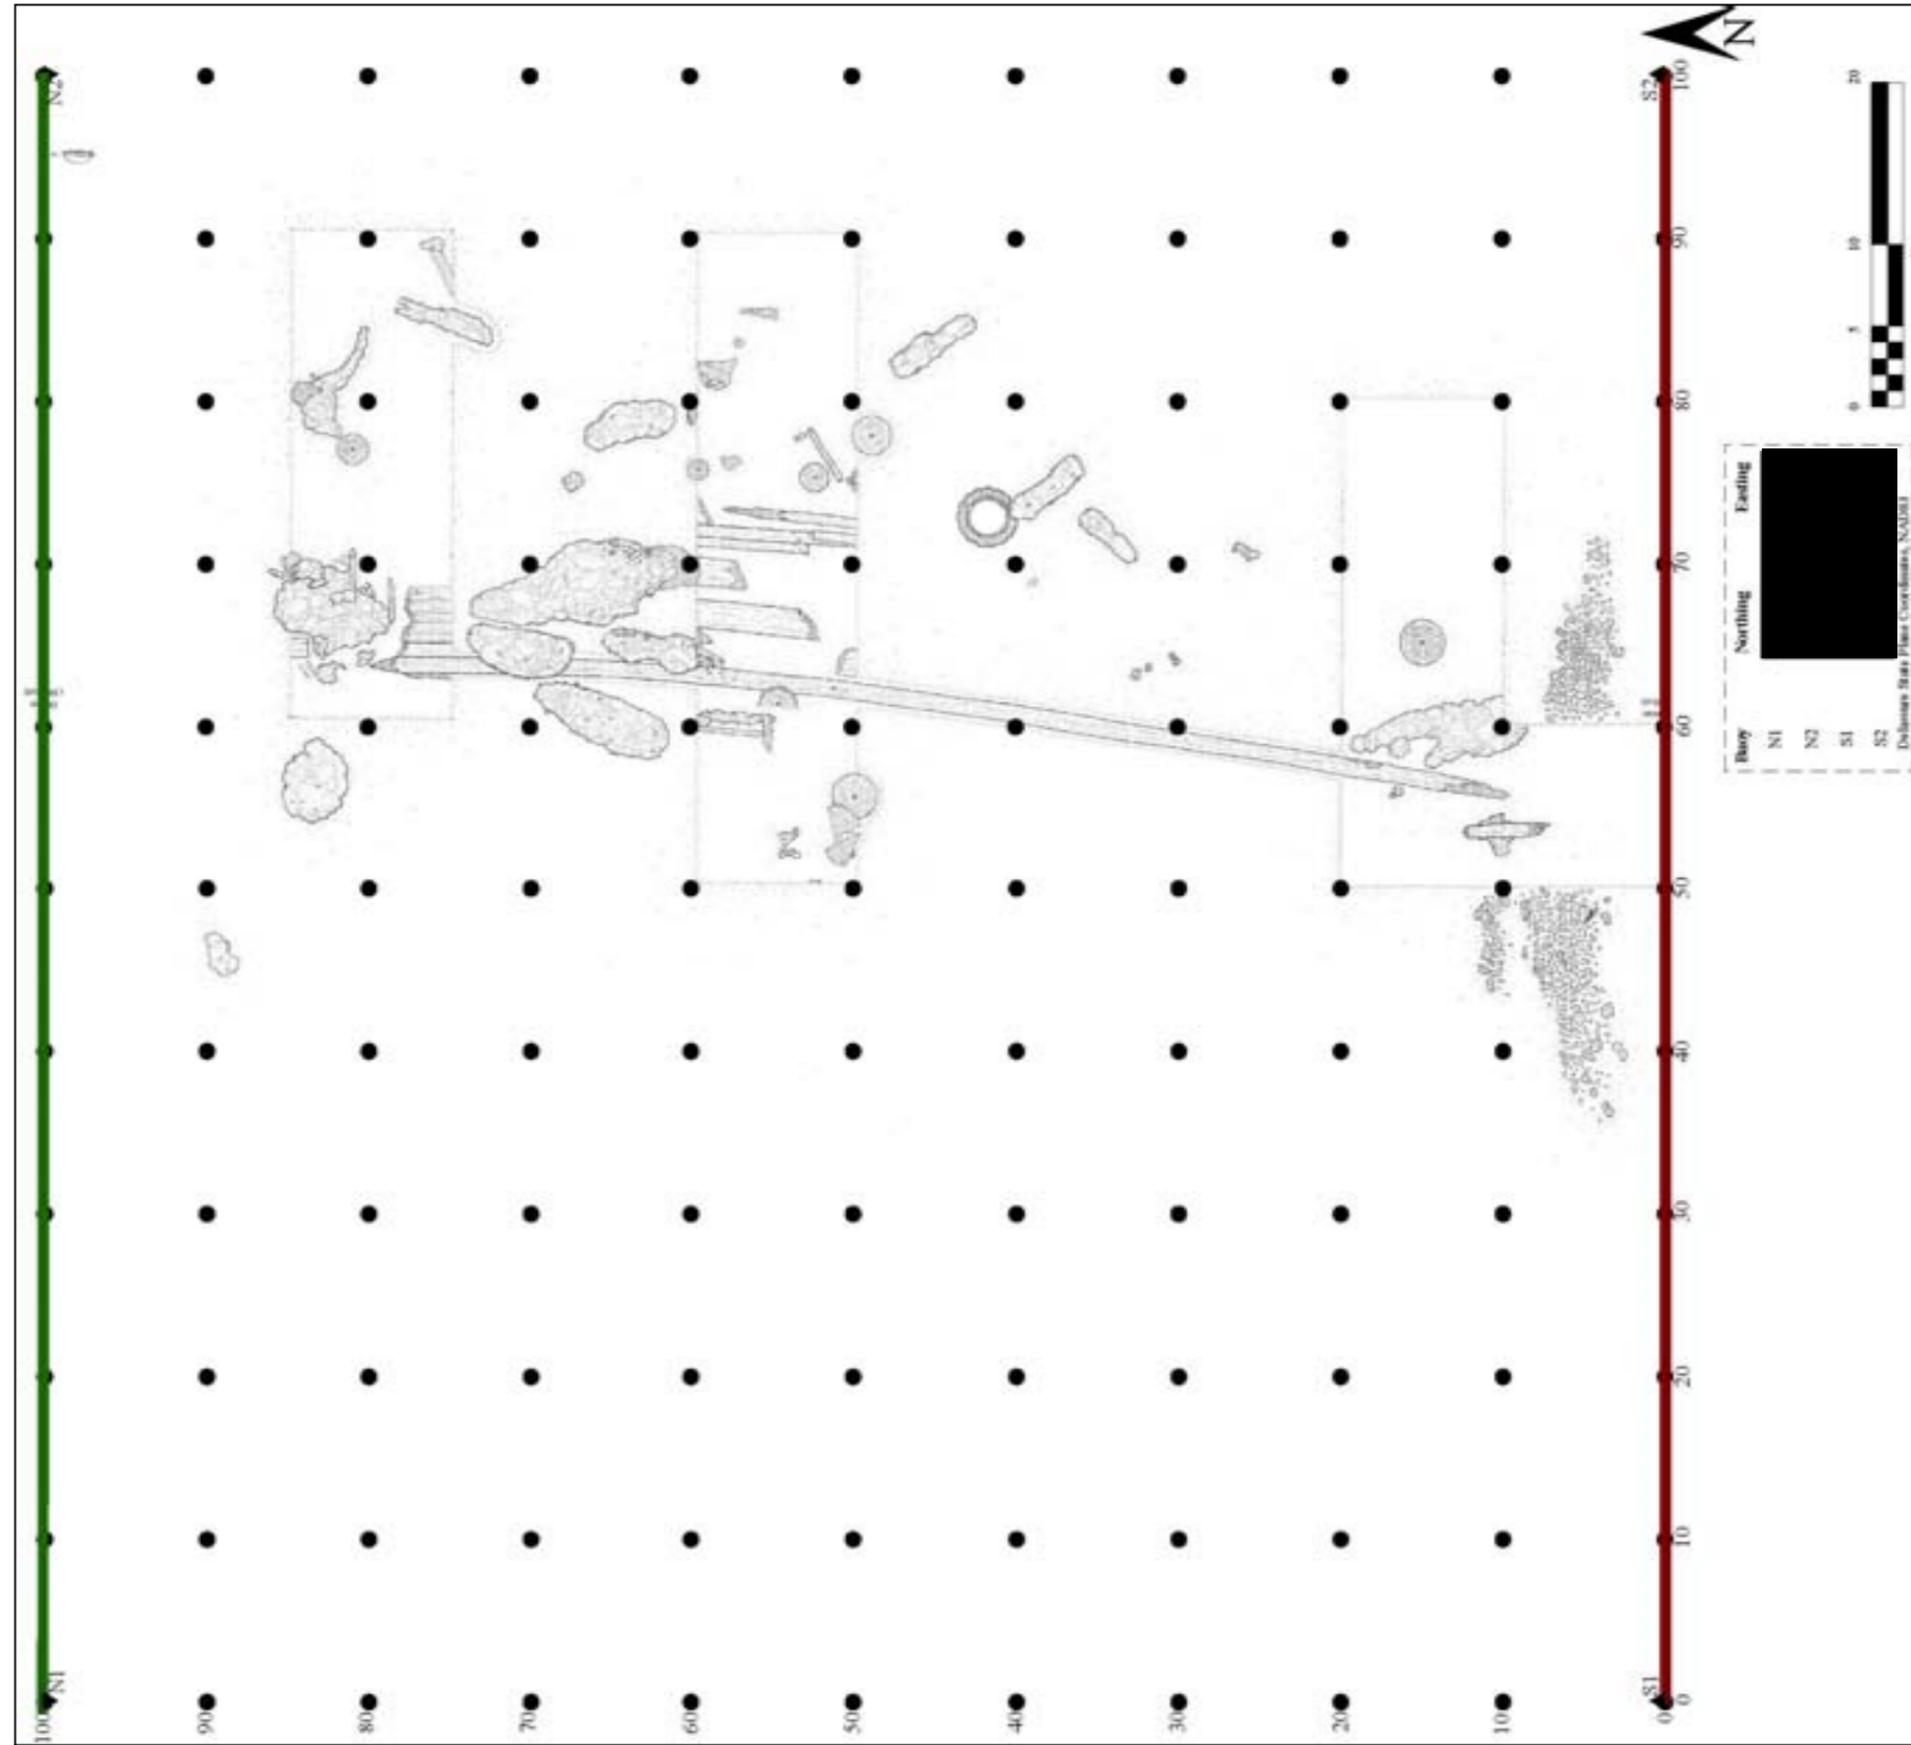
Figure 4.1.1. A total of 121 hydro probes were dropped at 10-foot intervals (denoted with black dots), guided by a movable baseline. The survey started from Transect East 0 (left) and proceeded to Transect East 100 (right).

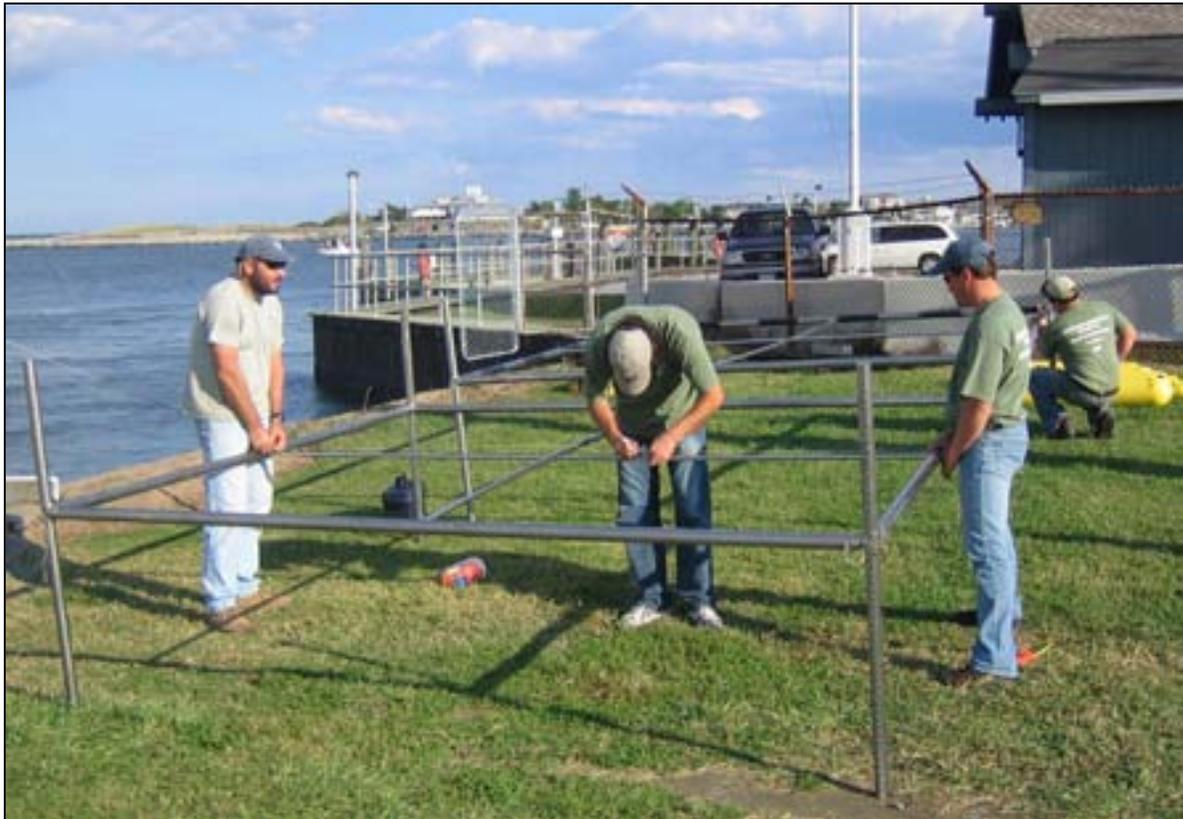
Figure 4.12. Both 10-x-10-foot stainless steel grid squares (shown here) were constructed on land and taped at one-foot intervals to assist divers in controlling artifact provenience during the excavation.

Once the third semi-permanent baseline was established (parallel to the exposed wreck site), two 10-x-10-foot stainless steel grids, specifically built for the project, were constructed on dry land and taped at one-foot intervals (Figures 4.12 and 4.13). Taping the grids at one-foot intervals assisted divers during the site excavation in accurately mapping *in situ* features in a near zero-visibility work environment.

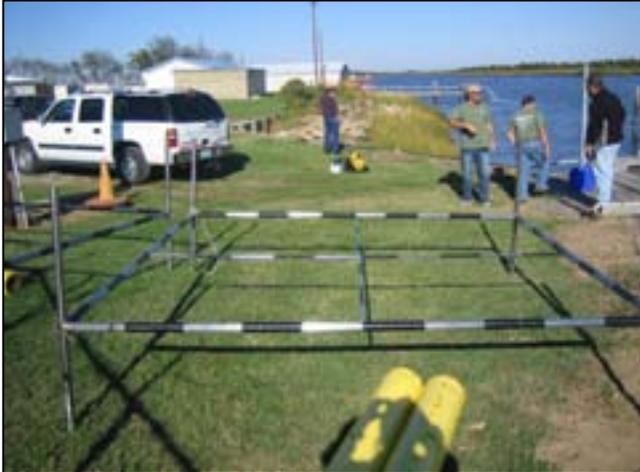
Figure 4.13. One of the 10-x-10-foot stainless steel grids (with cross members) specially built for the project. The grids were taped at one-foot intervals for reference underwater.

Each 10-foot grid was divided into four 5-x-5-foot quadrants using stainless steel cross members (see Figure 4.13). These quadrants allowed archaeologists a high degree of context control, the ability to record all surviving hull architecture and fittings, and to assist in determining the distribution of cargo and shipboard functions.

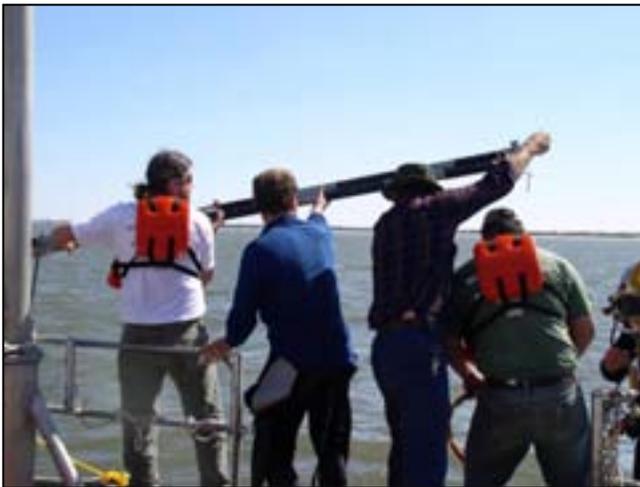
Figure 4.14. The grid squares were disassembled on land, lowered to the sea floor in sections, and reassembled by divers.

The two grids were partially disassembled and transported to the Roosevelt Inlet Shipwreck via the *Venture III*. The grids were lowered to the sea floor to a diver who reconstructed the grids relative to the north/south baseline (Figure 4.14). Both grids were initially positioned at the amidships area (North 50/East 50 and North 50/East 60) and moved accordingly as each grid was excavated to sterile levels.

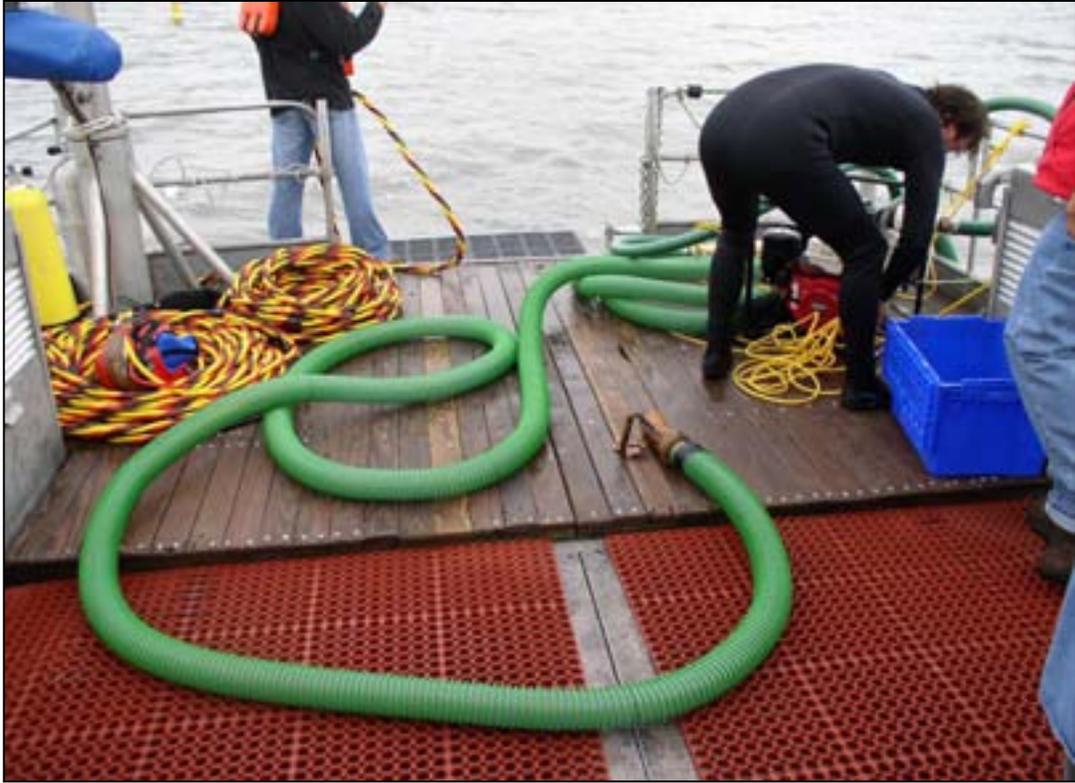
Figure 4.15. A 3-inch venturi-style dredge was used during the excavation phase of the project.

The methods employed for the excavation of each 10-x-10-foot grid included the use of a 3-inch venturi dredge (Figure 4.15). Archaeologists used the dredge to remove sediment from each 5-foot quadrant at 12-inch levels, always beginning in the southwest (SW) quadrant, proceeding to the northwest (NW) quadrant, then to the northeast (NE) quadrant, and finally to the southeast (SE) quadrant. Once an entire grid was cleared to 12 inches, the process repeated itself at 12-inch intervals in a clockwise fashion until sterile sediment was encountered throughout each quadrant. This process repeated itself for each of the eleven test units excavated.

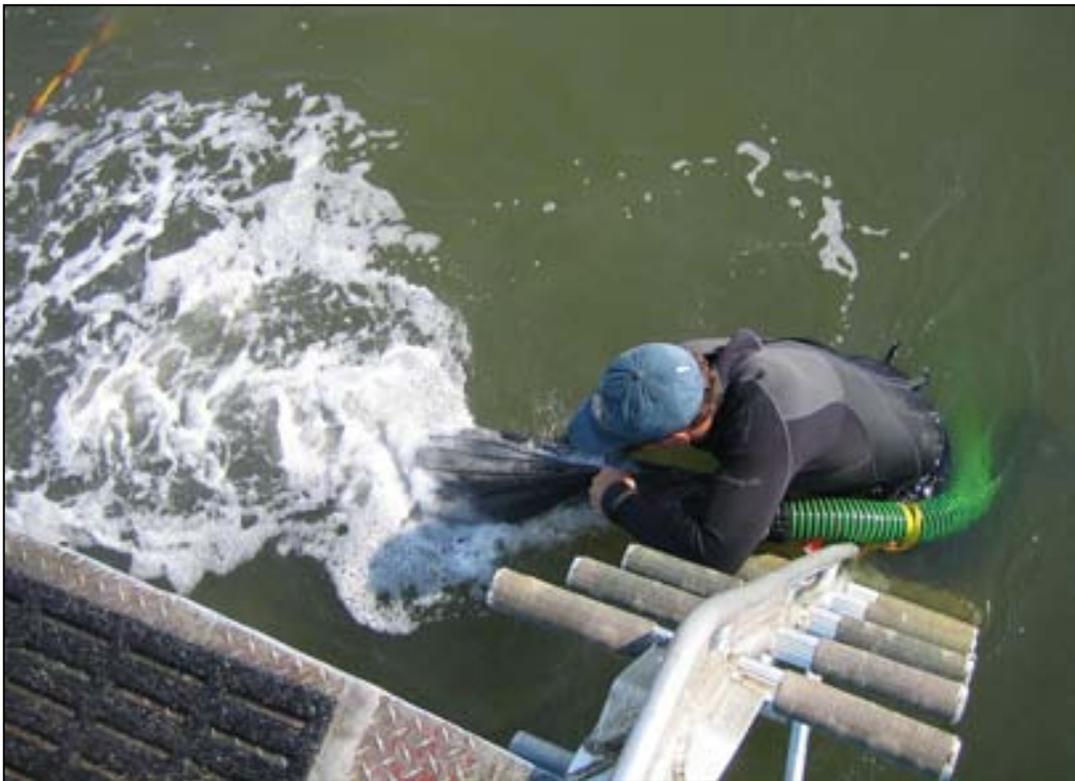
Figure 4.16. All dredge material removed from the wreck site was filtered through a fine-mesh bag. The recovery of small beads and pins indicate that the level of recovery of small artifacts was high.

This field method was revised to incorporate a fine mesh bag secured over the exhaust end of the dredge hose located at the water surface off the stern of the *Venture III*. Monitoring of the dredge exhaust and inspection of the cultural material confirmed that all excavated material, even small beads, were successfully retained within the mesh bag (Figure 4.16).

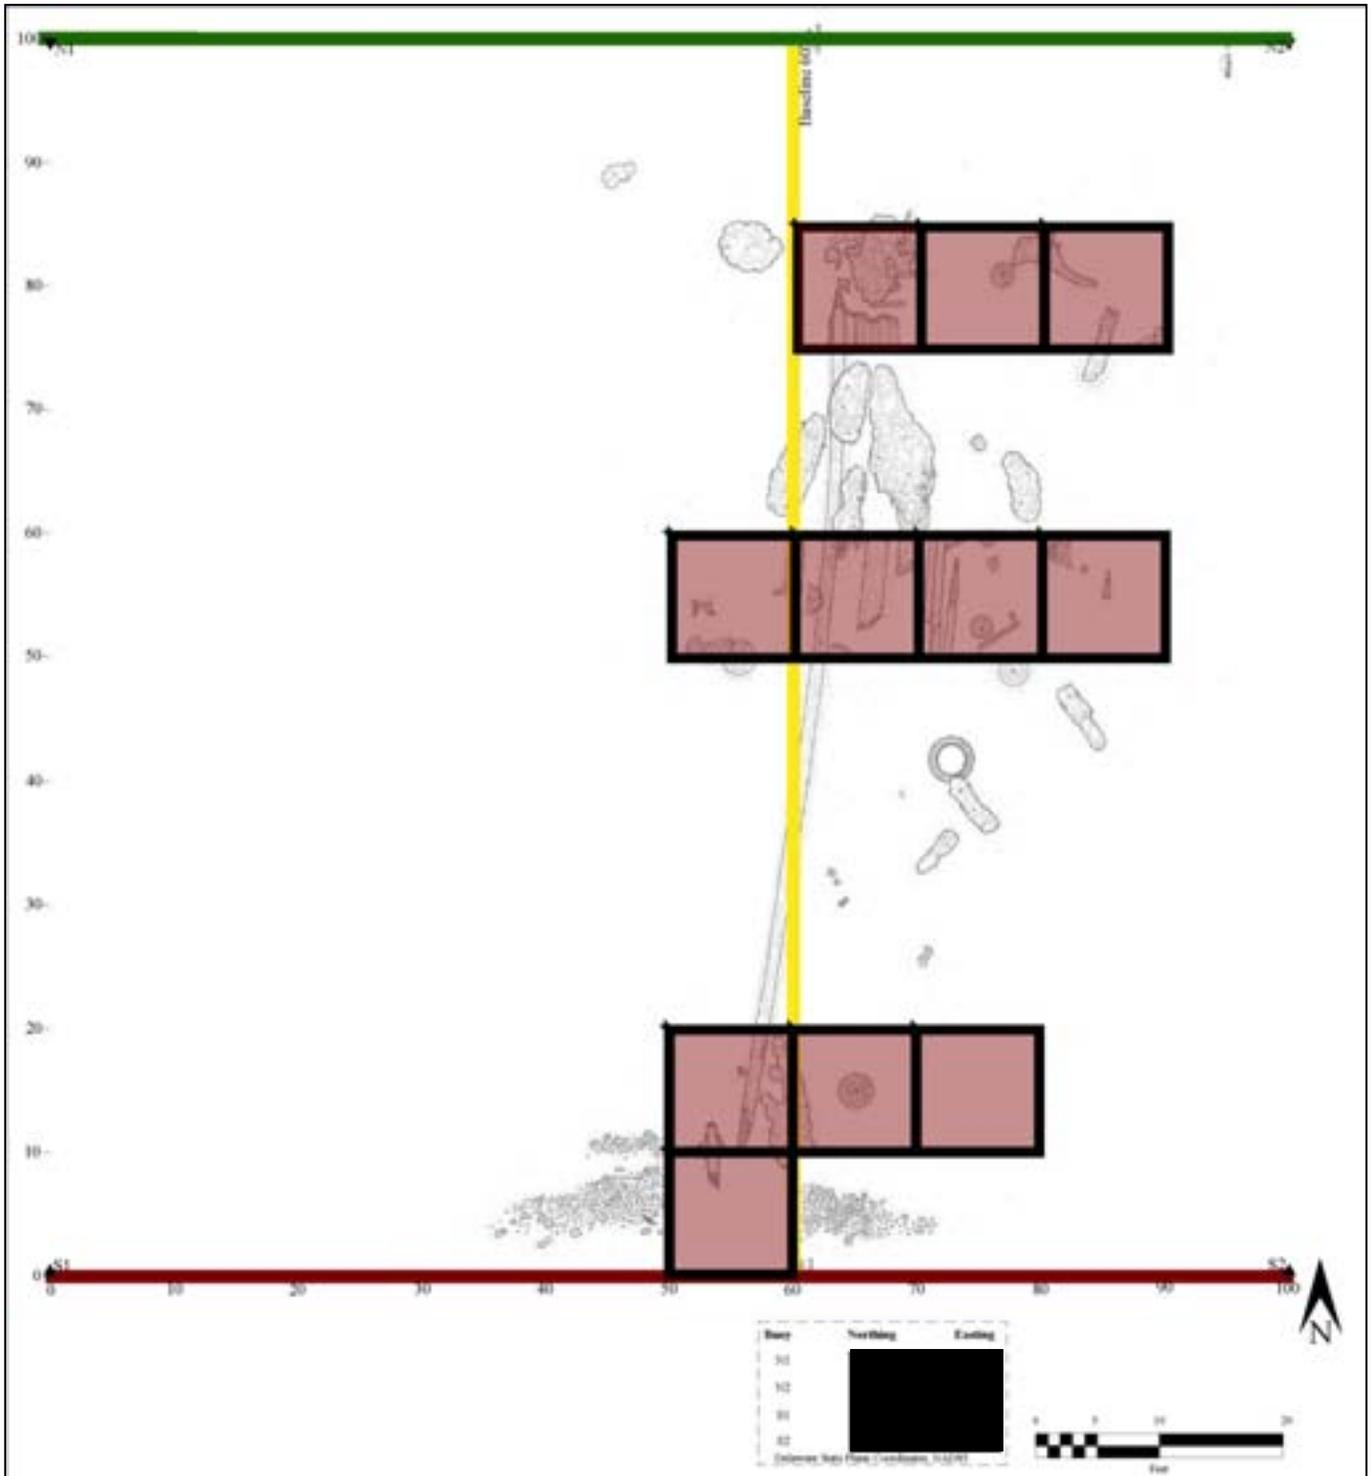
Figure 4.18. Location of all eleven 10-foot-by-10-foot grid squares excavated during SEARCH's investigation.

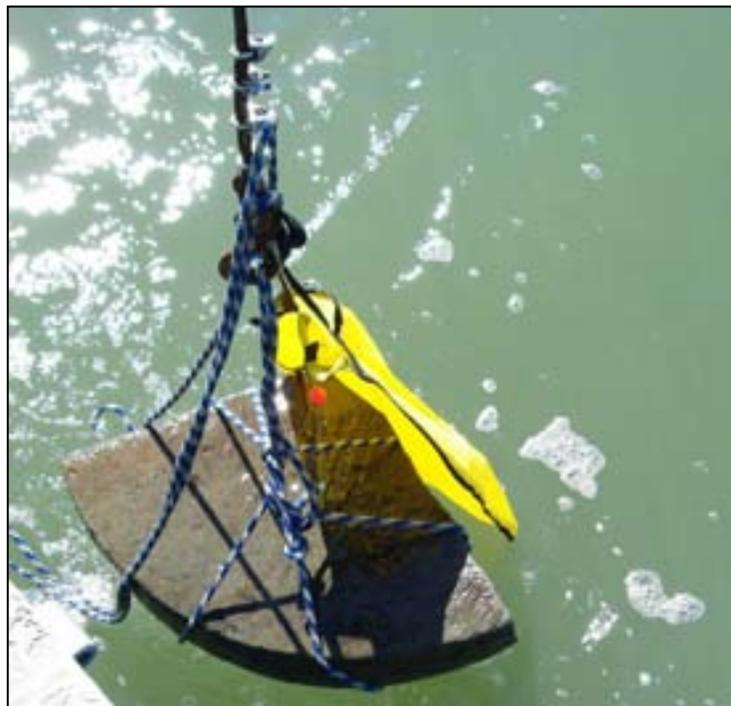
Figure 5.5. Partial millstone recovered from the Southwest Quadrant of N50/E50 for conservation and analysis.

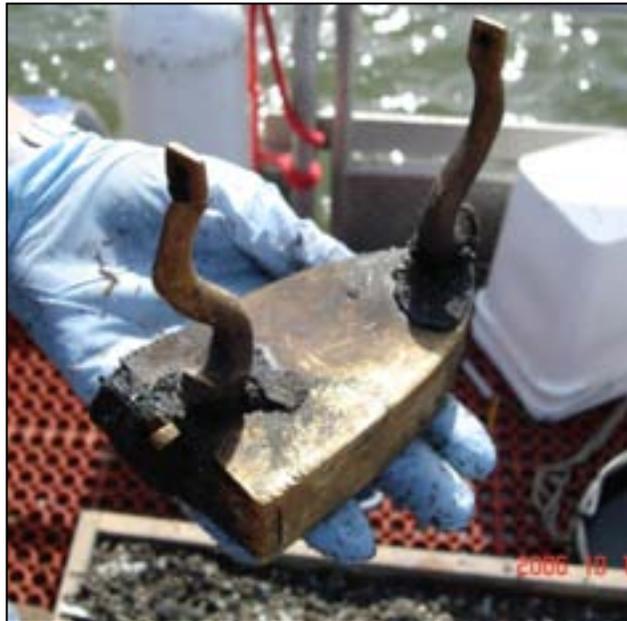
Figure 5.6. Brass iron recovered from the Southeast Quadrant of N75/E60. Note the dolphin-shaped handle supports. The wood handle has since eroded away.

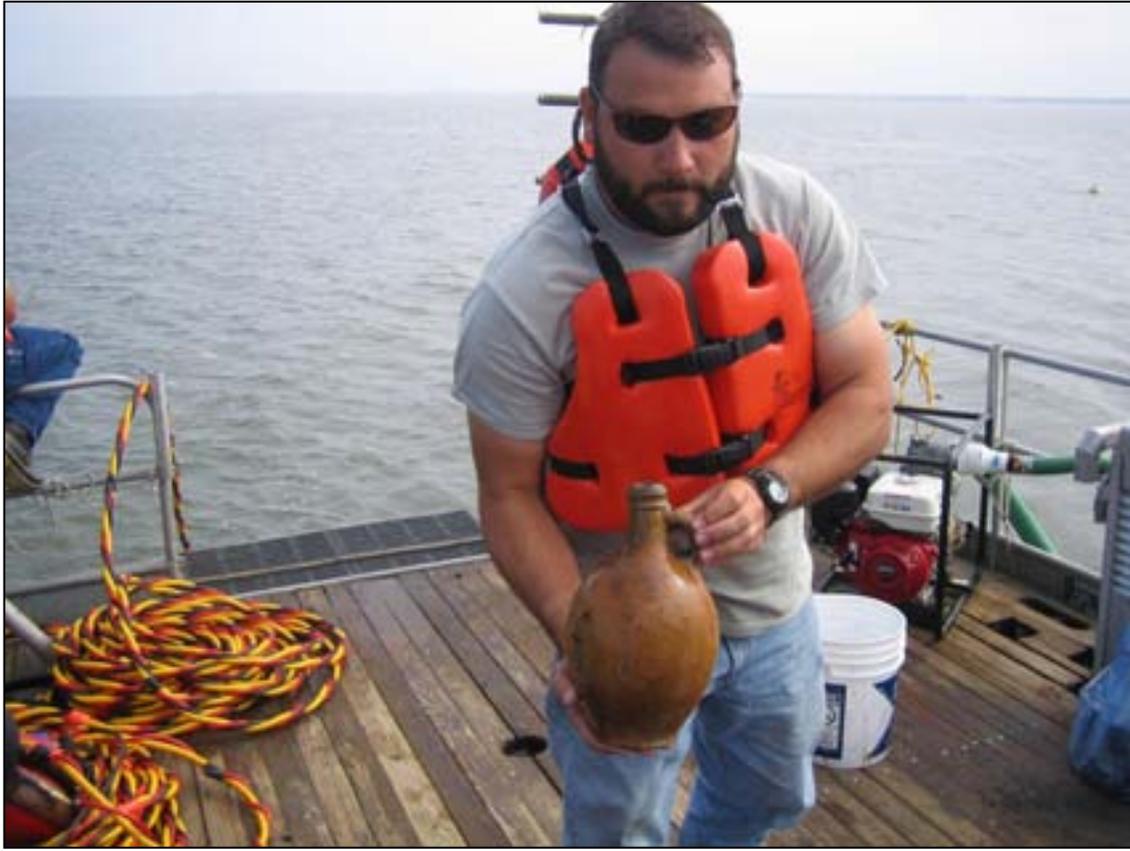
Figure 5.7. Intact stoneware jug recovered from the Southwest Quadrant of N75/E70.

Southwest Quadrant: This quadrant was devoid of any hull remains but included the highest density of artifacts (total recovered = 2,252). Of particular note is an intact stoneware jug recovered during the excavation (Figure 5.7), the large number of straight pins (614), and 419 cranberry-colored faceted glass beads. Also recovered were 47 ingot fragments and an additional 35 unidentified antimony objects, a bone domino, a bell, 7 buttons (various kinds), a curtain tie back, a nail, a rivet, 48 faceted glass stones, several pewter miniatures, a watch key and watch parts, 4 thimbles, 6 thimble cases, a spoon, a finial, 2 pieces of slate, and a shot. The extensive artifact collection also includes 295 pipe stem and bowl fragments, a whole brick, 109 tin-glazed earthenware sherds, 4 pieces of porcelain, 54 creamware sherds, 268 fragments of stoneware (188 brown salt glazed), 117 glass bottle fragments (case, wine, round), glass tumbler fragments, and 178 shards of window glass. The full inventory of all artifacts recovered from the Southwest Quadrant of N75/E70 is presented in Appendix E.

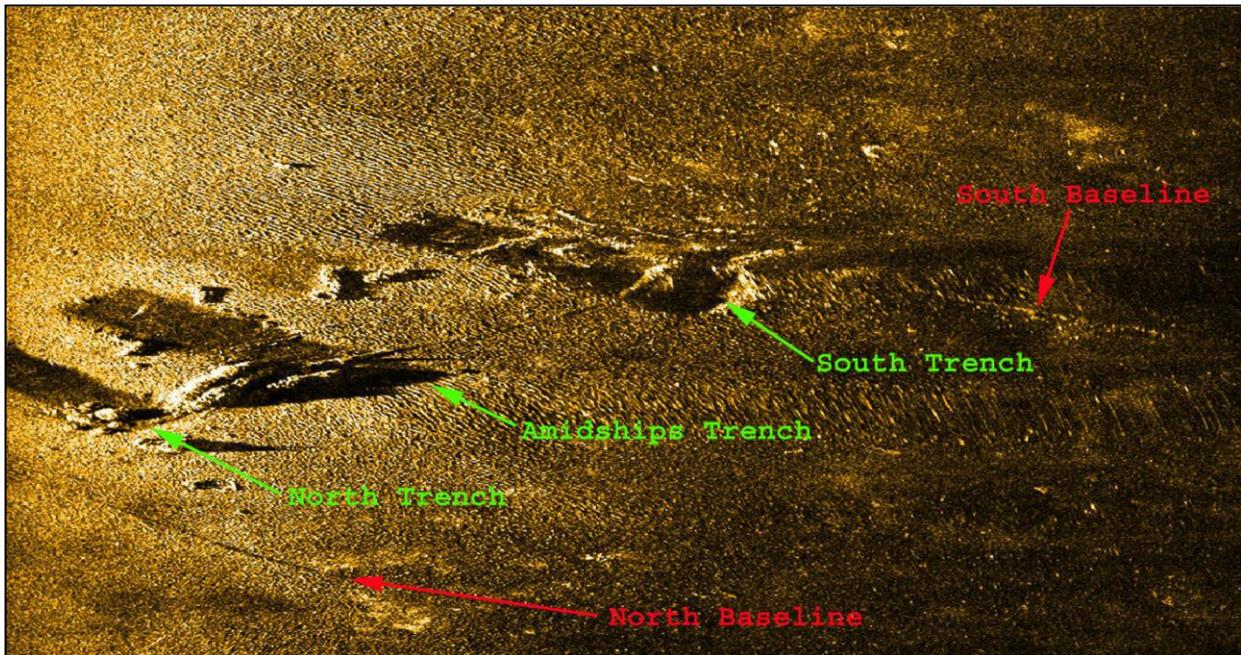
Figure 5.8. Post-side scan sonar image clearly showing the trenched areas excavated during the current investigation. Both the north and south baselines are also visible and labeled above.

Results of the side scan sonar survey clearly identified the three trenches excavated during the current investigation: the north, amidships, and south trenches. Weather conditions during the post-remote sensing survey were not ideal. However, the trenches are clearly visible as dark bands across the wreck site (Figure 5.8). Based on observations after a nor'easter during the current investigation, the movement of sediment suggests these three trenches will likely fill in quickly after the next major storm event.

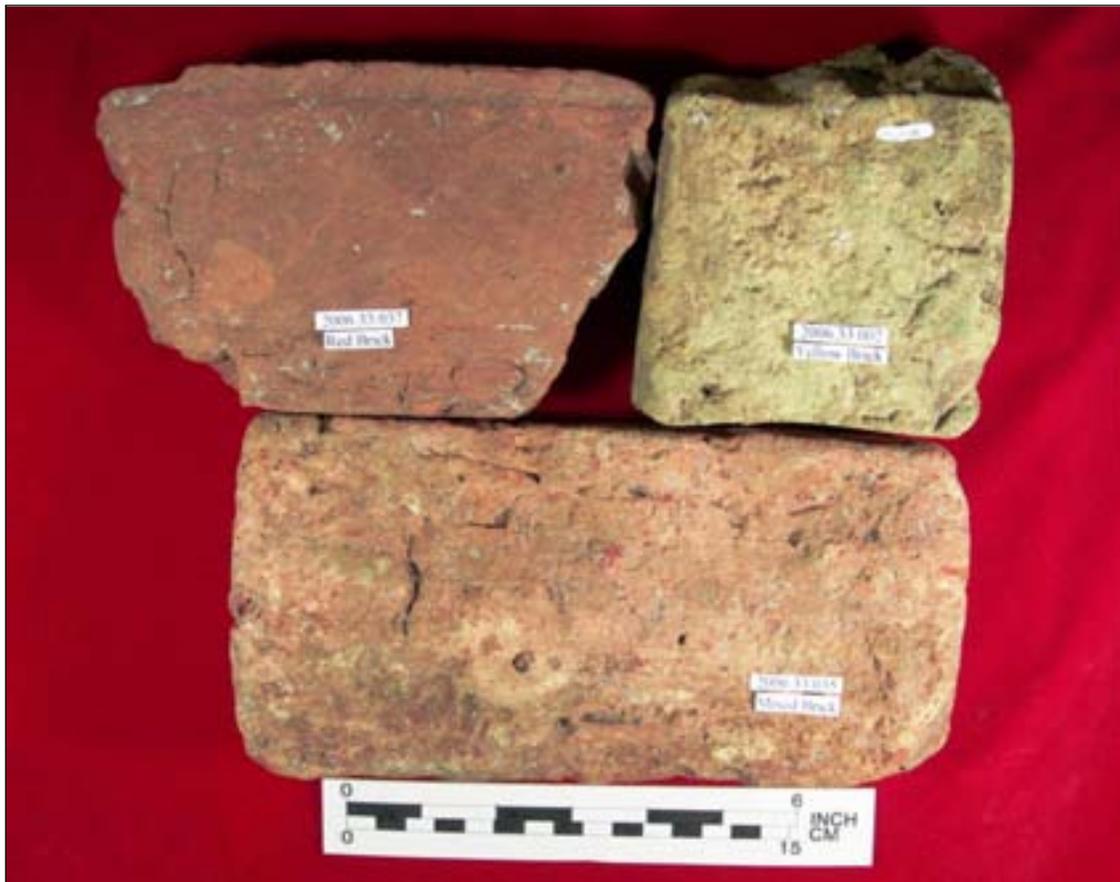
Figure 6.1. Representative examples of bricks recovered from the Roosevelt Inlet Shipwreck site.

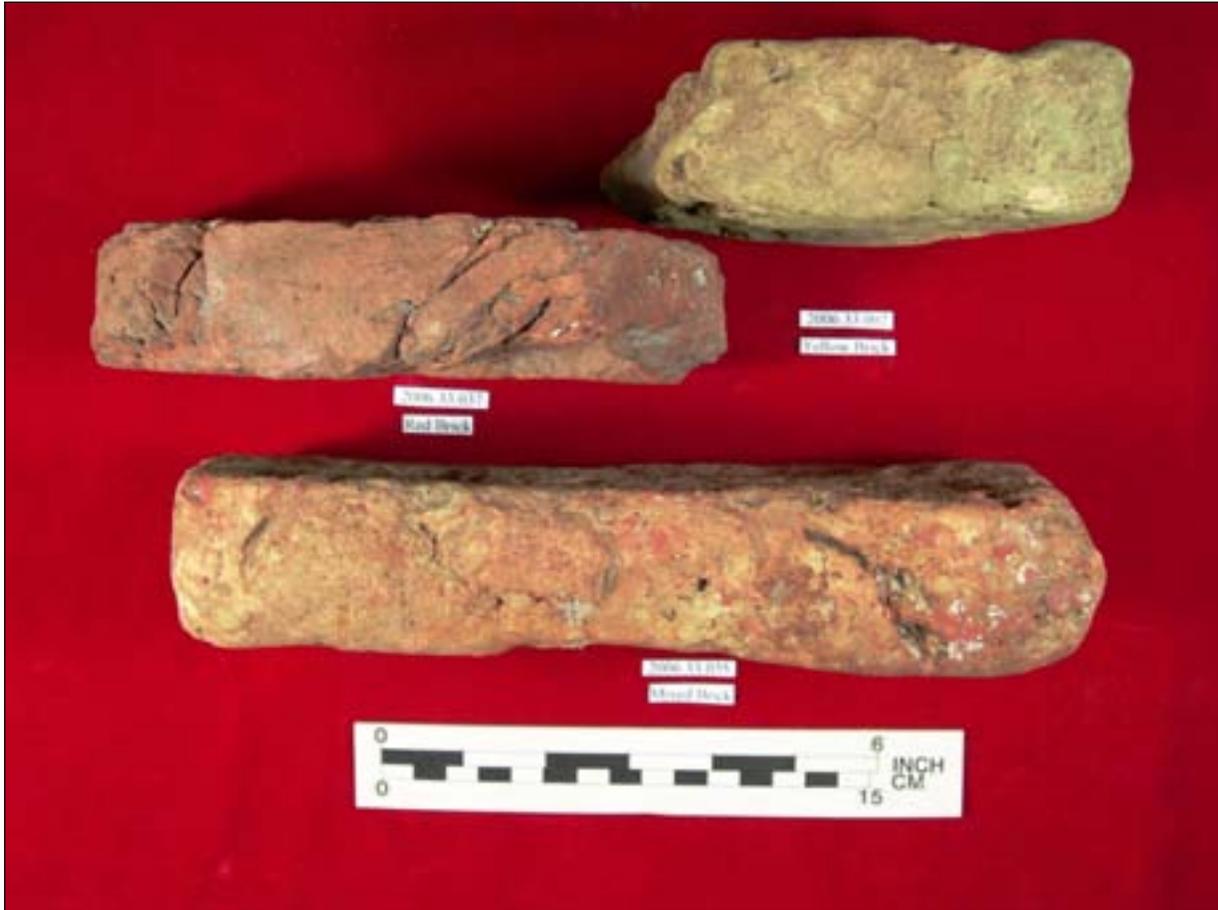
Figure 6.2. Side view of bricks showing the variation in thickness.

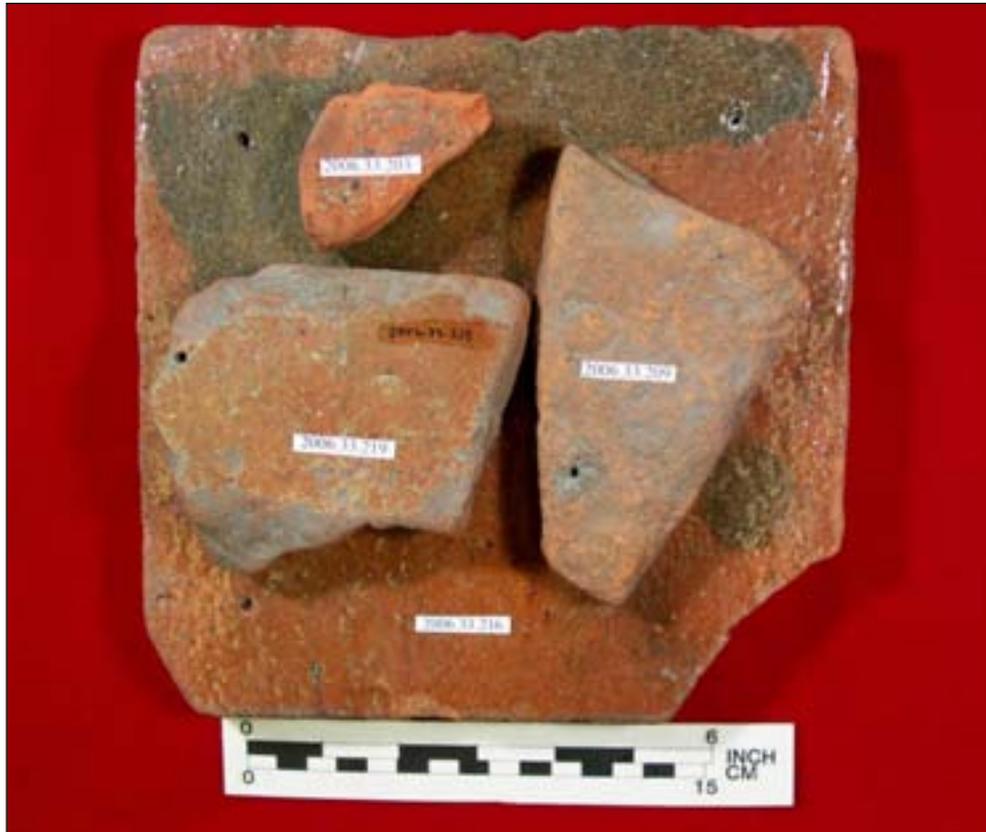
Figure 6.3. Lead glazed tiles with pre-drilled nail holes, suggesting possible roofing tiles.

Nineteen ceramic tile fragments were recovered from the excavations. Of these, ten are lead glazed, five are tin glazed, and four are either unglazed or the glaze has spalled off. Tile fragments were spread fairly evenly across the test units with the majority of tin glazed pieces coming from the north end of the wreck. Several of the lead glazed tiles appear to have pre-drilled nail holes, suggesting that they may be roofing tiles rather than floor or fireplace tiles (Figure 6.3; compare with Figure 6.4). All of the tin glazed fragments appear to be from thin fireplace or wall skirting tiles as they are less than 15.88mm (5/8") thick, in contrast to thicker floor tiles (usually greater than 19.05mm or 3/4") (Noël Hume 1969). Samples of collected tin glazed tiles are shown in Figure 6.5. A full inventory of ceramic tiles which lists additional information such as glaze color and location of recovery may be found in Volume 3.
