UNDERWATER ARCHAEOLOGICAL INVESTIGATION OF THE ROOSEVELT INLET SHIPWRECK (7S-D-91A)

VOLUME 1: FINAL REPORT

State Contract No. 26-200-03
Federal Aid Project No. ETEA-2006 (10)

SOUTHEASTERN ARCHAEOLOGICAL RESEARCH, INC.

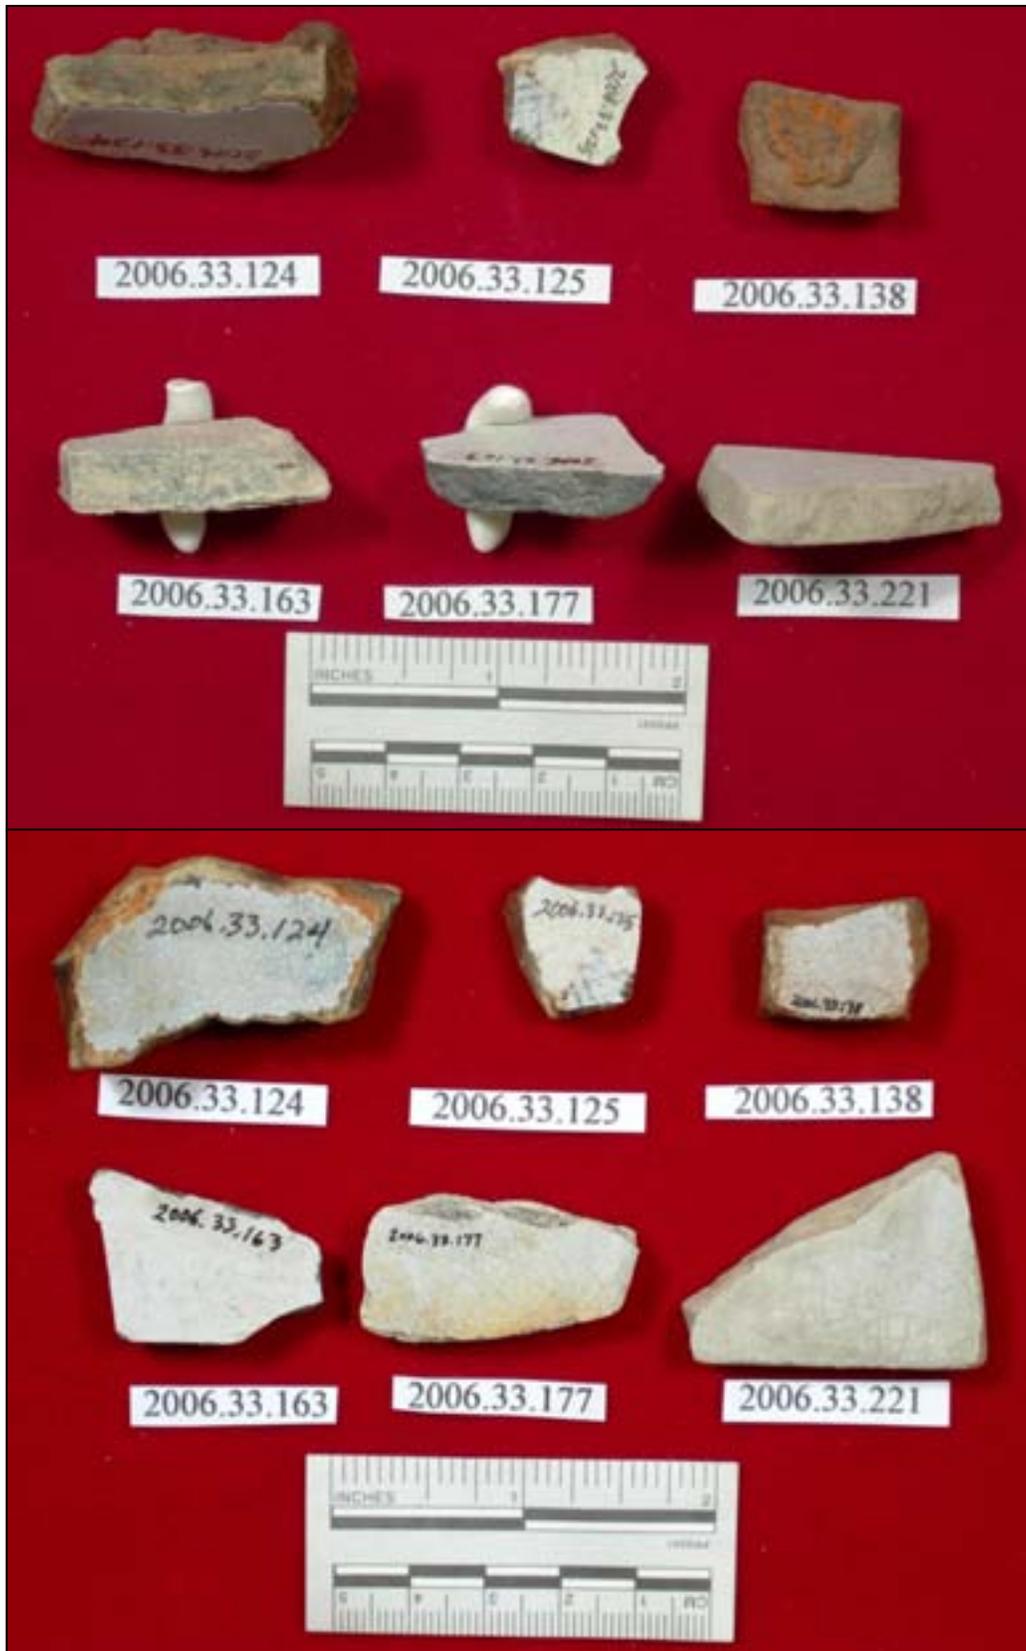
Figure 6.5. Examples of tin glazed tiles recovered from the site; side view (top) and front view (bottom).

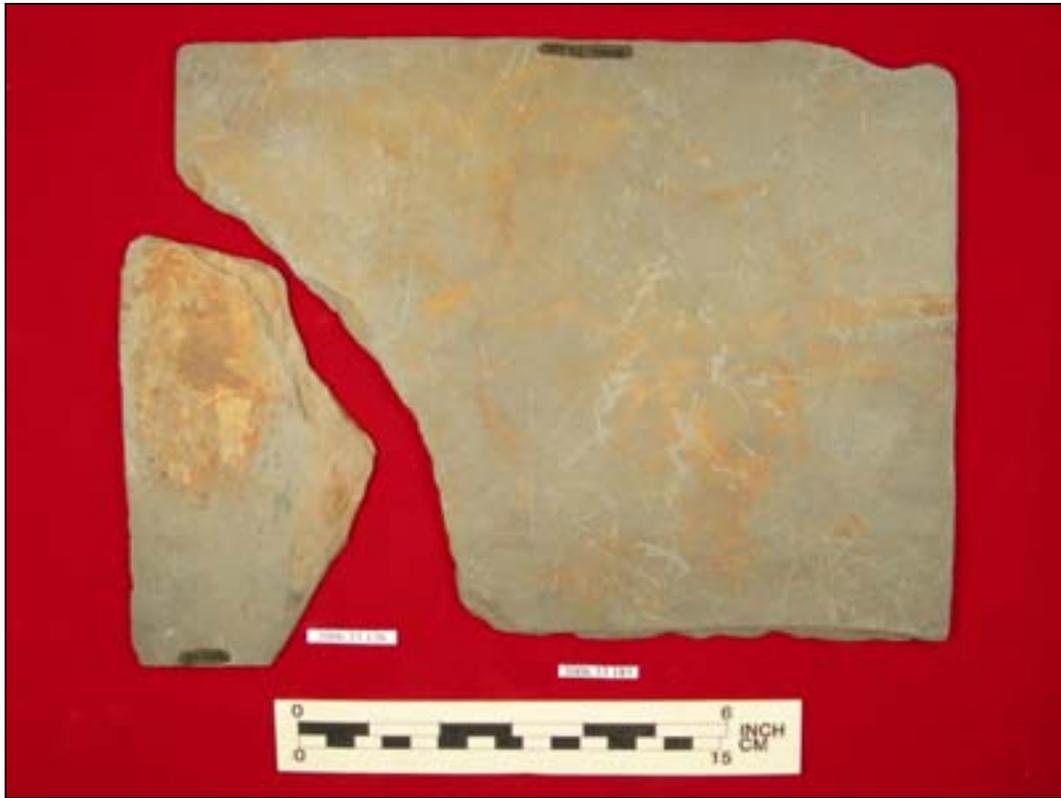
Figure 6.6. Slate fragments recovered from the site.

Three slate fragments were collected during the October 2006 field season. These consisted of one 170g fragment from N50/E50, plus one $\frac{3}{4}$ -complete tile weighing 868g and measuring 268.97mm x 206mm x 8.9mm and one fragment weighing 4g from N75/E70. Figure 6.6 is a photograph showing these slate artifacts.

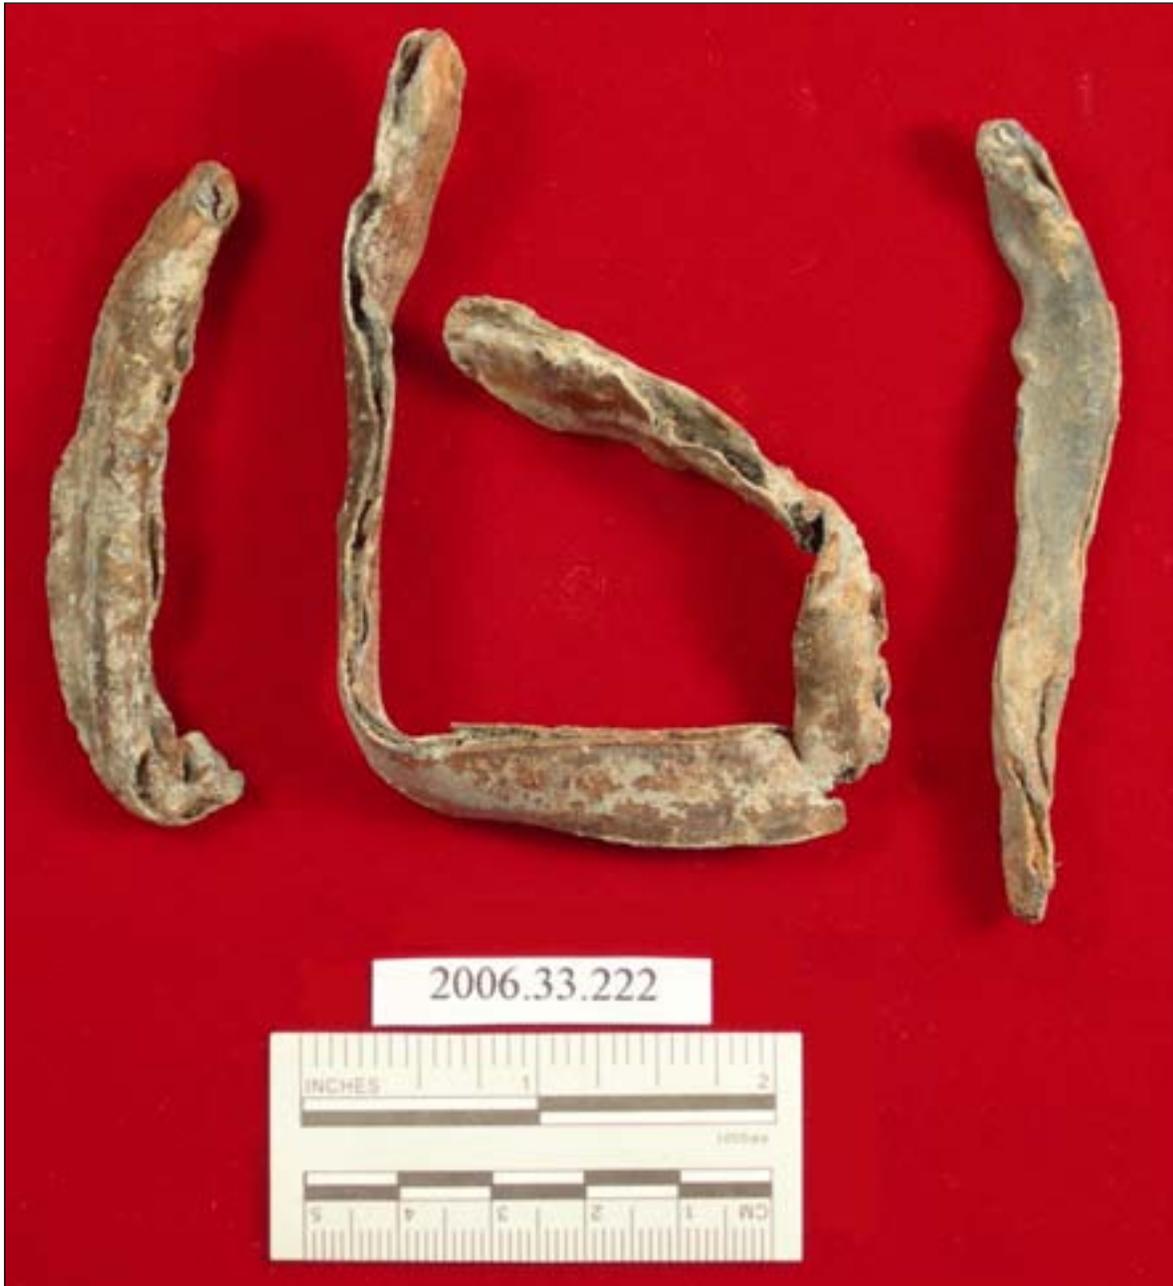
Figure 6.9. Flattened lead comes (2006.33.222).

Twenty-three window came (metal strips used to hold multi-shaped glazed glass within a wooden casement) fragments were also recovered from the excavations. One came has been identified as being pewter while the remaining 22 are lead. Of these, five have possible maker's marks which may yield specific manufacturing location and year information with additional research. It is suggested that additional comes be unfolded and examined for maker's marks, and that research into these marks be completed as part of future study. Figure 6.9 portrays examples of flattened lead comes. A full inventory of all comes collected from the October 2006 excavations is shown in Volume 3.

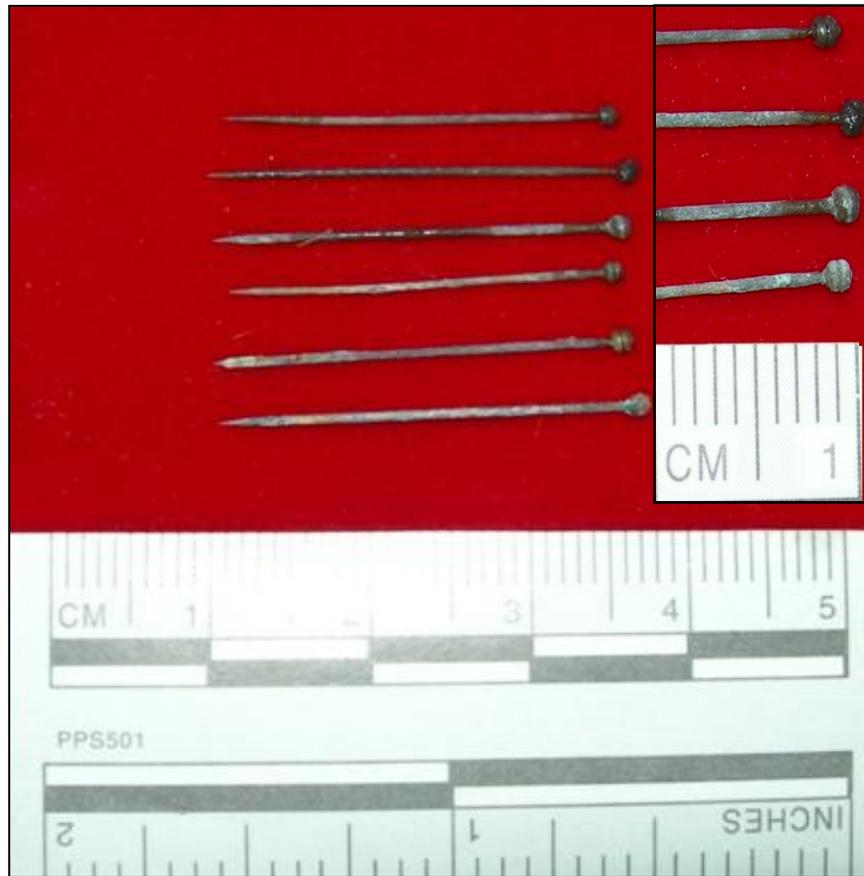
Figure 6.10. Straight pins from the Roosevelt Inlet Shipwreck site. Inset shows pin detail of pin heads.

Straight pins have always served two purposes. They were used both to fasten clothes while being worn, and they were used in the manufacturing process to hold fabric in place during sewing or hold thread during the production of bobbin lace. Sixteen hundred ninety-five (1,695) copper alloy straight pins were recovered during the October 2006 excavations (see Volume 3 for a full inventory). All of these pins were constructed of two pieces with a drawn wire shank and wire wound head (see Figure 6.10 inset, below). This style of pin manufacture is seen from the sixteenth through the early nineteenth centuries, until Lemuel L. Wright was given an English patent to manufacture solid headed pins (1824) (Beaudry 2006; Noël Hume 1969). The RIS pins appear to have evidence of tinning, a method of coating the surface in tin to impart a silver-like appearance. Tinning was carried out by “boiling the pins in a solution of potassium bitartrate containing granules of tin” (Deagan 2002:194, Tylecote 1972:184). Additional examination of photographic examples reveals that the shafts of some of the pins narrow slightly at the head, a characteristic noted by Tylecote (1972:187) in pins dating to 1778. All of the pins recovered thus far from the wreck range in size between 18.78 and 37.4 mm in length, which puts them in the range of common straight pins rather than special use pins (Beaudry 2006; Deagan 2002). Examples from the site are shown in Figure 6.10.

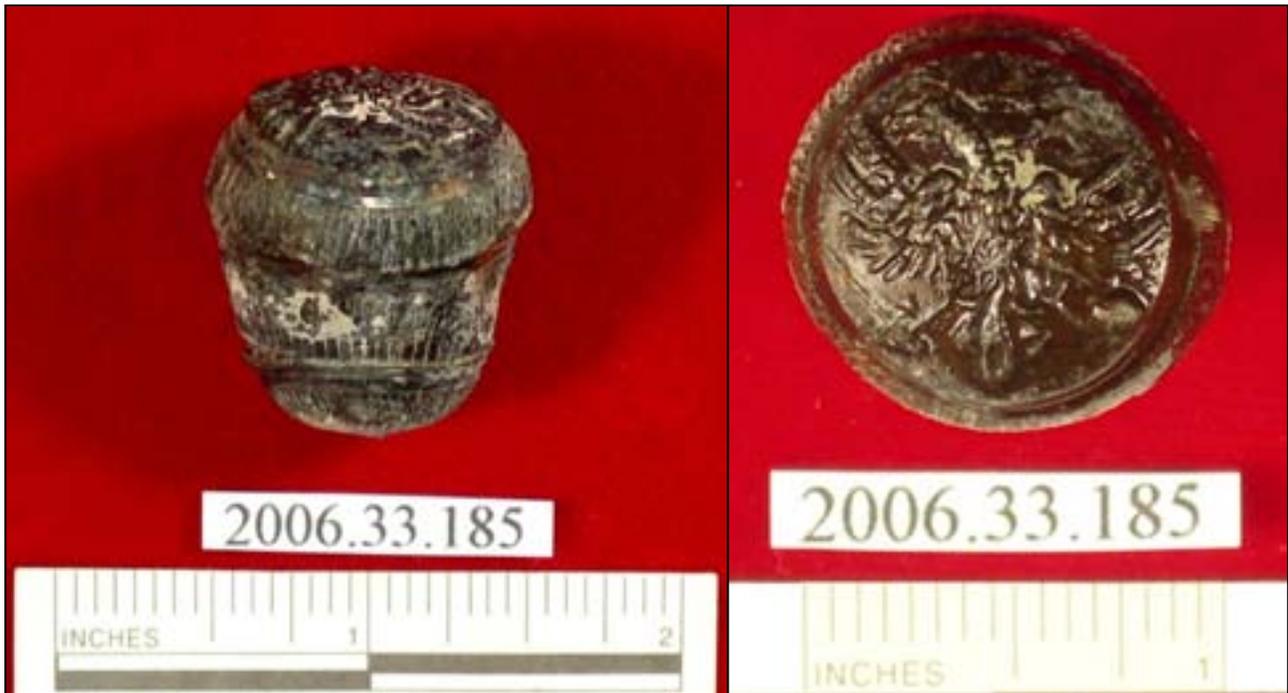
Figure 6.14. Thimble case with eagle insignia (2006.33.185); side view (left) and detail of insignia (right). Note the sword and orb clasped in the talons.

Also recovered were 26 egg- or acorn-shaped metal containers with threaded caps that have been tentatively identified by State of Delaware researchers as thimble cases (Faye Stocum personal communication with Mary Beaudry 2008, see Appendix F). All but two of these objects are of pewter construction with one identified as copper alloy and one as lead (or probably poorly made pewter). Some of these cases have molded decorations such as ribbing or concentric rings, leaf, or other designs. Seven have stamped double eagle-with-sword-and-orb designs on the cap that are similar to the insignia of those found in the Byzantine, Holy-Roman (prior to 1803) and Russian Empires (Figures 6.14 and 6.15) (Victoria and Albert Museum 2010). In the nineteenth century this heraldic design continued to be associated with the Austrian Empire prior to the forming of the Austro-Hungarian Empire in 1867 (Embassy of Austria 2010). Further research needs to be completed before the exact nature of these objects can be fully understood. Volume 3 is an inventory detailing these items.

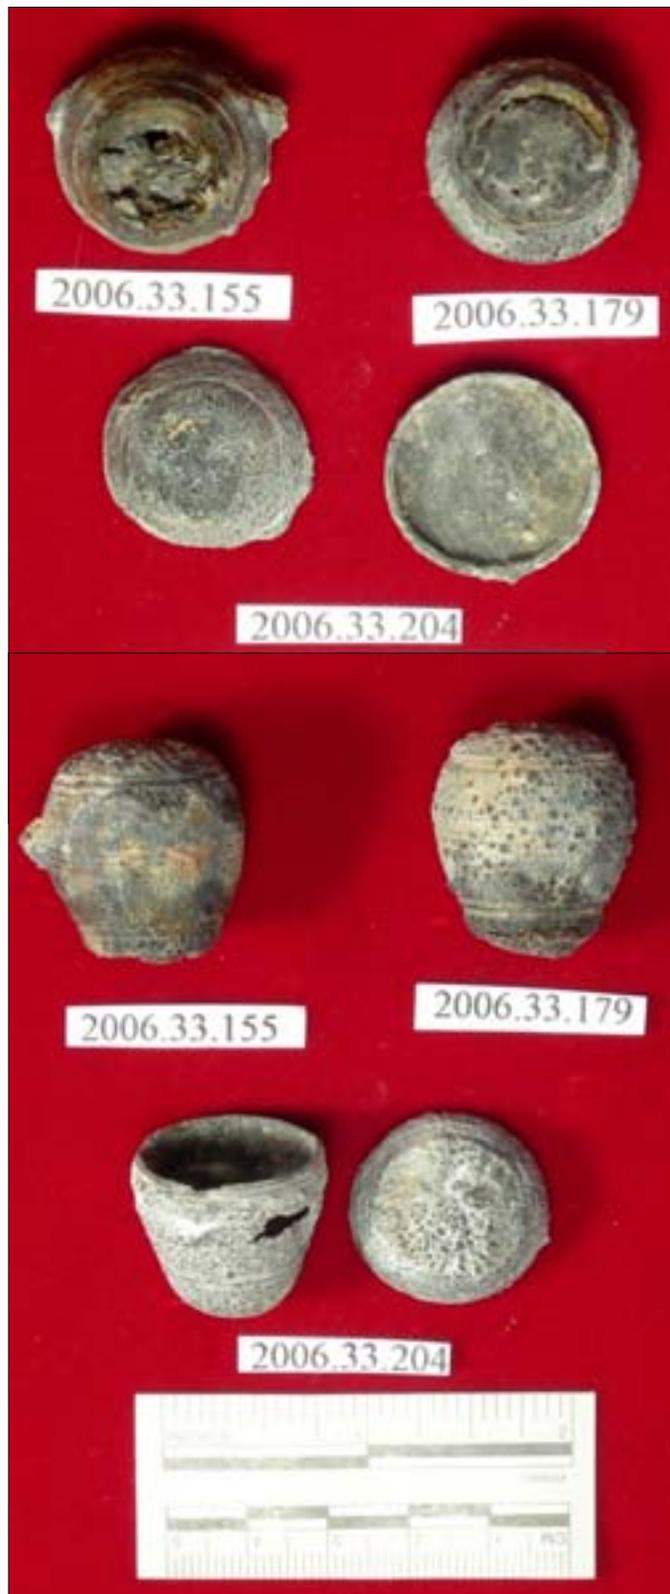
Figure 6.15. Thimble cases from the Roosevelt Inlet Shipwreck site.

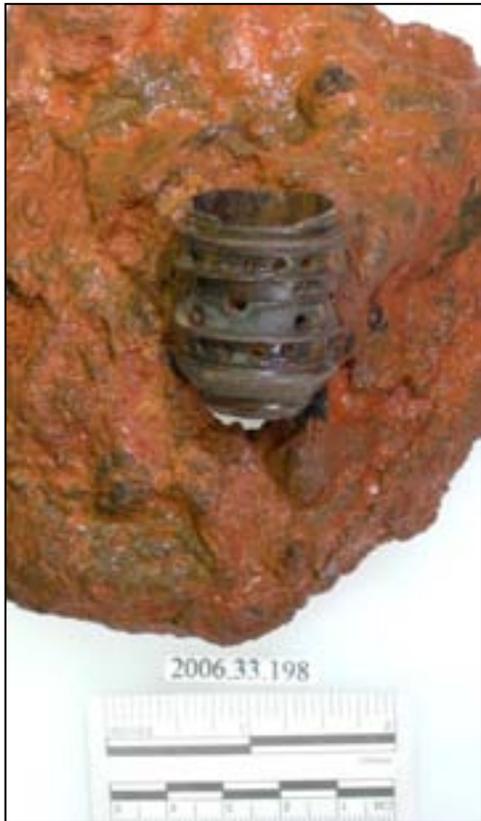
Figure 6.16. Thread case made of bone (2006.33.198).

Four bone objects have been identified as thread cases or bobbins. Figures 6.16 and 6.17 are examples of these items. One other bone object has been identified as a needle case (Figure 6.18). All of these items are constructed of polished bone.

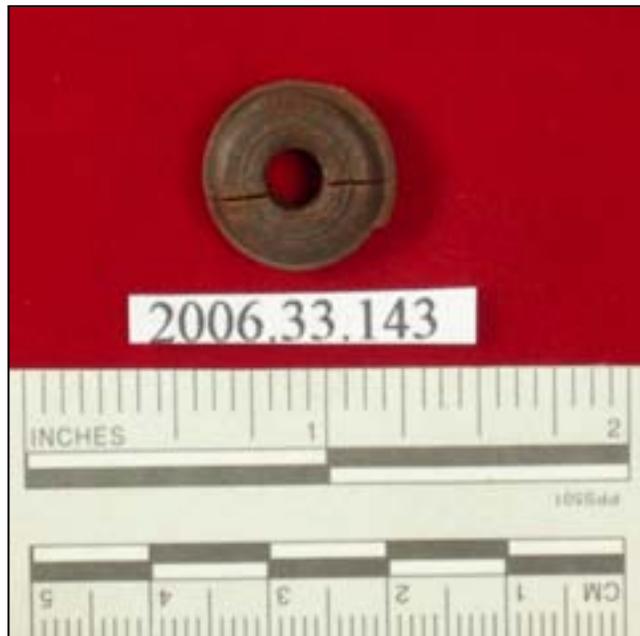
Figure 6.17. Bone bobbin (2006.33.143).

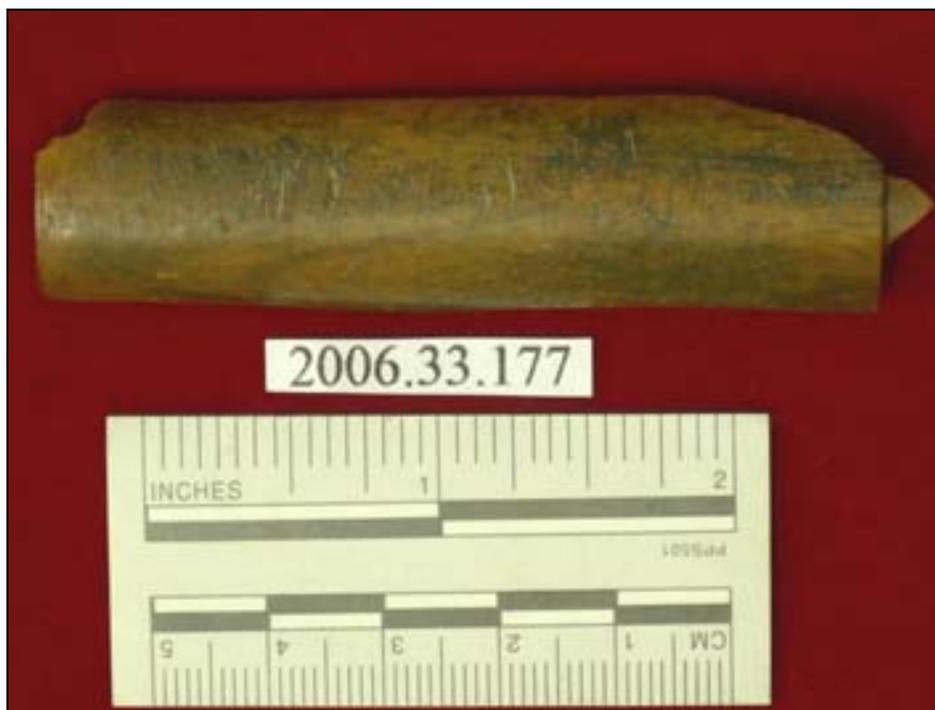
Figure 6.18. Bone needle case (2006.33.177).

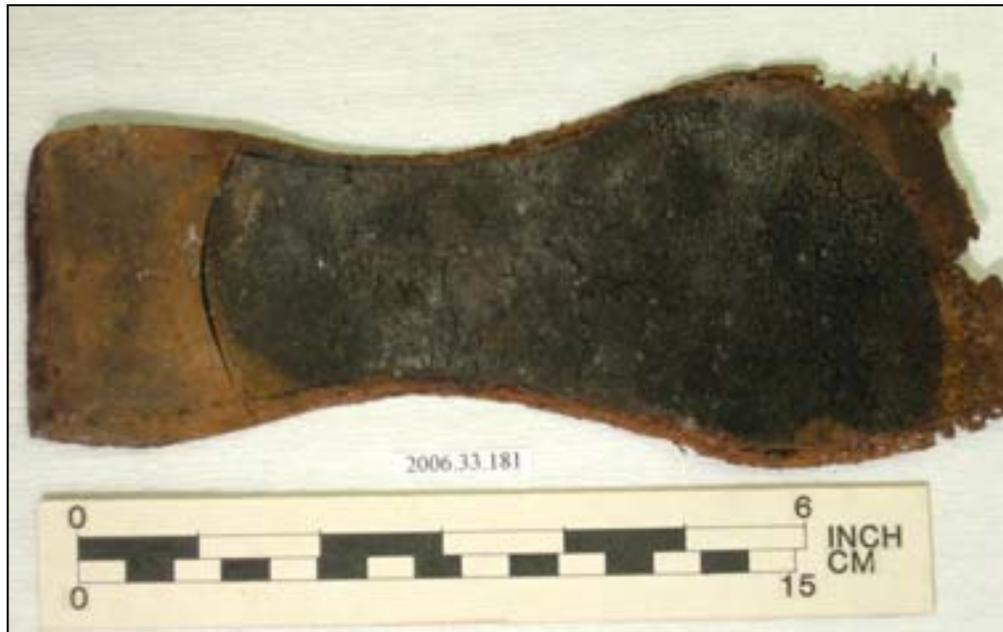
Figure 6.19. Shoe sole recovered from the Roosevelt Inlet Shipwreck site (2006.33.181).

Thirty-four shoe fragments have been identified from the October 2006 materials. Figures 6.19 and 6.20 are examples of shoe soles recovered from the Roosevelt Inlet Shipwreck site. Of the recovered shoe fragments, eighteen are leather fragments, six are felt, and the remainder is unidentified as to material type. An artifact inventory of shoe items recovered from the site is presented in Volume 3. This table details the shoe analysis completed thus far.

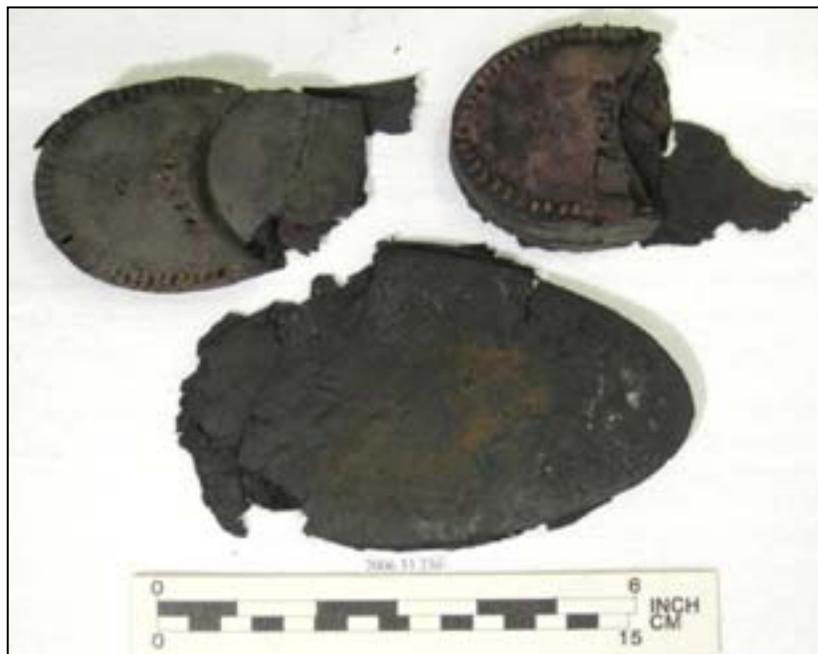
Figure 6.20. Shoe sole recovered from the Roosevelt Inlet Shipwreck site (2006.33.230).

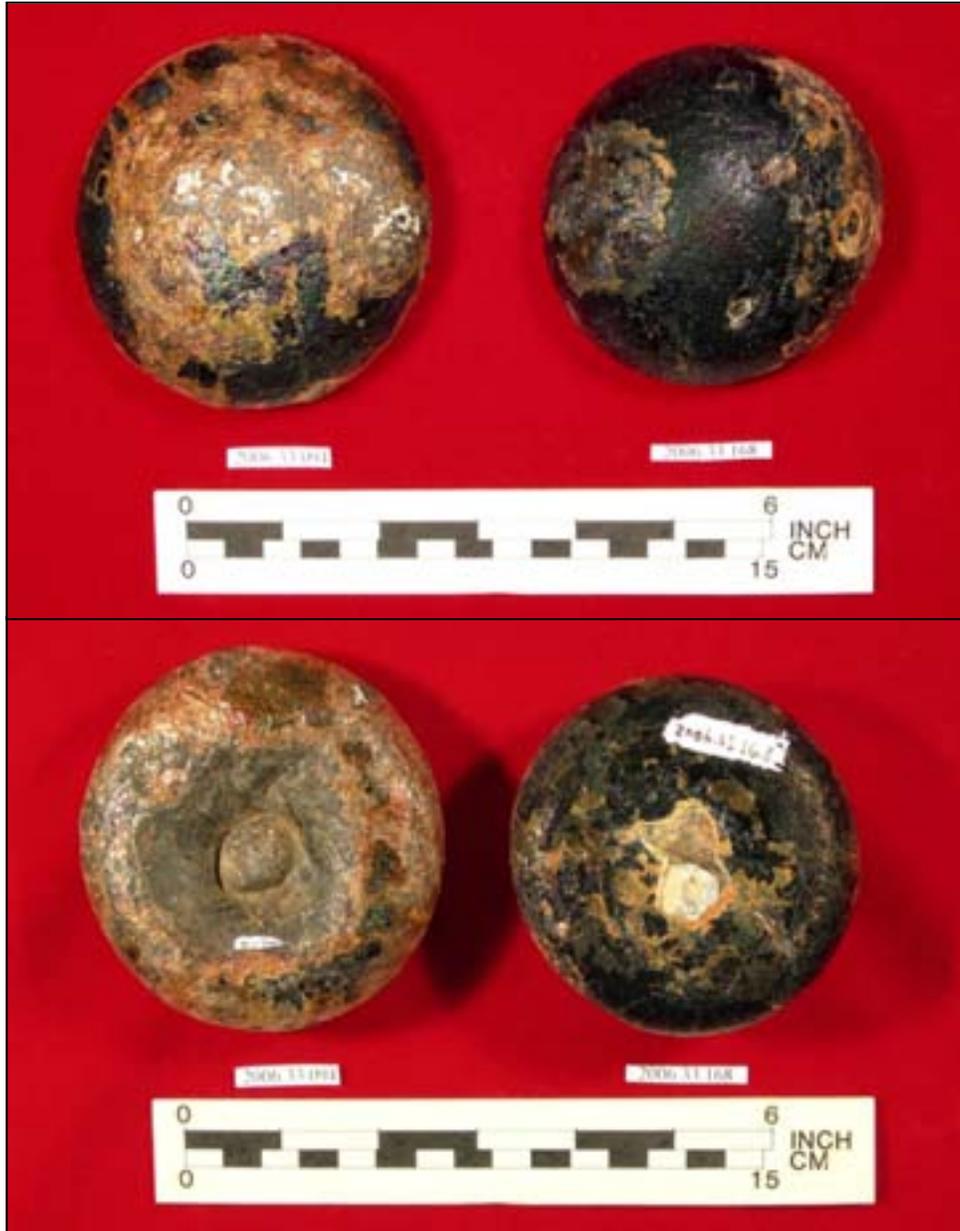
Figure 6.21. Dark green glass linen smoothers; convex view (top), concave view (bottom).

Two plano-convex dark green glass linen smoothers (Figure 6.21) were recovered from the wreck along with one ornate copper alloy pressing box type iron. Figure 6.22 is a composite of two views of this iron along with a line drawing by Sharyn Murray. These glass knobs would have been used to smooth out thin garments or to press fabrics in folds and pleats and would have been used with a small wooden smoothing board. Glass smoothers have been found in archaeological contexts dating from the Viking period in Europe and into the nineteenth century (University of Glasgow 2010). The iron has cast dolphin handle supports, and a compartment with a locking door in the body to house a

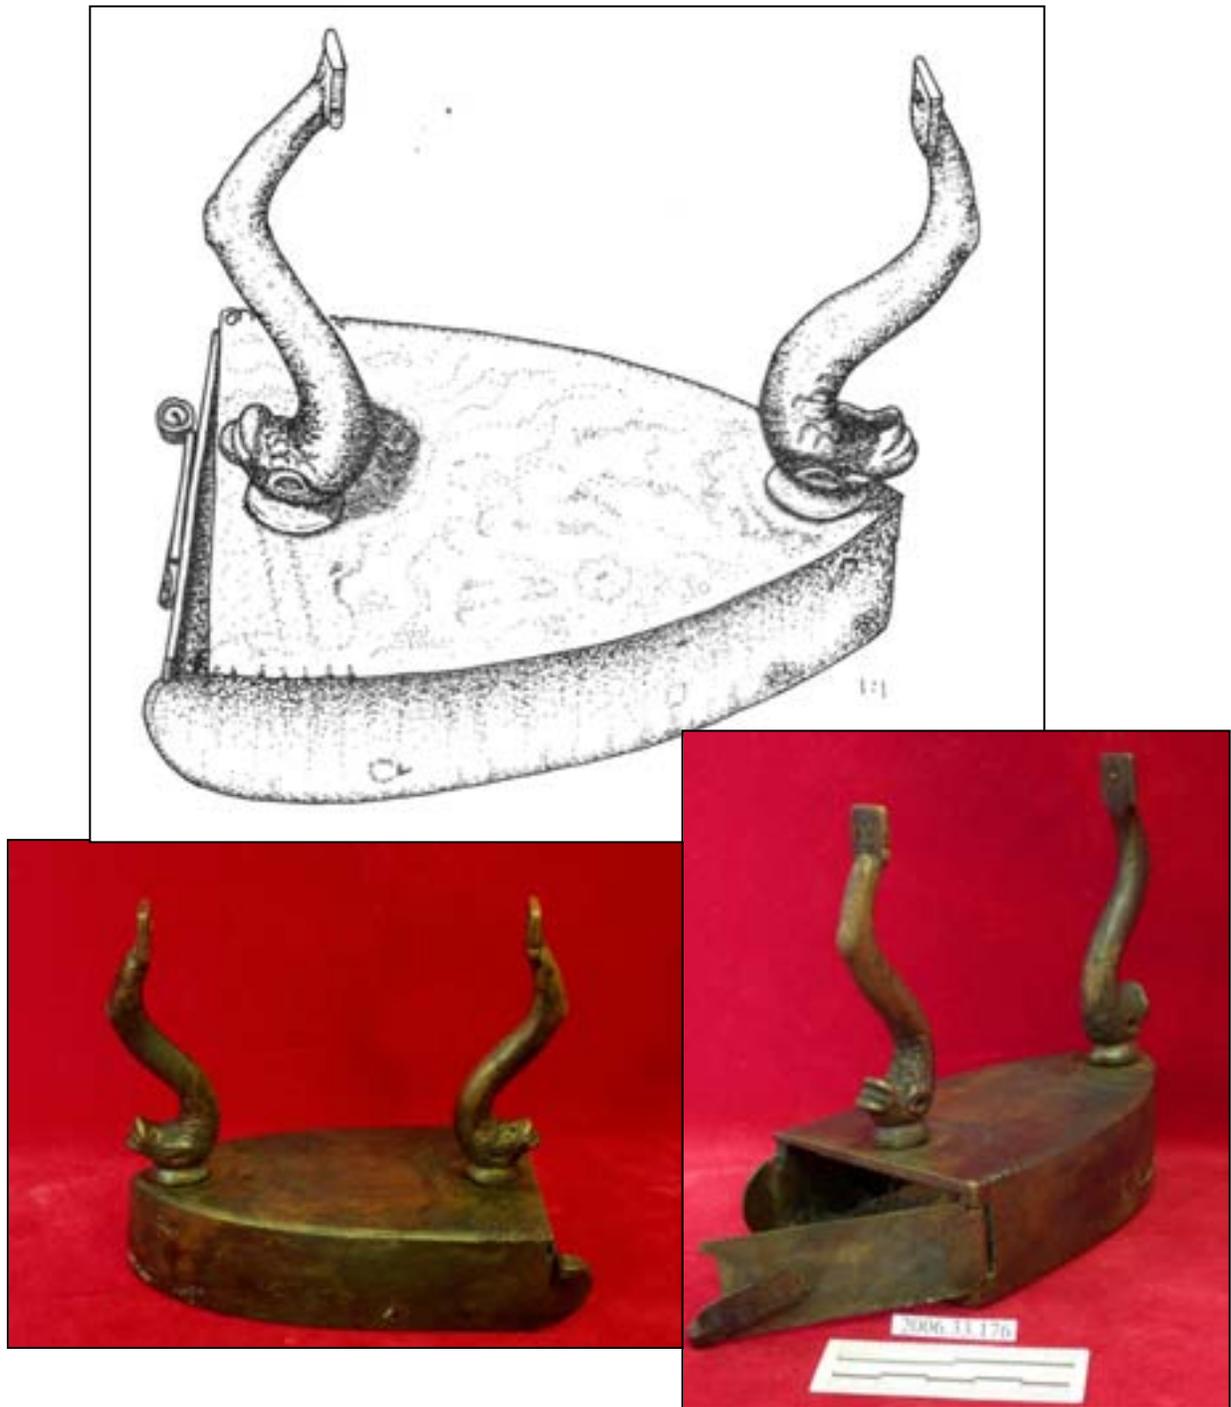
Figure 6.22. Illustration, rear and side views of brass pressing iron with dolphin-shaped handle supports (drawing by Sharyn Murray).

heating element. A similar iron from the period is shown in a copy of the circa 1765-82 portrait of a maid doing laundry (Figure 6.23), painted by Henry Morland (1716-1797) from the Tate Museum collection (Tate Museum 2010). Similar irons utilized loose charcoal as a heating element but irons of this type would have had vent holes to allow the coals to “breathe” and therefore continue to combust. The probable wooden handle from the box iron was not recovered during excavations.

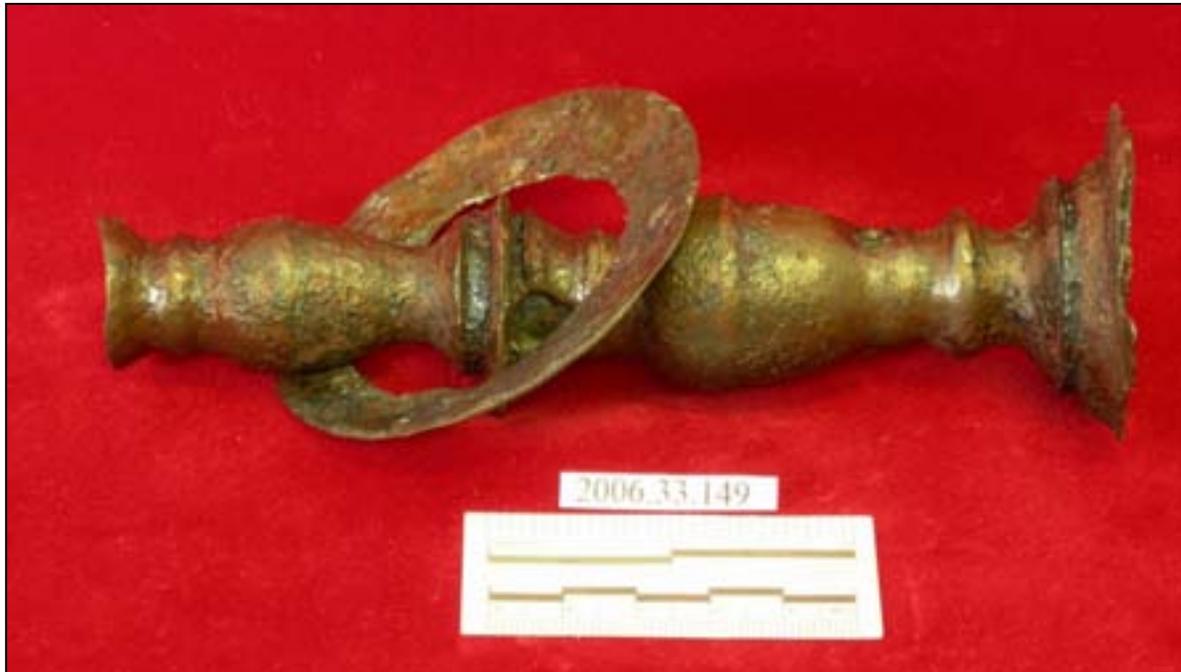
Figure 6.24. Candlestick holder; multi-piece design similar to Dutch styles of the seventeenth century (Schiffer 1978:148-149) (2006.33.149).

Two candlesticks and one candlestick holder were recovered from the October 2006 excavations. The first is an incomplete copper alloy candlestick consisting of mainly the center section, with the very top and outer edges of the base missing (Figure 6.24). It appears to be of a multi-piece construction formed with two balusters joined horizontally in the center of the stem. Next is a complete, two-piece mold design with a central baluster stem and tulip shaped holder. The base of this copper alloy candlestick is square with clipped corners (Figure 6.25). Last is a copper alloy, tulip-shaped holder with a drilled clean-out hole. This holder has evidence of having been broken away from a stem (Figure 6.26).

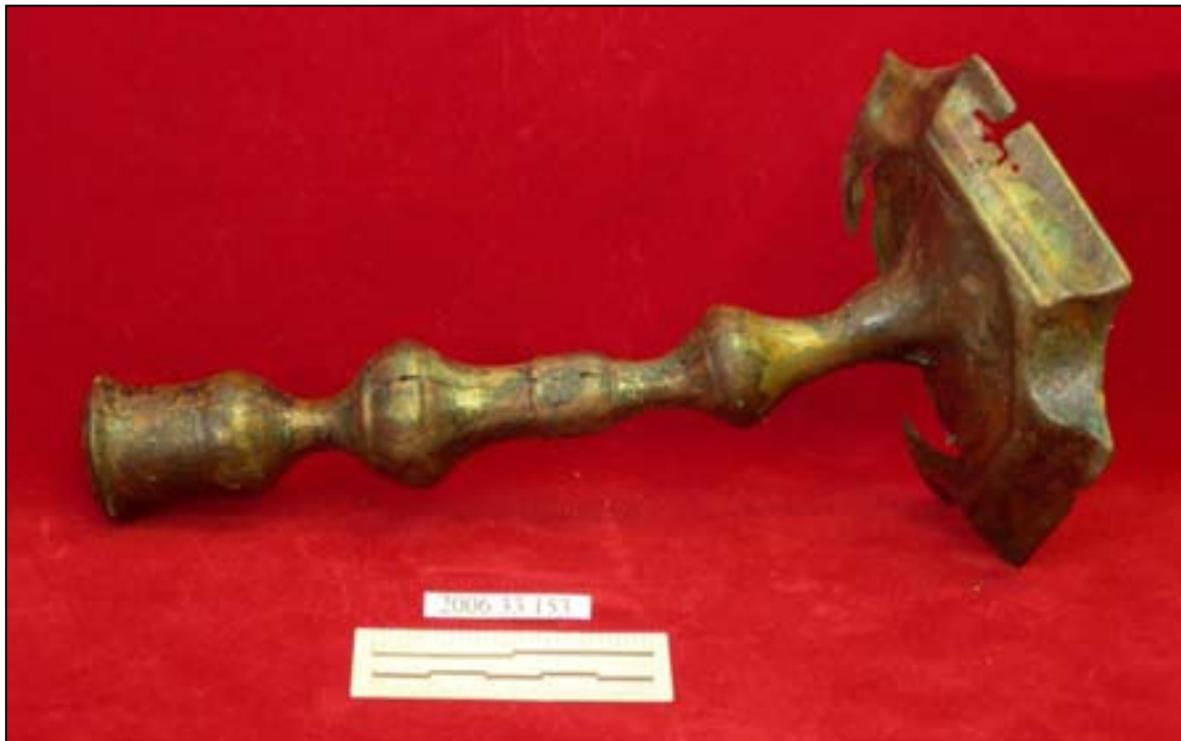
Figure 6.25. Candlestick holder; two piece mold design with tulip shaped holder and square base similar to English style of the early eighteenth century (Shiffer 1978:195B) (2006.33.153).

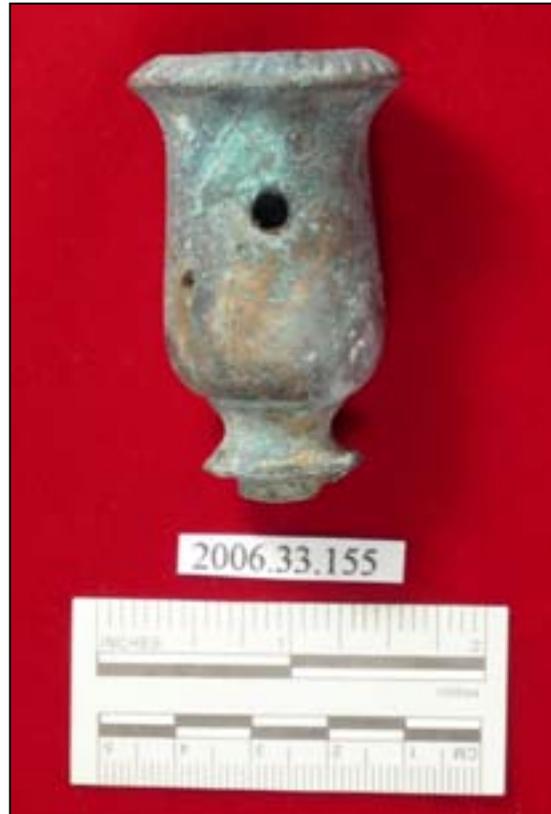
Figure 6.26. Tulip-shaped candle holder with a drilled clean-out hole (2006.33.155).

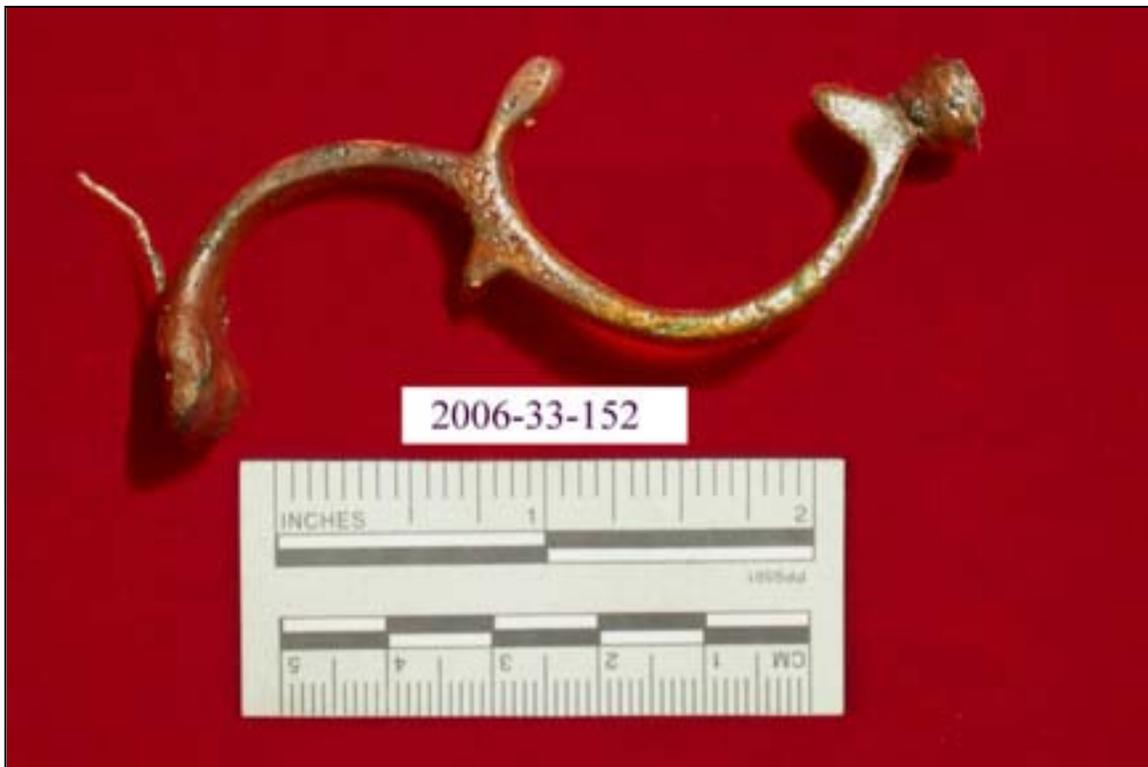
Figure 6.27. Copper alloy Rococo style arm from either a sconce or a chandelier (2006.33.152).

Additionally, one cast copper alloy arm from either a sconce or a chandelier was also recovered from the wreck. This curved fragment is cast in the Rococo style made popular in France during the eighteenth century. Figure 6.27 is a photograph of this item.

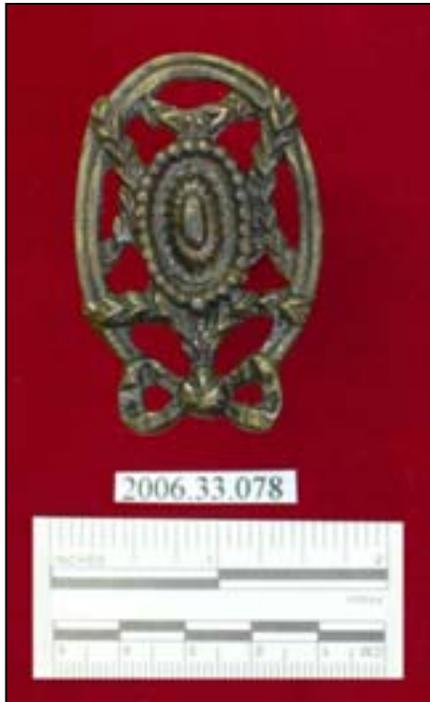
Figure 6.28. Curtain tie back with crest (2006.33.078).

Other furnishing pieces recovered include one cast copper alloy bracket or faceplate with three small holes and three glass wall sconce or chandelier fragments. Other copper alloy items include two curtain rings, three curtain tie backs, one drawer pull, and one finial. Also collected were three pewter finials. One possible clock foot (copper alloy) with a foliate pattern, and several other plain feet were also recovered. Figures 6.28-6.36 illustrate examples of the above items.

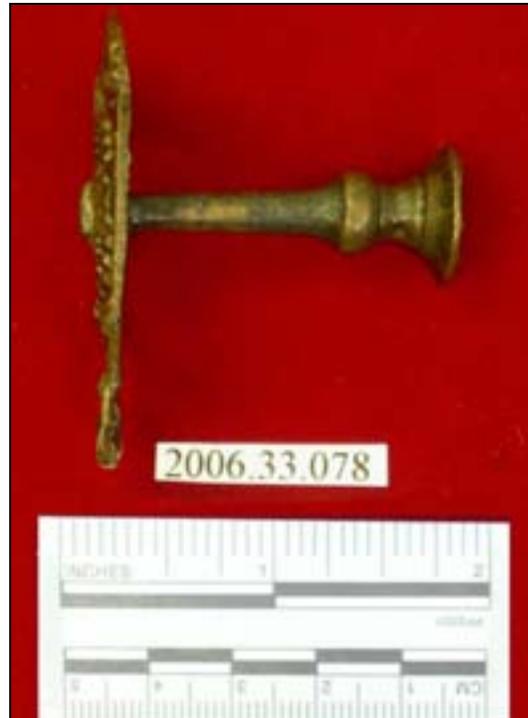
Figure 6.29. Side view of curtain tie back.

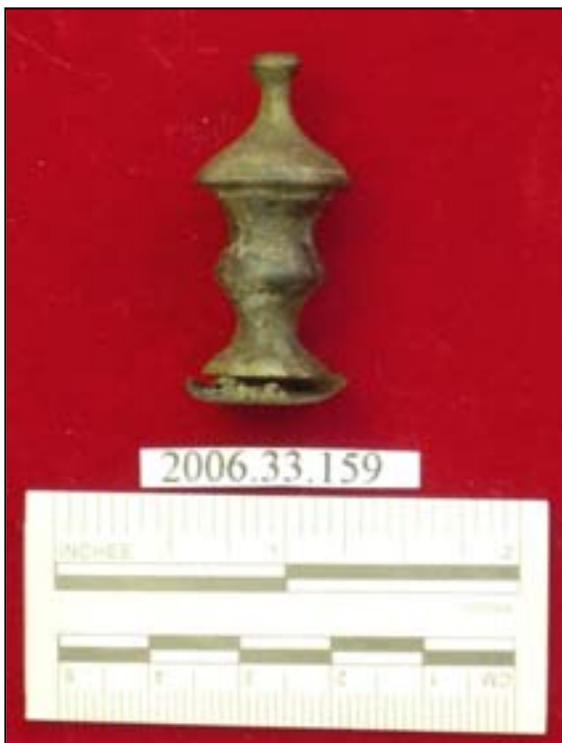
Figure 6.30. Copper alloy finial (2006.33.159).

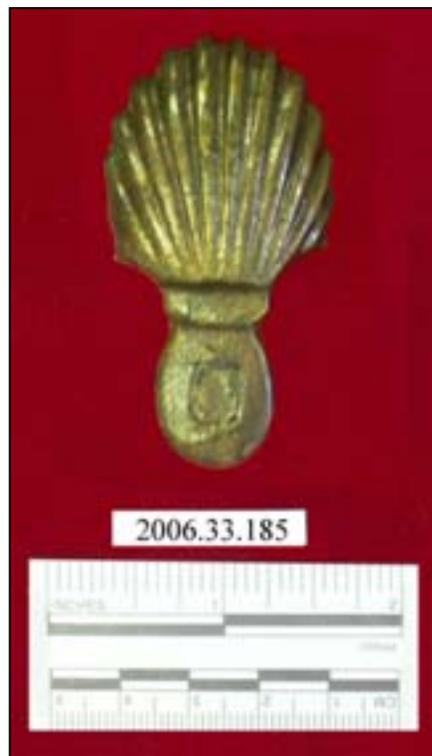
Figure 6.31. Shell shaped curtain tie back (2006.33.185).

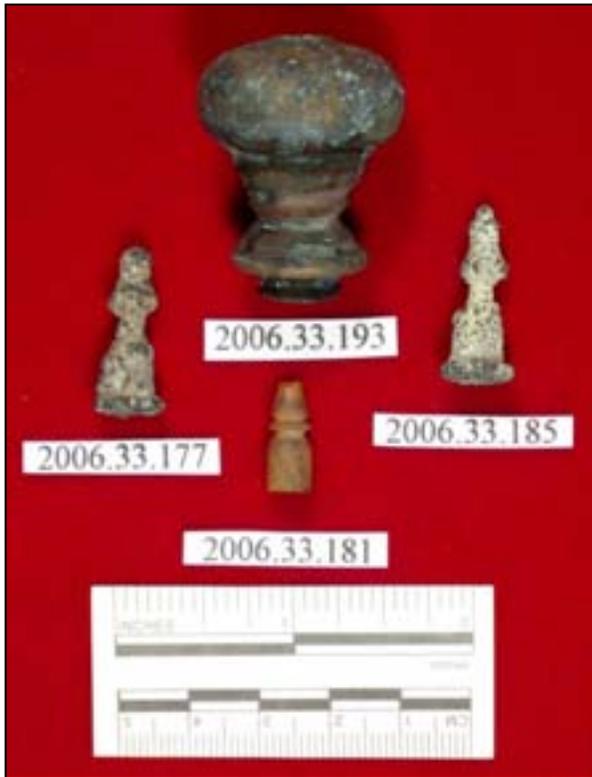
Figure 6.32. Copper alloy drawer pull and pewter finials.

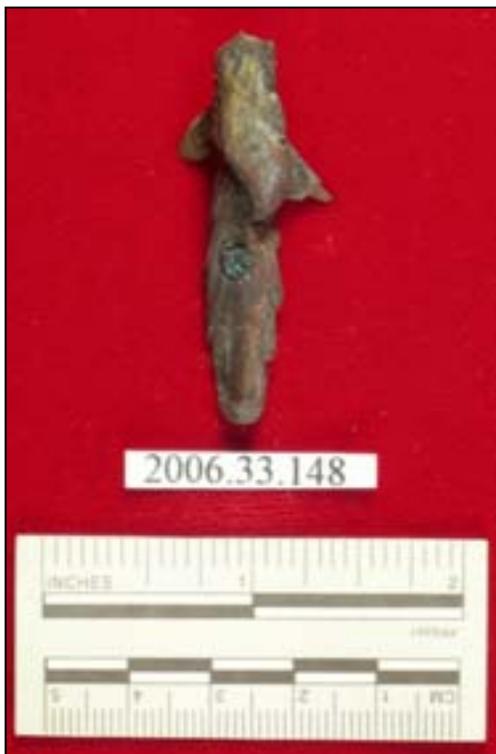
Figure 6.34. Possible clock foot with foliate pattern (2006.33.148).

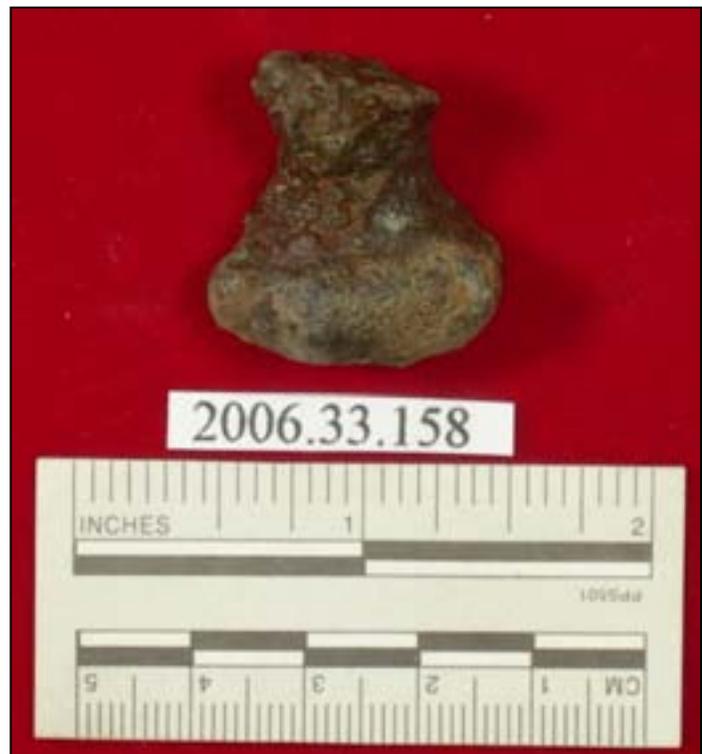
Figure 6.35. Plain foot from a decorative object (2006.33.158).

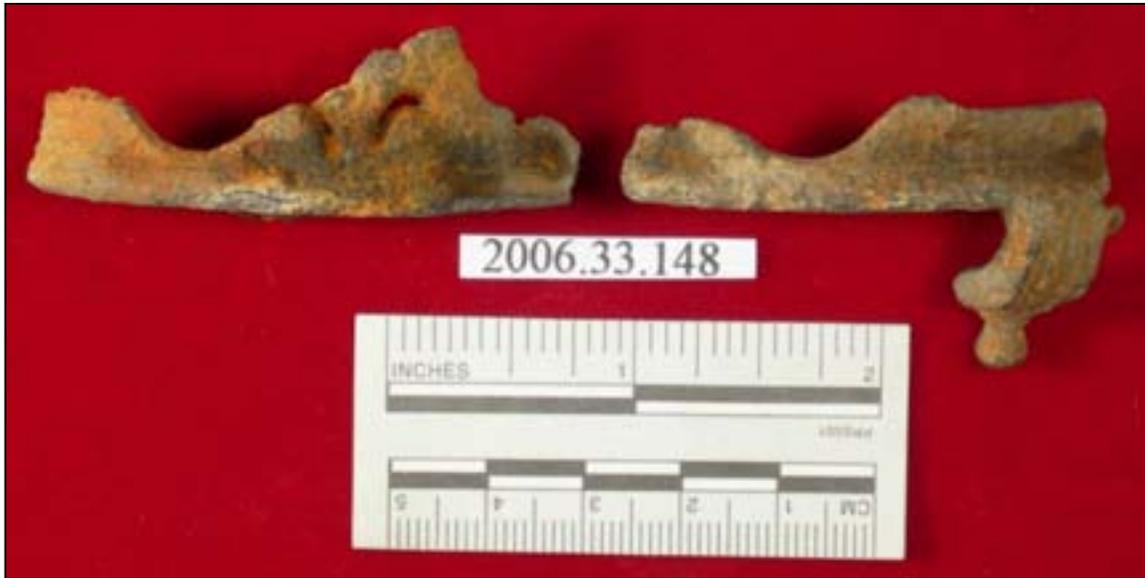
Figure 6.36. Feet from a clock or decorative object (2006.33.148).

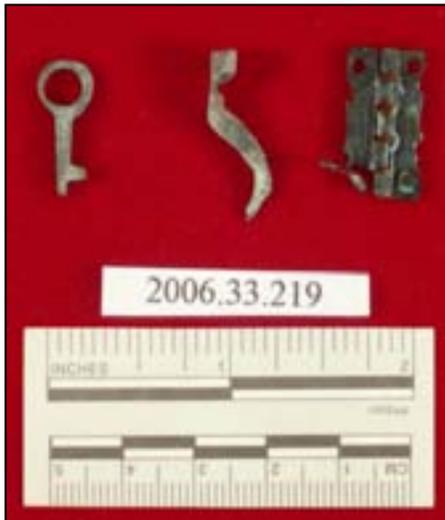
Figure 6.37. Small furniture parts (2006.33.219).

In addition, one furniture chest or clock hinge (Figure 6.37) and one escutcheon plate or lock part was found, also of copper alloy (Figure 6.38). Finally, one spring catch and 197 copper alloy upholstery tacks were identified (Figure 6.39). Upholstery tacks are common from the seventeenth century onwards and consist of hollow domed heads with welded shanks. None of these items, however, are diagnostic for either origin of manufacture or temporal placement.

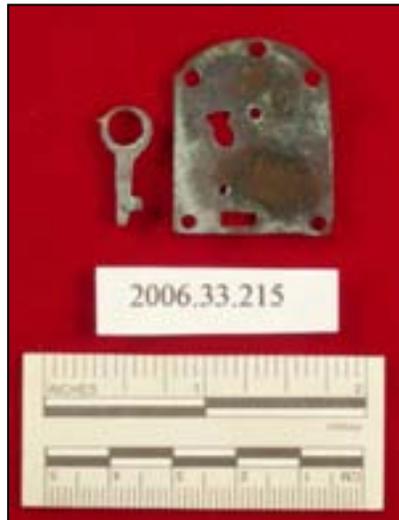
Figure 6.38. Escutcheon plate (2006.33.215).

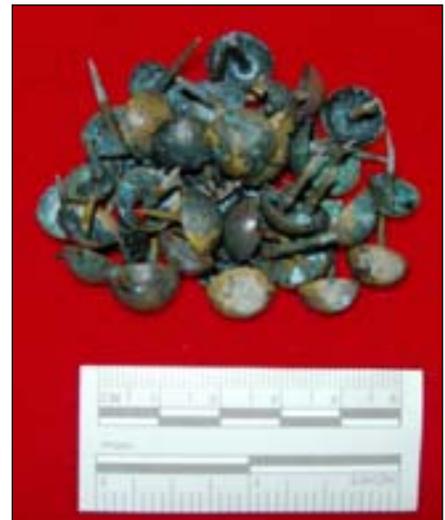
Figure 6.39. Copper alloy upholstery tacks.
