UNDERWATER ARCHAEOLOGICAL INVESTIGATION OF THE ROOSEVELT INLET SHIPWRECK (7S-D-91A)

VOLUME 1: FINAL REPORT

State Contract No. 26-200-03
Federal Aid Project No. ETEA-2006 (10)

SOUTHEASTERN ARCHAEOLOGICAL RESEARCH, INC.

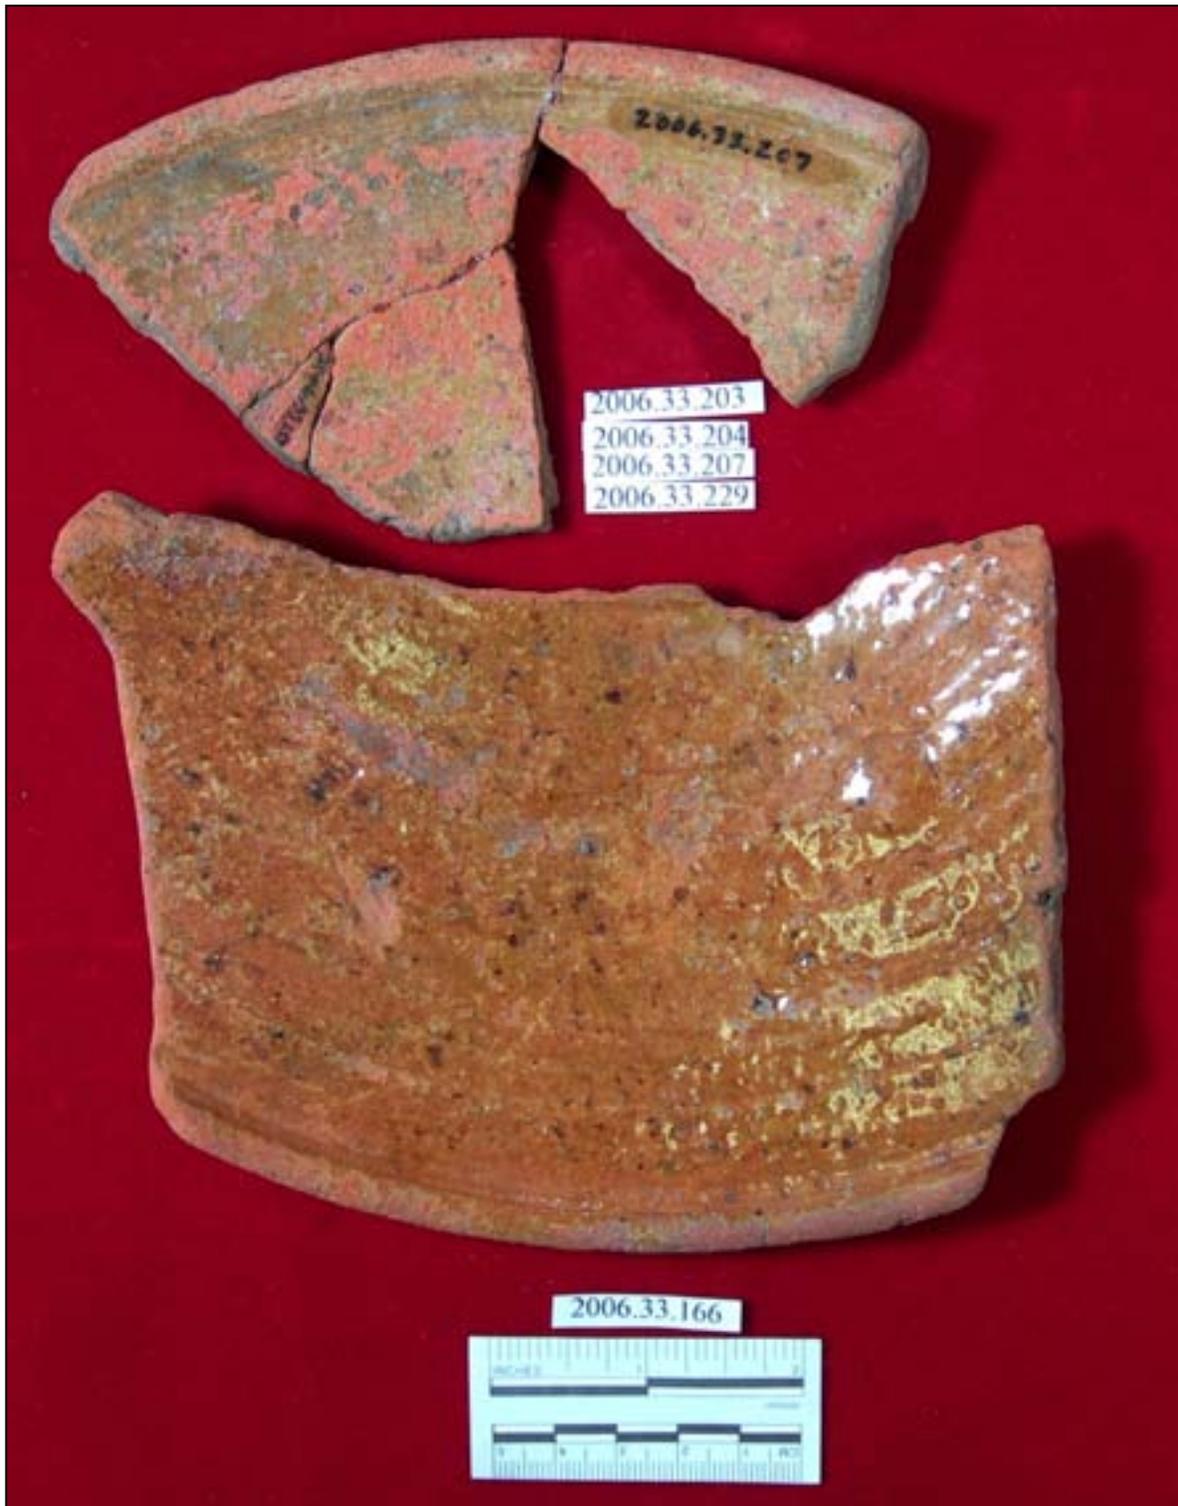
Figure 6.40. Red bodied, lead glazed coarse earthenware fragments from a large vessel.

Examples of lead glazed coarse earthenware found at the Roosevelt Inlet Shipwreck include red-bodied variants along with white-to-yellow-buff bodied. Figure 6.40 is an example of the red-bodied variant recovered from the wreck. Glazes on these sherds are often clear but can also be yellow-green, yellow-brown, or green in color. Sherds from each of these color ranges have been recovered from the wreck. One very distinctive, bright apple green perforated vessel sherd (Figure 6.41) recovered from the beach surface collection is very

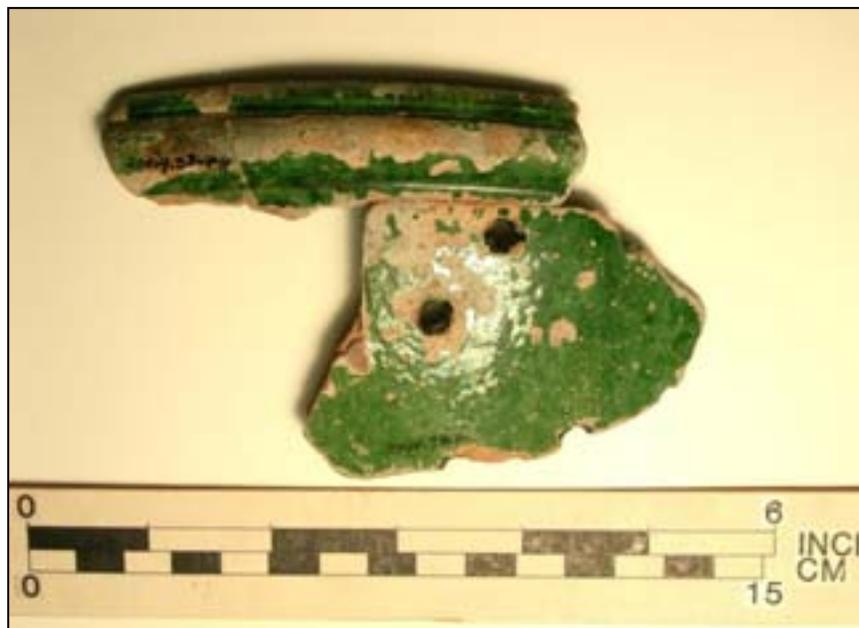
Figure 6.41. Distinctive bright apple green perforated vessel sherd from the beach surface collection.

similar in color and paste to French pottery from the southwest area of Saintonge, examples of which were recovered from the vessel *Machault* which sank in Chaleur Bay inbound for Montreal in 1760 (Bartels 1998; Sullivan 1986:98).

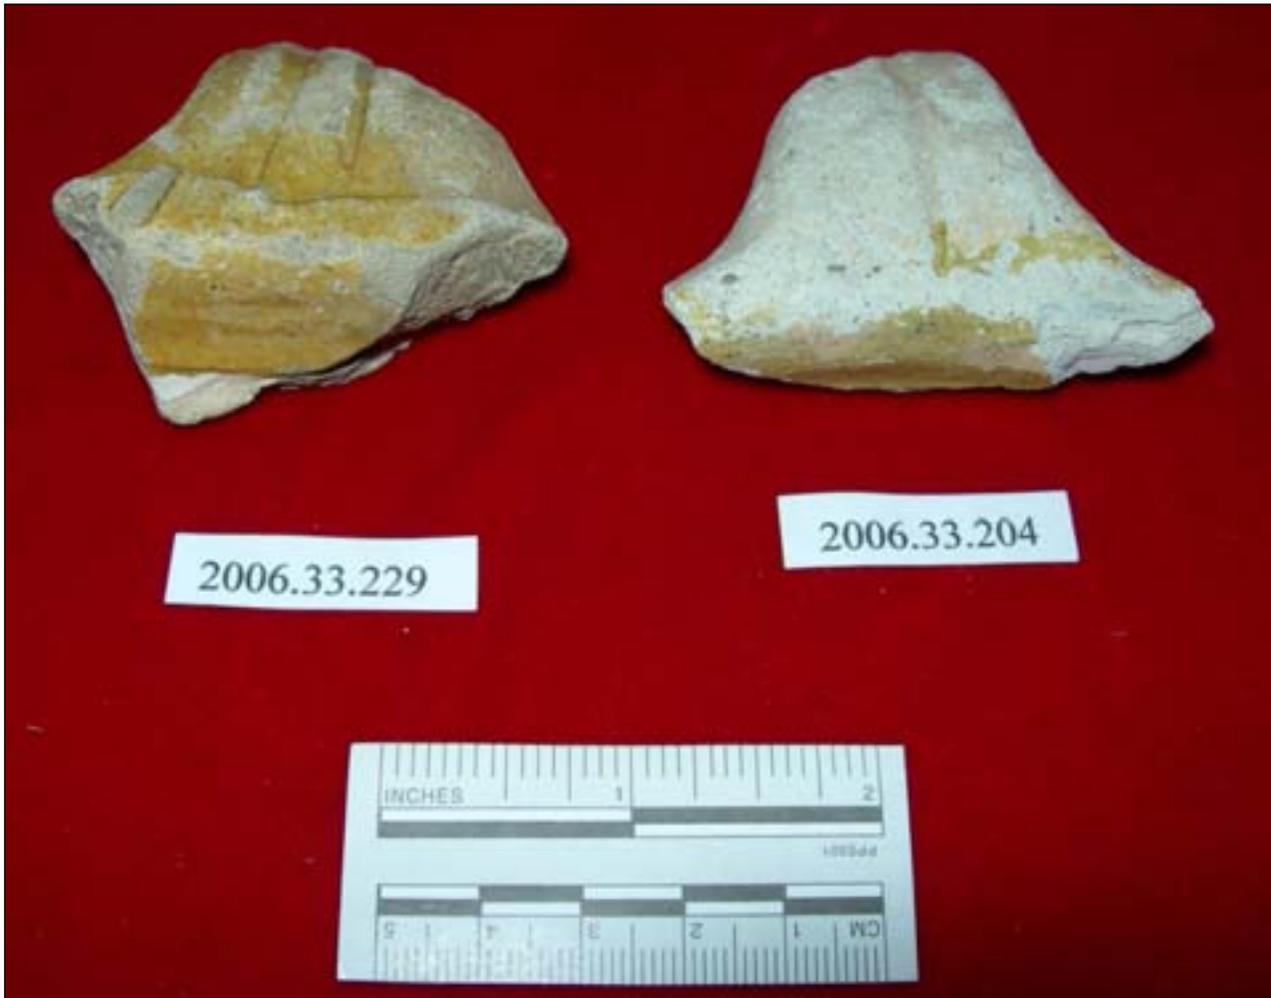
Figure 6.42. Yellow bodied German Frankfurter ware handle fragments (2006.33.229 and 2006.33.204).

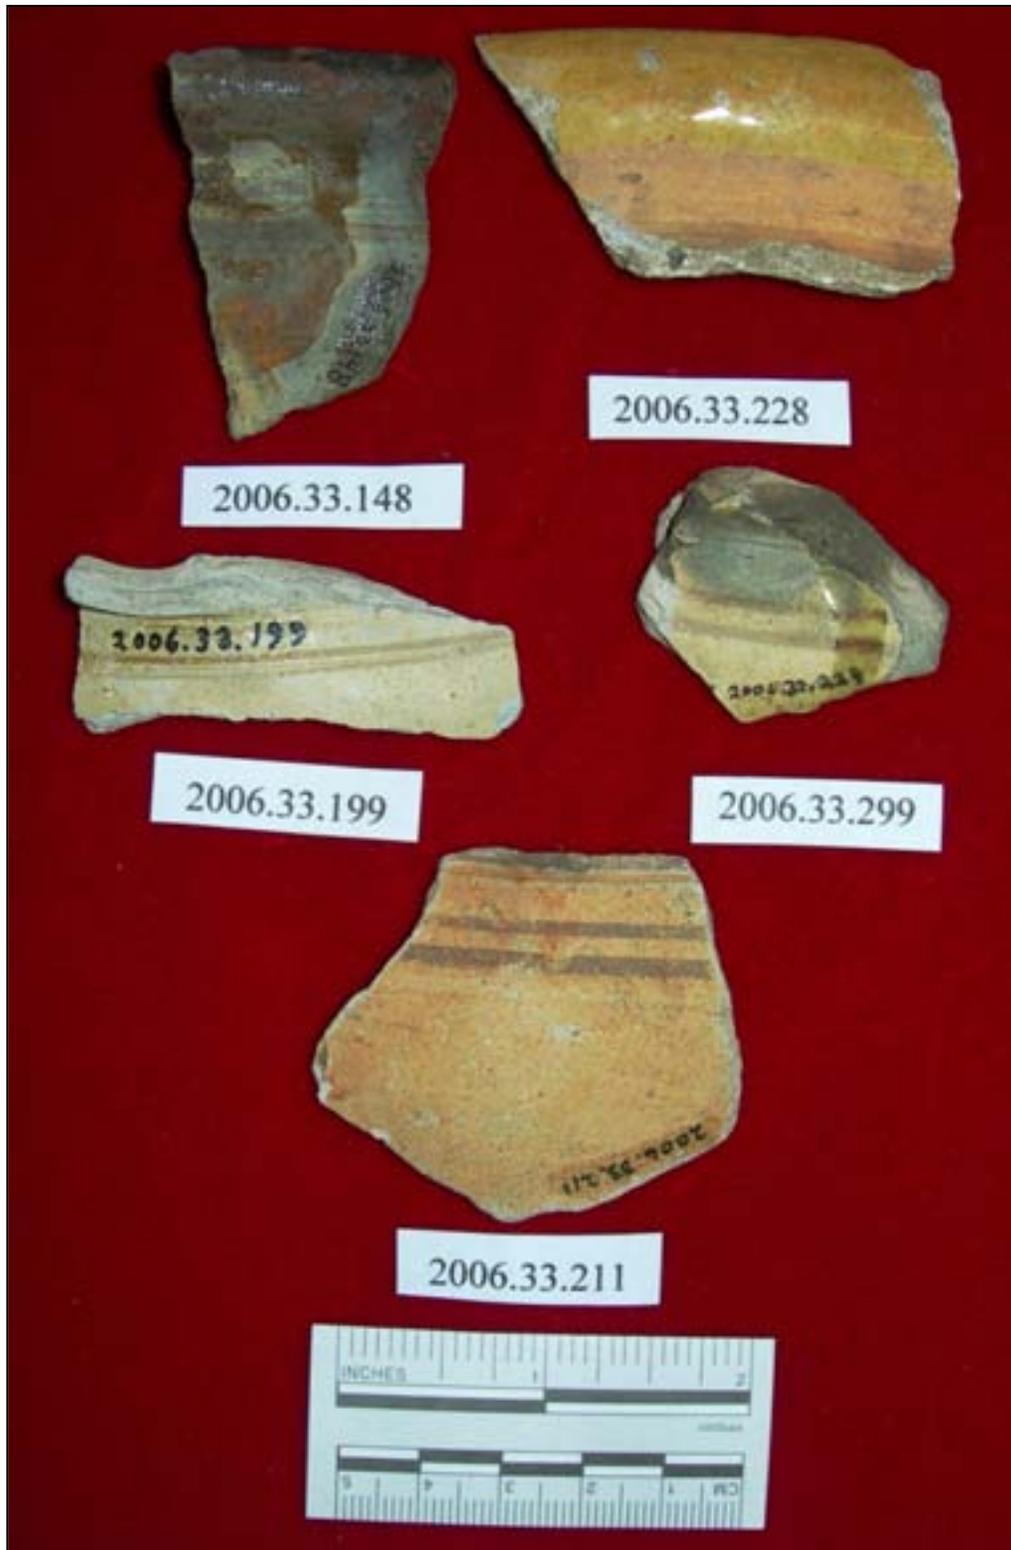
Figure 6.43. Assortment of Frankfurter ware vessel fragments.

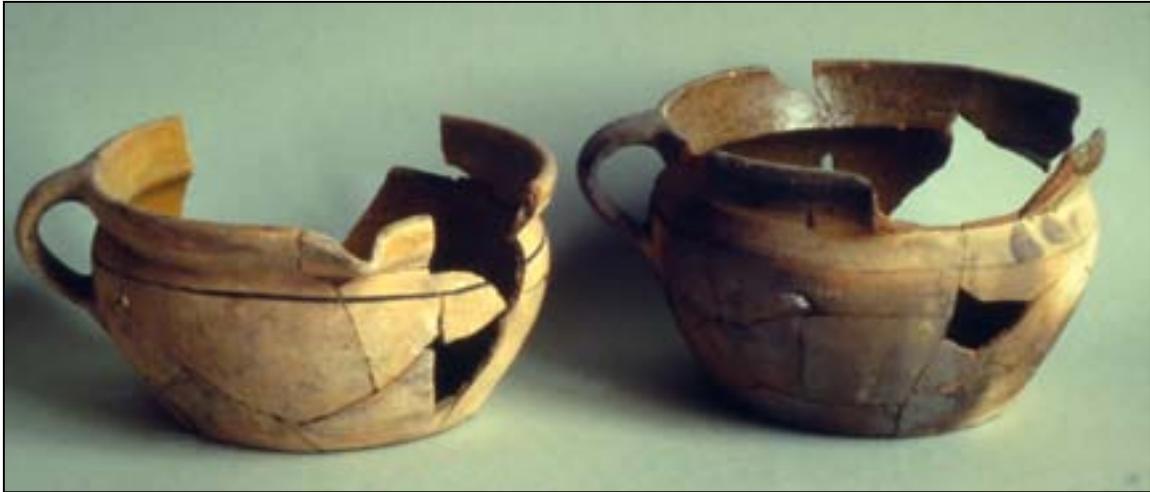
Figure 6.44. Examples of Frankfurter ware from the Netherlands. (Bartels 1998)

Analysis to determine minimum number of individual (MNI) vessels based on singular attributes estimated that at least 21 separate vessels are represented in the data. (Appendix G, Table G-1 tabulates this analysis.) Forty-two of the 166 Frankfurter ware sherds recovered from the excavation are base fragments. Of the remainder, 73 are body sherds, two are from handles (Figure 6.42), two are handle/rim, 36 are rim, and 11 are undetermined fragments. All of the yellow/white Frankfurter ware recovered from the shipwreck has been identified as being of German manufacture by Michiel Bartels (State of Delaware March 2010). The ceramics shown in Figure 6.43 have also been identified as Frankfurter ware. Figures 6.44 and 6.45 are examples of Frankfurter ware from the Netherlands (Bartels 1998).

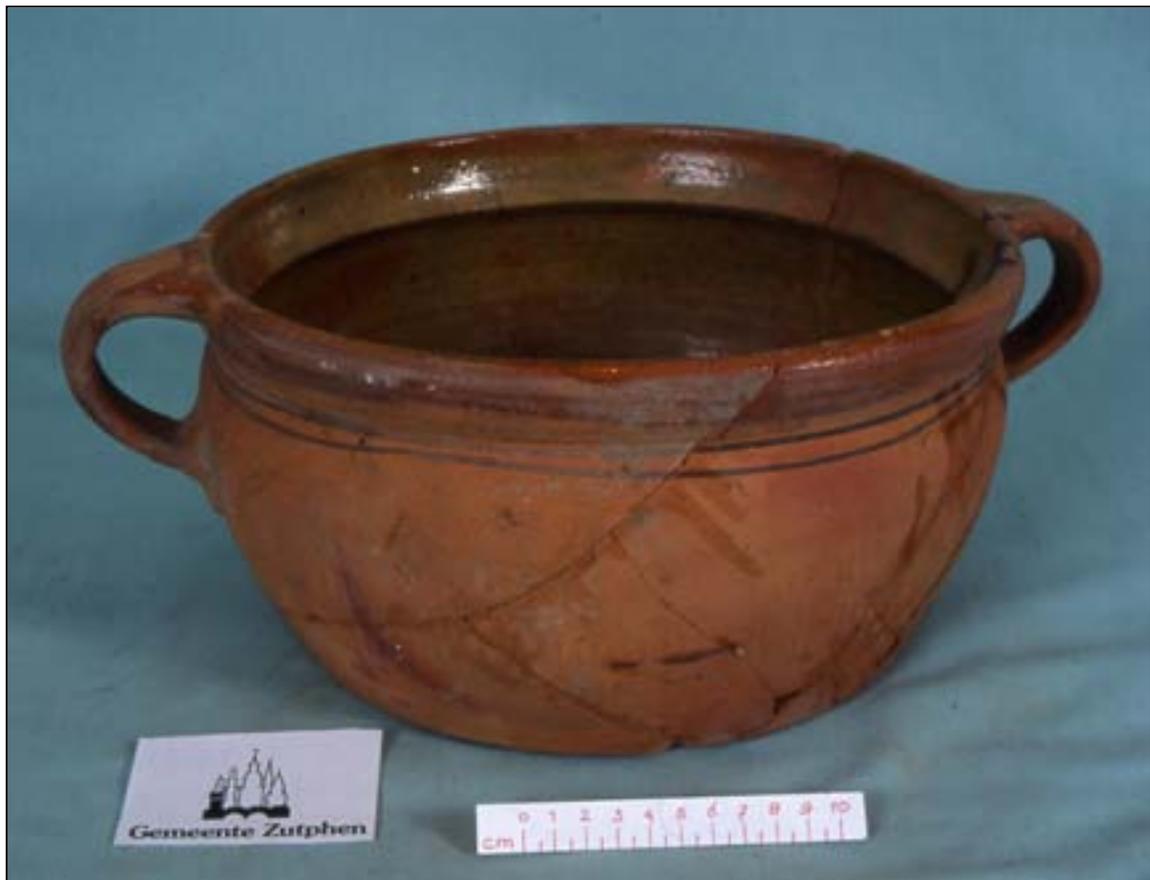
Figure 6.45. Example of red bodied Frankfurter ware from the Netherlands. (Bartels 1998)

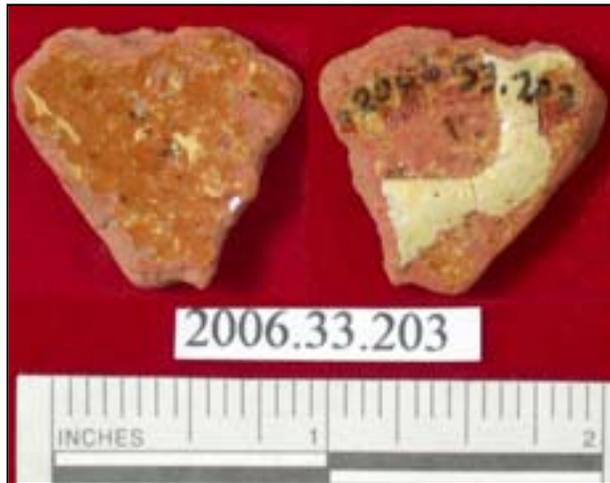
Figure 6.46. Red bodied slip decorated vessel fragments (2006.33.203).

Decorative techniques varied across the manufacturing regions. In England, slipwares were often white slipped on the interior of plates and platters, on both the interior and exterior for open containers such as bowls and mugs or porringers, and on the exterior for jugs and bottles with the addition of combed, dotted, or slip painted decoration in a contrasting color. A clear lead glaze was then applied over the air dried decoration, and then fired. Traditional patterns include combed and trailed, dotted and combed, and sgraffito (tool etched) decorated. Continental traditions varied somewhat and tended toward the abstract rather than formal motifs. German wares often consisted of wavy lines drizzled over the surface of a plate rim with concentric circles in the center. The addition of copper oxide powder to the vessel body before firing created a distinctive green blotching that is a common feature on German slipware and its descendants, including the wares from the low countries and England. American slipware from the North Carolina and mid-Atlantic regions of Philadelphia and Virginia, which have been attributed to Moravians, evidence this decorative technique and provide a cultural link to the Old World pottery traditions (Grigsby 1993; Hunter 2003; Noël Hume 1969). Figure 6.46 illustrates two red-bodied slip decorated earthenwares from the October 2006 excavations.

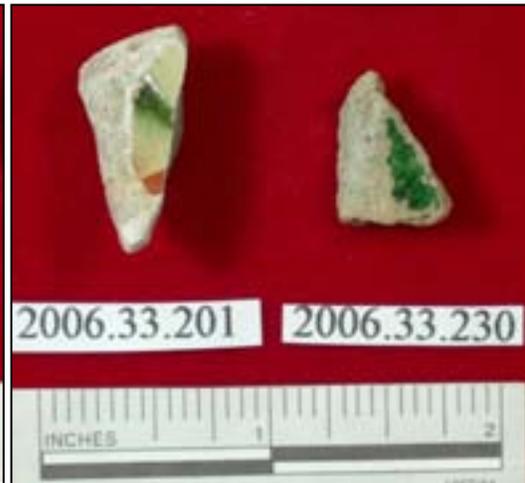
Figure 6.47. White bodied slip decorated sherds recovered from the Roosevelt Inlet Shipwreck.

Figures 6.47 and 6.48 show examples of a white bodied variant that have been tentatively identified as most likely Dutch, French, or German in origin. Figure 6.47 is an example of the white bodied slip decorated sherds recovered from the site, and Figure 6.48 is an example from the beach surface collection. From an examination of photographs of the slipware and red-bodied sherds, British archaeologist Peter Davey suggests that the arcaded slipwares are from the Low County of Europe while the red-bodied examples are most likely “Low County or from neighboring parts of north Germany” (Davey personal communication 2010, see Appendix F). Further research on Dr. Davey’s part along with examination of the photographs by ceramic researchers Duncan Brown (Southampton), Derek Hall (Perth, Scotland), David Gaimster (Society of Antiquities in London), Hugo Blake, and Andre Leclaire, (France) suggests that the slipwares thus far recovered from the vessel itself and the associated items recovered from the beach collection represent Weser/Werra and Low Countries material. Leclaire posits that some of the material may be *pa de Calais* or Low County French in origin (Davey personal communication 2010, see Appendix F). French slipwares differ in decoration from both English and German styles in both color and motif. Often whole slipped with a white slurry, decoration consists mainly of abstract lines and naturalistic interpretations of birds, or leaves. Blue, green and

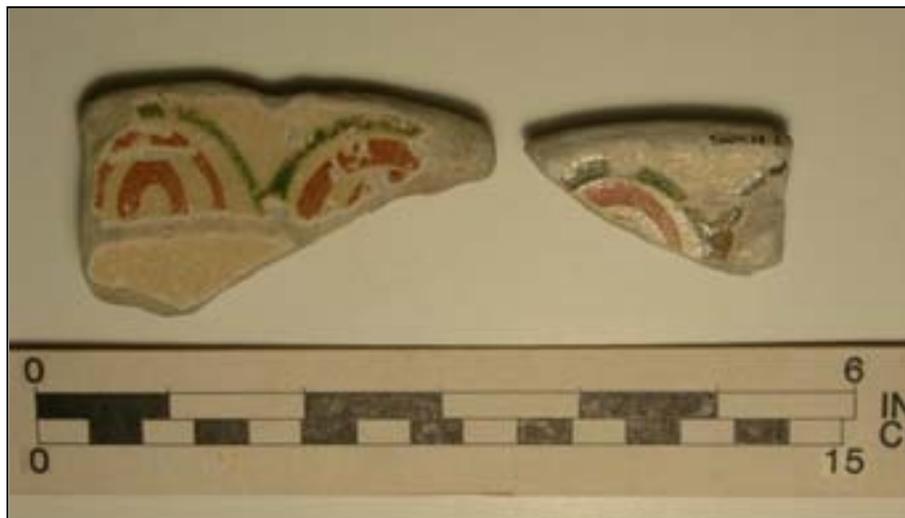
Figure 6.48. White bodied slip decorated sherds from the beach surface collection.

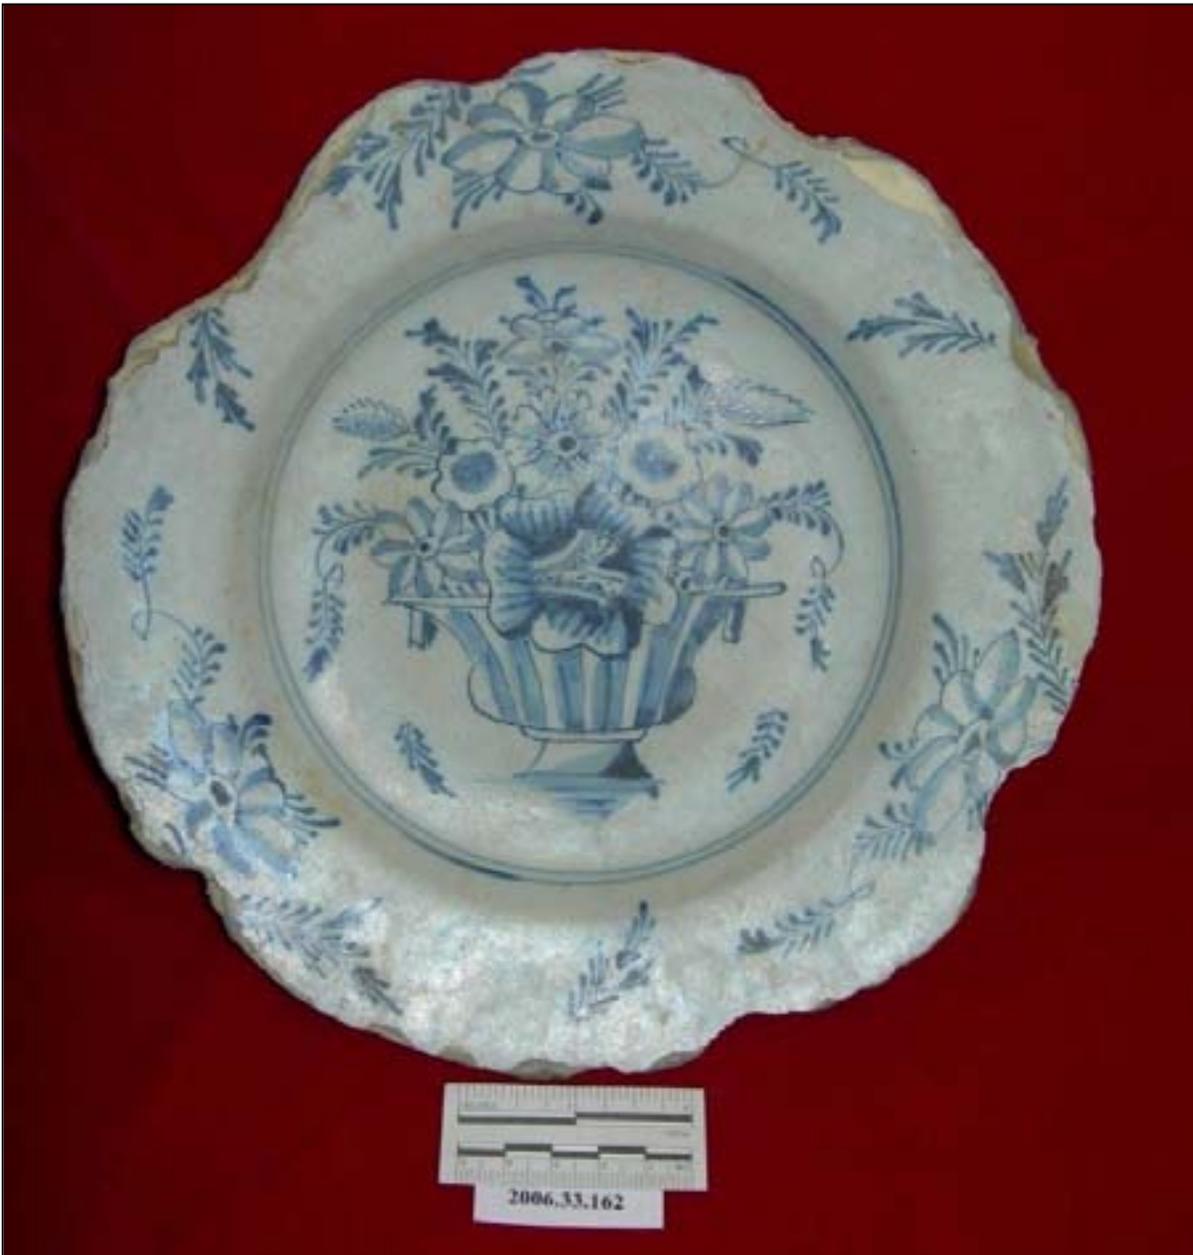
Figure 6.49. Intact tin-glazed earthenware plate with blue painted flower-in-urn pattern (2006.33.162).

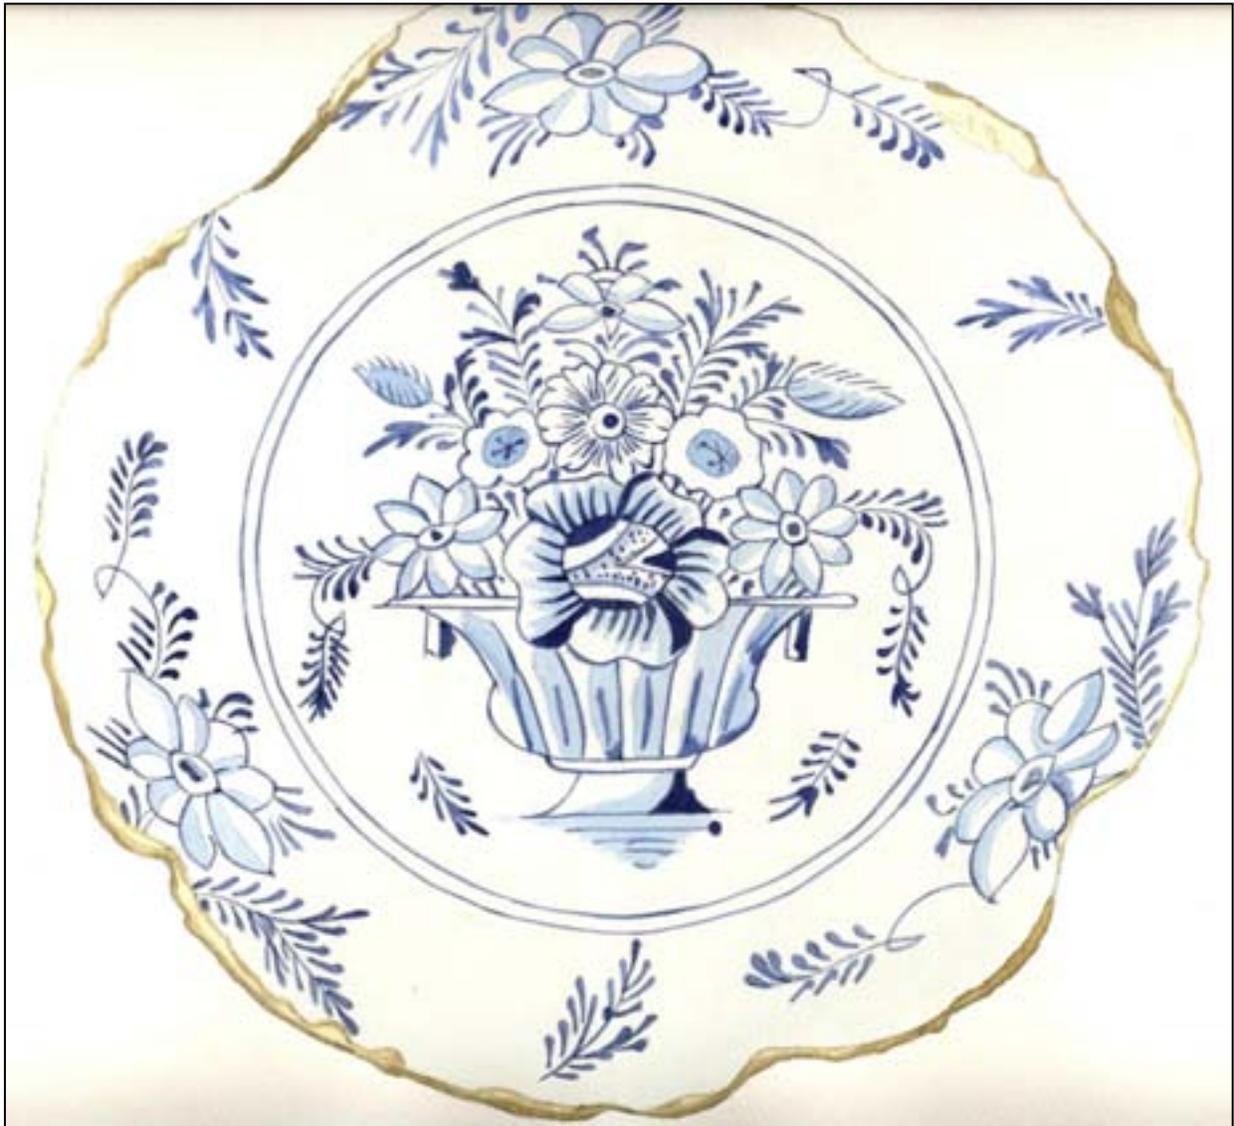
**Figure 6.50. Detail illustration of tin-glazed earthenware plate (2006.33.162)
(by Sharyn Murray).**

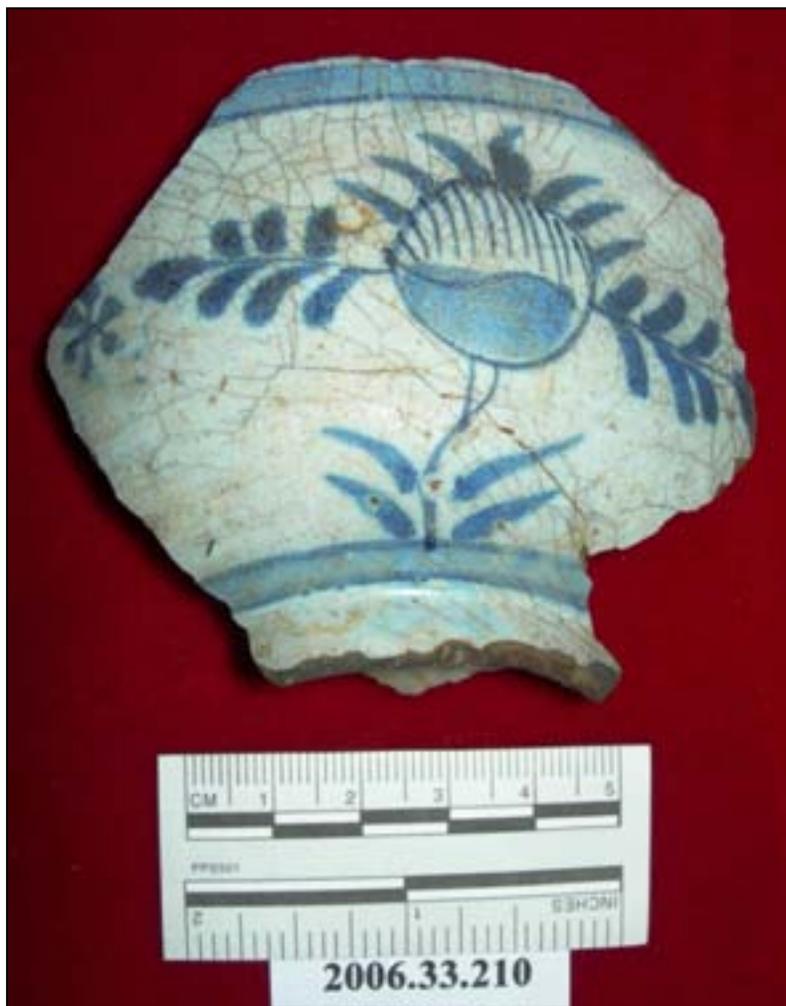
Figure 6.63. Plain Border with Blue Line motif tin-glazed earthenware (2006.33.156 and 2006.33.162).

1790 (Type 2528 and 2529, FLMNH Digital Type Collection 2010). Figure 6.63 is very similar to Plate #120 in the Florida Museum of Natural History Collection. This sherd is identified as a Brittany Blue on White Faience vessel recovered from the Santa Rosa Pensacola site in Escambia County, Florida. This type dates between 1750 and 1765 and is of French manufacture. Further research should be carried out to study the motifs thus far identified in an effort to more conclusively determine the origin of manufacture for this ware type.

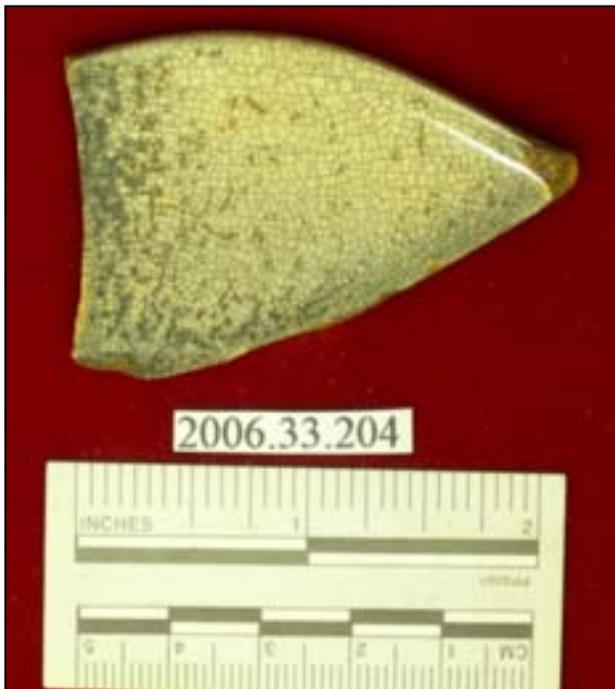
Figure 6.72. Royal pattern creamware rim fragment (2006.33.204).

Few varieties of refined earthenware vessels have been recovered from the October 2006 excavations at the Roosevelt Inlet Shipwreck. Josiah Wedgwood, working with Thomas Whieldon, produced a ceramic with a cream colored, finely ground and mixed paste as early as 1759. This ware, sometimes called Whieldonware and often covered with a mottled or tortoiseshell glaze, is only represented at the site by a single utensil handle which is shown in the cutlery section below. Creamware, first patented in 1762 by Wedgwood at Burslem, Staffordshire, England and manufactured until approximately 1820, was the culmination of the attempt to mimic Chinese porcelain and therefore expand the marketability of English made ceramics (Noël Hume 1969, 2001). Five hundred twenty-three (523) examples of this ware were identified by the State of Delaware analyst from the October 2006 collection. All but one sherd is plain. This press molded fragment has been identified as the Royal pattern (1762-1820) and is shown in Figure 6.72 below (Maryland Archaeological Conservation Lab 2002b; South 1977).

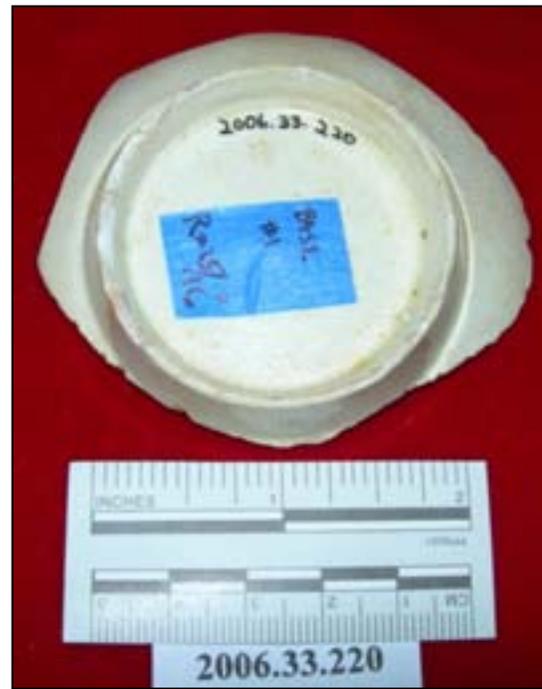
Figure 6.73. Vessel base with foot ring (2006.33.220).

Vessel base analysis was used to determine MNI for this ware type. This analysis indicates that at least 44 vessels are present in the data (see Appendix G, Table G-4 for the inventory of this analysis). Of these, 22 are bowls, 10 are cups, and one has been identified as a saucer. The remainder of fragments in the collection is not identifiable as to form. One vessel foot ring has a beaded decoration on the exterior. Figure 6.73 is a vessel base sherd with a foot ring.

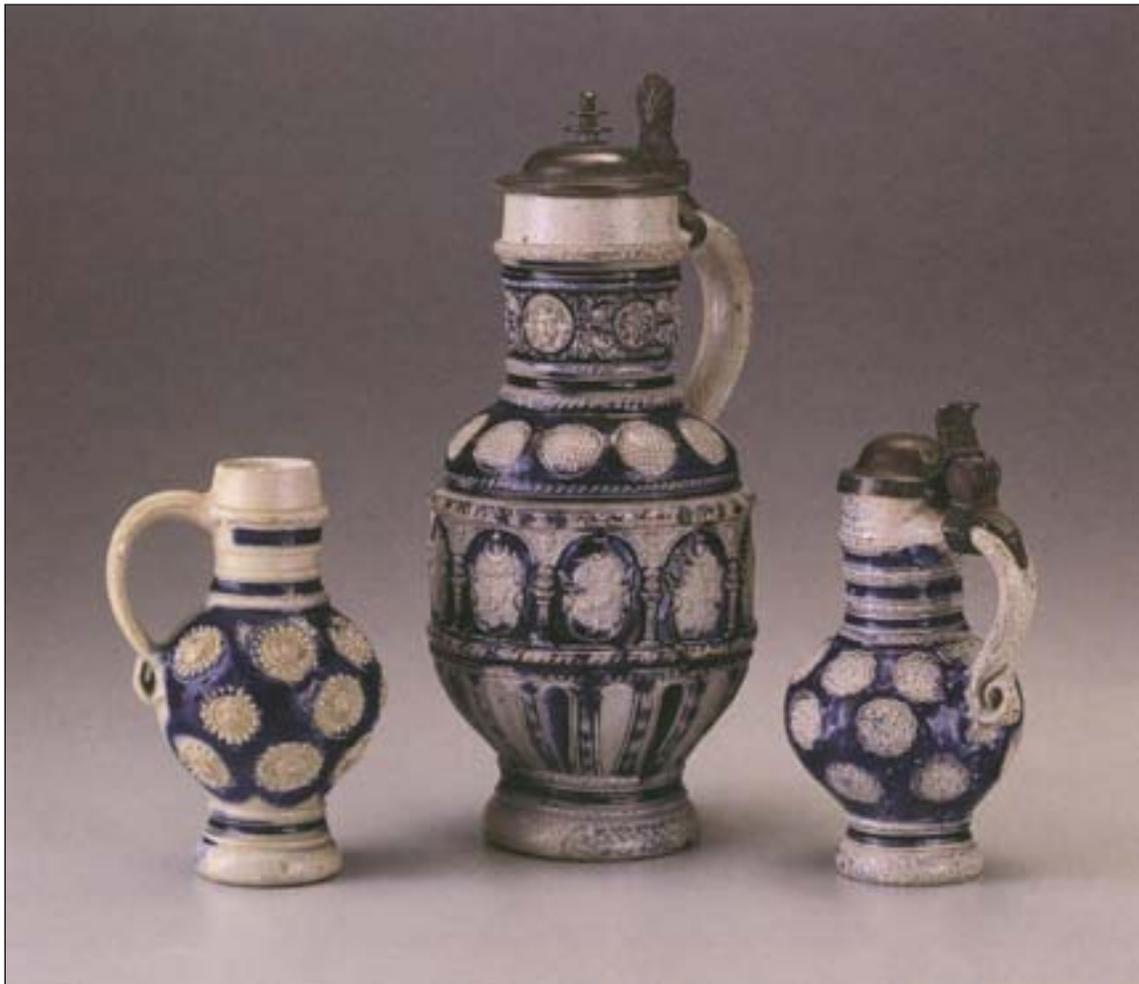
**Figure 6.74. Examples of Westerwald stoneware tankards with copper alloy lids.
(Source: Noël Hume 2001)**

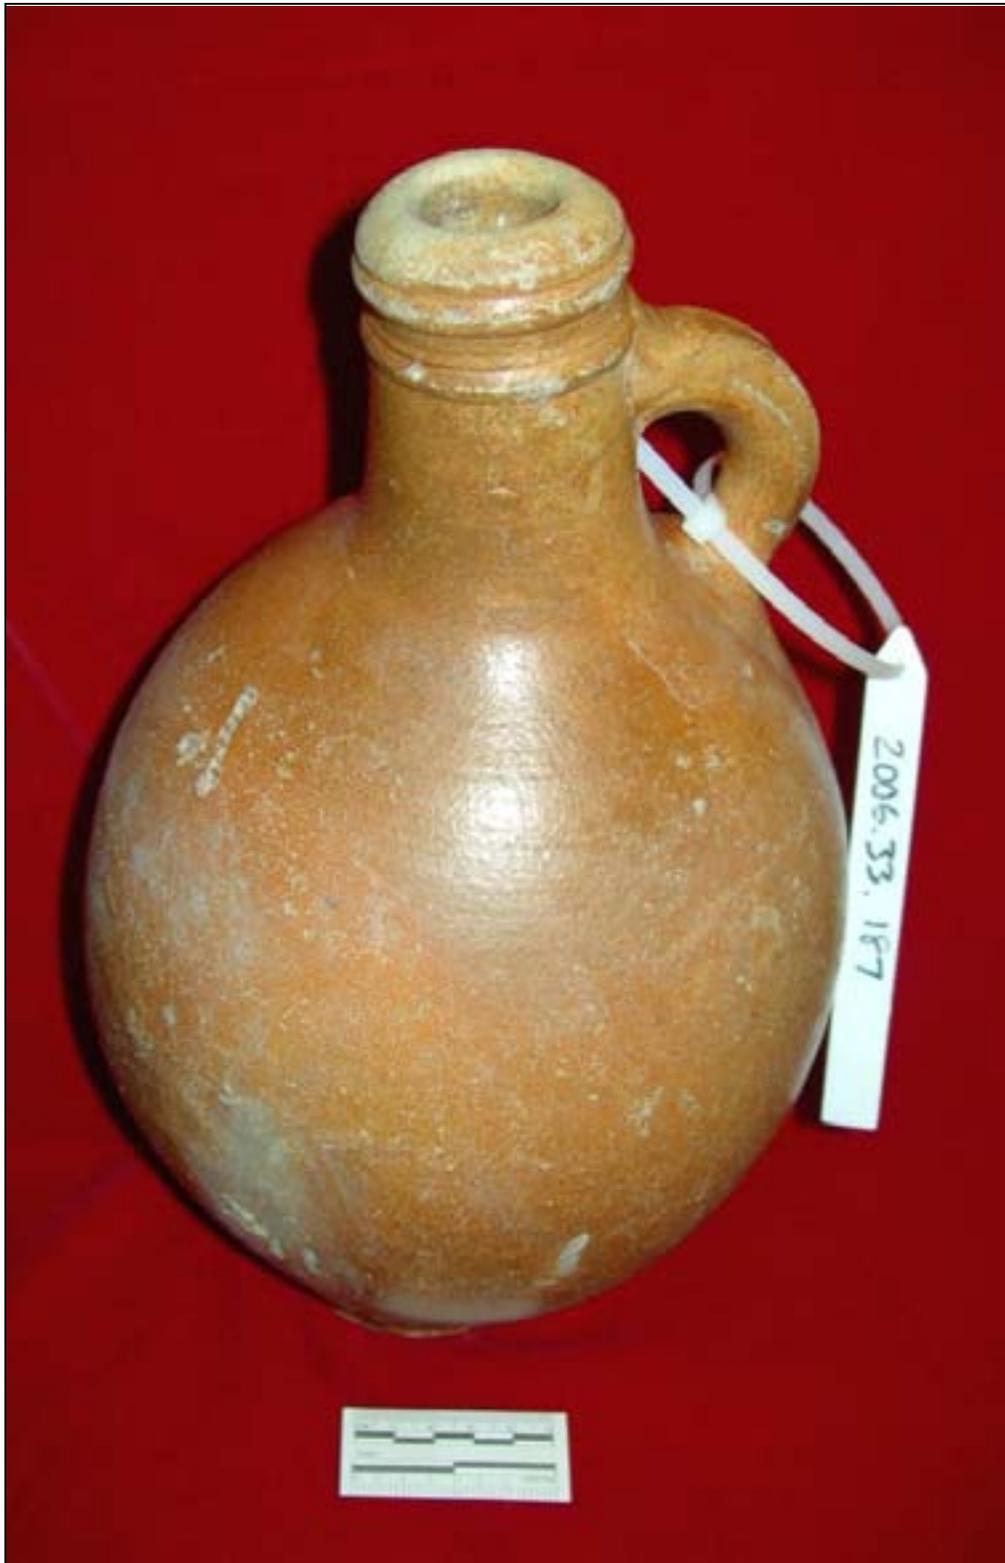
Figure 6.76. Complete brown salt-glazed stoneware bottle (2006.33.187).

Brown salt-glazed vessels were recovered in both bottle form and wide-mouth storage jars. Fragments were identified as to vessel section. There were 145 bottle base fragments, and 2,384 body, 26 handle, 10 handle/neck/finish, 45 neck/finish, 22 neck/handle, and 77 undetermined form sherds recovered. After minimum number of individual (MNI) analysis had been carried out on the bottle bases, it was determined that at least 125 separate bottles are represented in the collection, including four complete bottles. Figure 6.76 illustrates one of the complete bottles. Appendix G, Table G-6 is an inventory list of the vessel base MNI analysis.

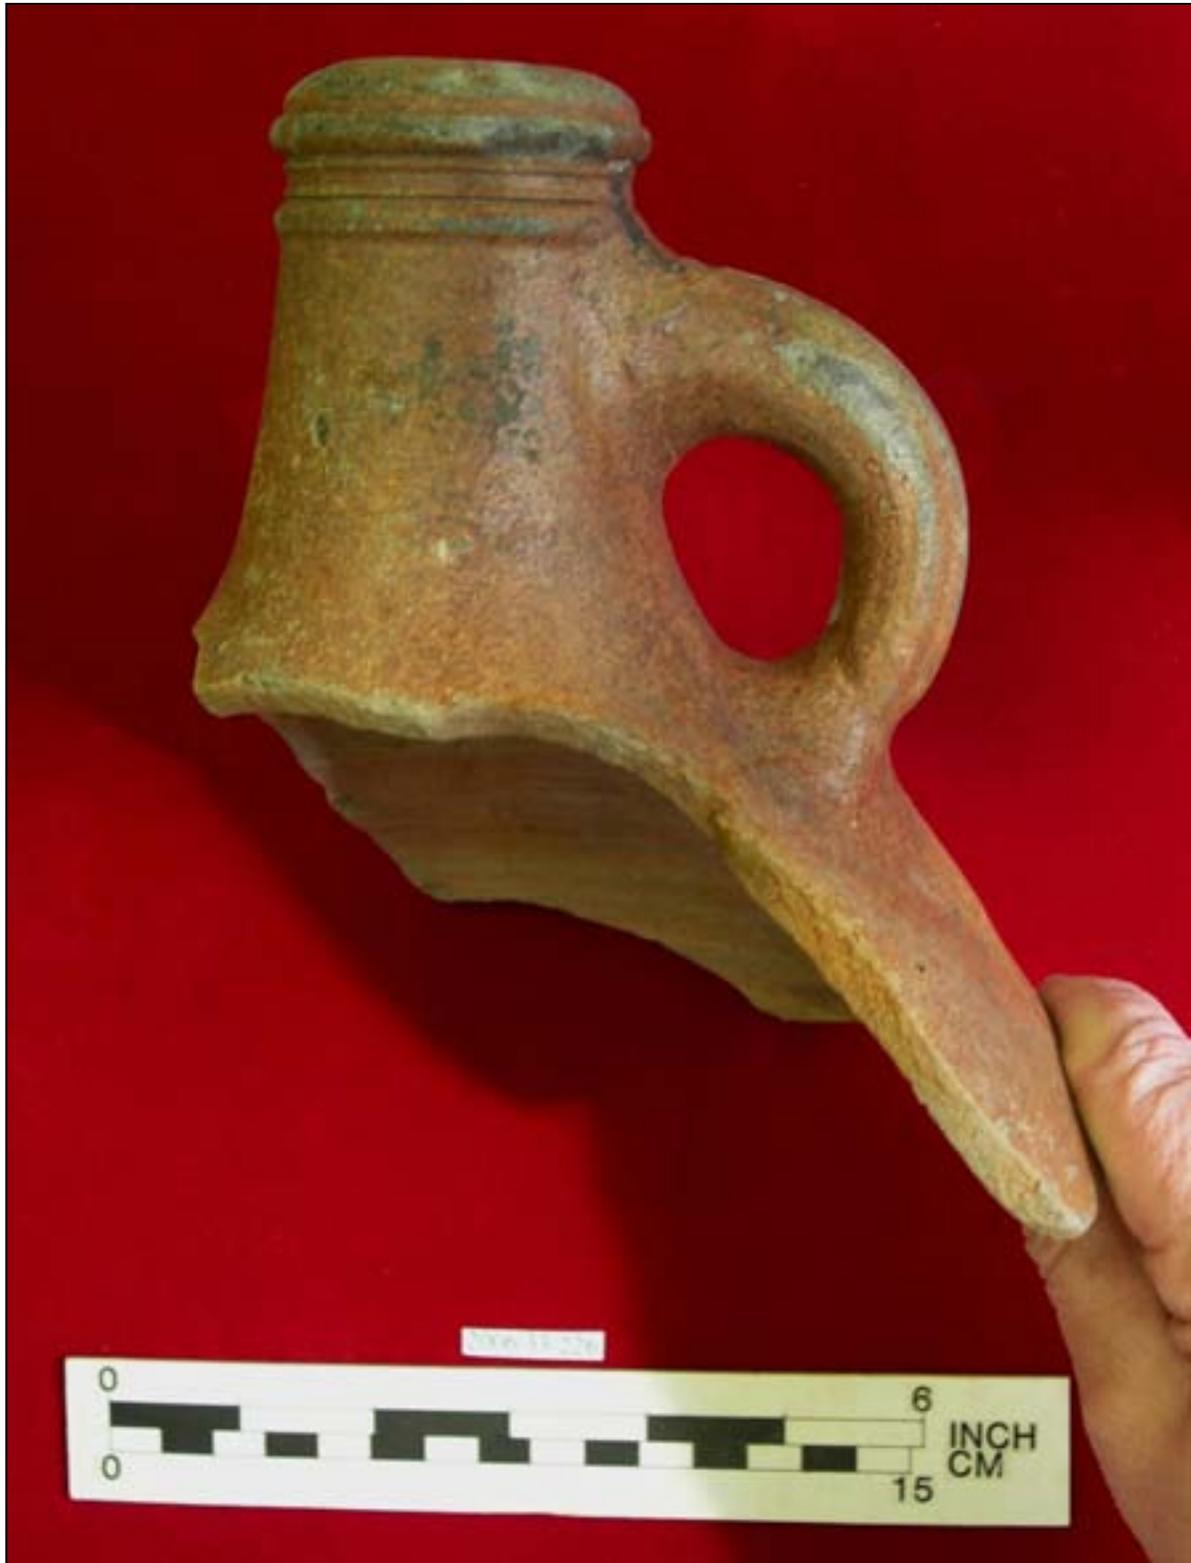
Figure 6.77. Brown salt-glazed stoneware bottle fragment with handle and incised lines (2006.33.226).

The brown salt-glazed bottles may be of Rhenish or English origin. They have a globular body, handle, and incised lines around the neck and on the handle (Figure 6.77). Two of the bottles have partial Bartmann faces on them (2006.33.139 and .229, Figures 6.78 and 6.79) which, according to Gaimster (1997) were not a continued part of the English brown bottle tradition after the beginning of the eighteenth century (Glenn 2002; Maryland Archaeological Conservation Lab 2002c). Bartmann jugs were produced between the mid-sixteenth and mid-eighteenth centuries (Thwaite n.d.). These jugs were produced in Germanic areas of Europe and were widely distributed; similar jugs to those recovered from the Roosevelt Inlet site were also found at the *Avondster* site, wrecked in 1659 in Sri Lanka (Maritime Lanka 2003) and the *Vergulde Draeck*, wrecked in 1656 on the Western Australian coast (WAMM n.d.). In addition to the Bartmann faces, several of the bottles were marked with what has been identified as capacity marks. One is marked with a “2”, four are stamped with the number “3” (including two of the intact bottles), and six display the number “4”. Figure 6.80 illustrates an example of one capacity mark. It should be noted that none of the brown stoneware bottles had corks *in situ* and they may represent provisions for the crew aboard the vessel or empty containers being carried as cargo. A full inventory of all identified marks on brown salt-glazed stoneware bottle fragments is tabulated in Appendix G, Table G-5.

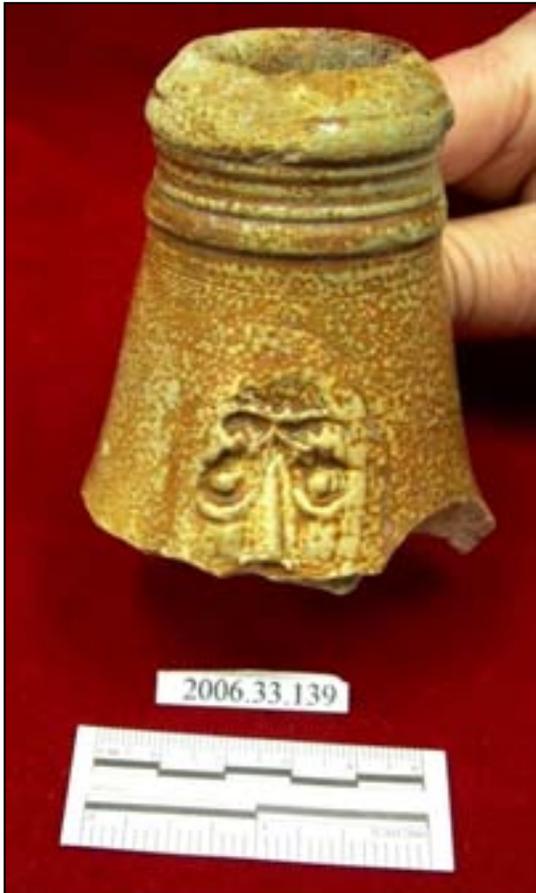
Figure 6.78. Brown salt-glazed stoneware bottle fragment with partial Bartmann face (2006.33.139).

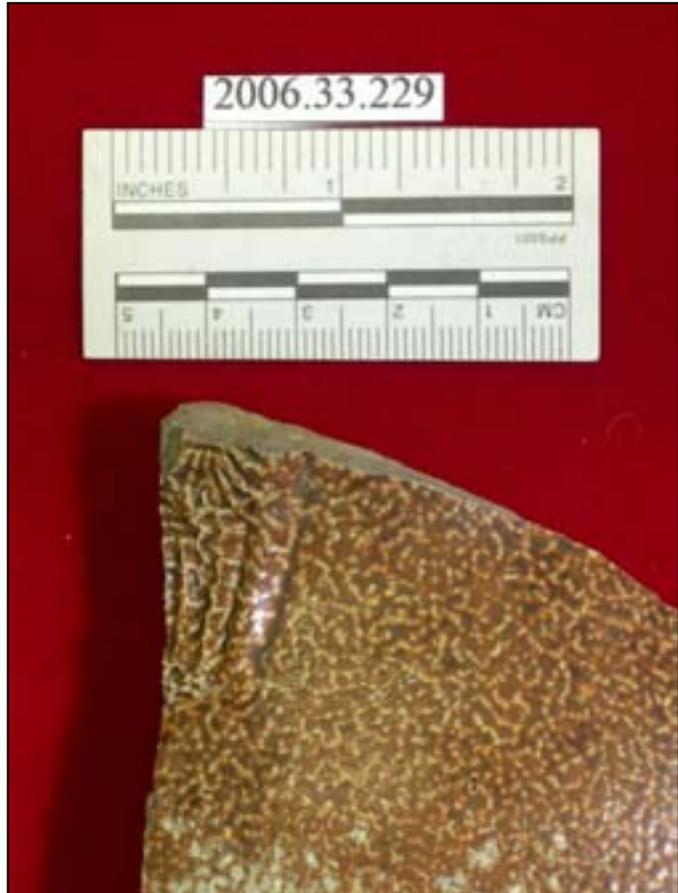
Figure 6.79. Brown salt-glazed stoneware bottle fragment with partial Bartmann face (2006.33.229).

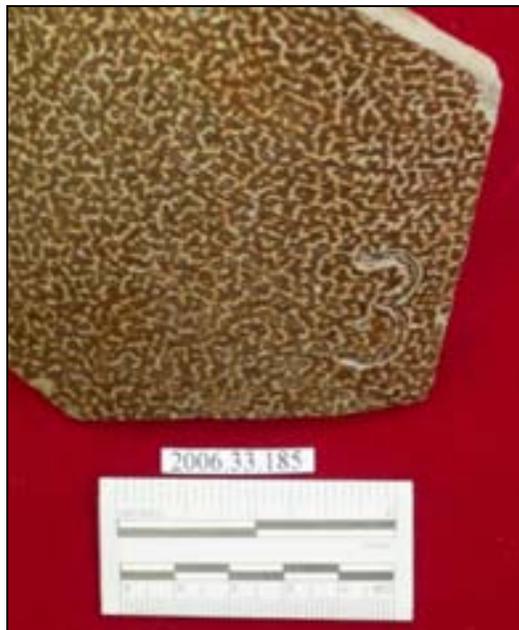
Figure 6.80. Capacity mark (2006.33.185).

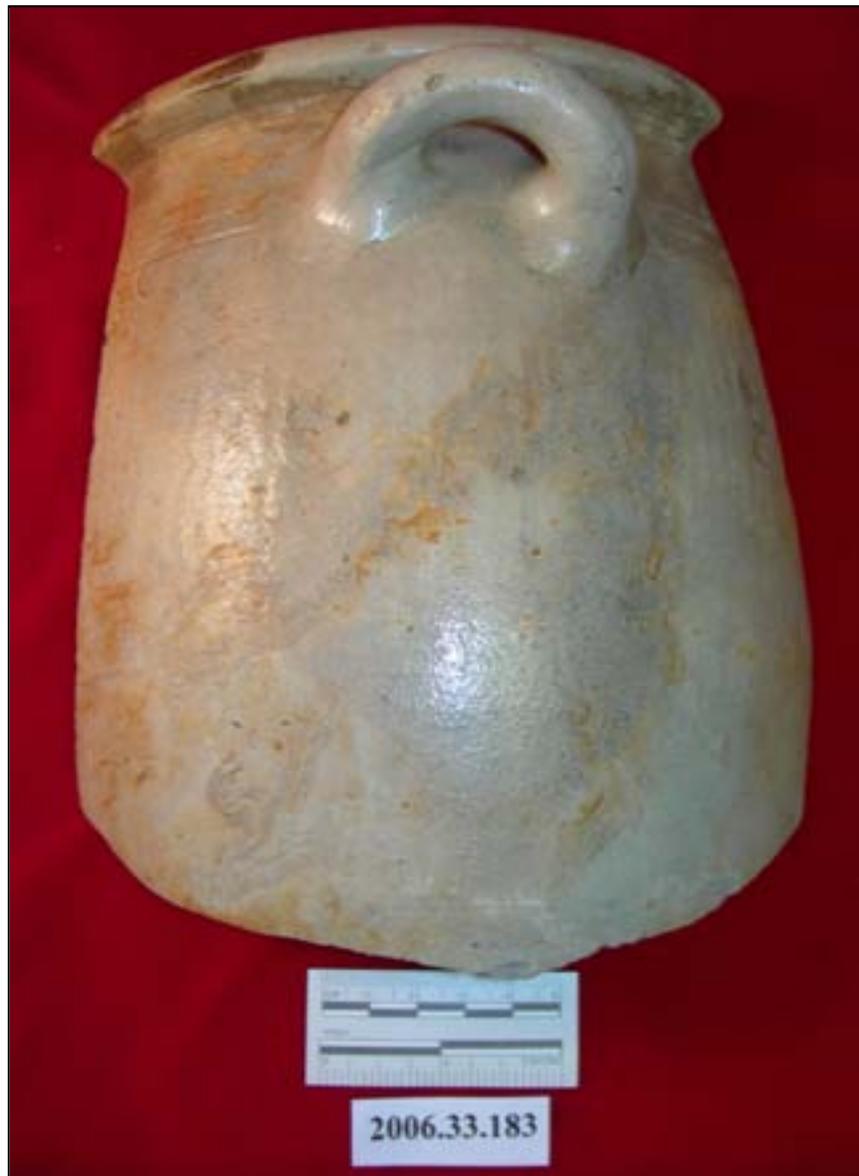
Figure 6.81. Brown salt-glazed stoneware wide-mouth jar with handle and incised lines (2006.33.183).

These wide-mouth jars are slightly ovoid with a constricting or narrowing of the orifice directly below the rim. Laterally attached handles were applied to the neck immediately below the rim. As with the bottles, incised bands or lines were noted under the rim. One jar bears a “1½” mark that may be a capacity stamp. Others have floral stamps, rouletted stamps, or stars. Figures 6.81-6.85 detail features of these artifacts. See Appendix G, Table G-8 for a full listing of these marks.

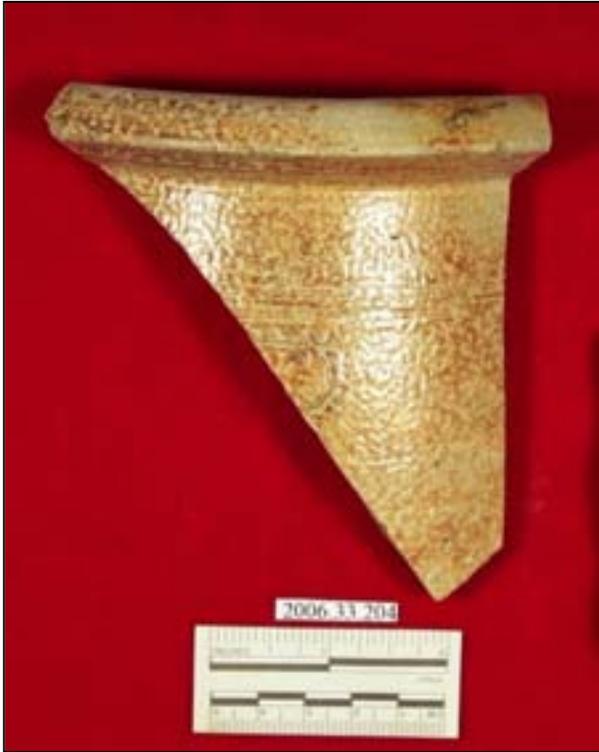
Figure 6.82. Incised lines and shield-like stamp (2006.33.204).
