UNDERWATER ARCHAEOLOGICAL INVESTIGATION OF THE ROOSEVELT INLET SHIPWRECK (7S-D-91A)

VOLUME 1: FINAL REPORT

State Contract No. 26-200-03
Federal Aid Project No. ETEA-2006 (10)

SOUTHEASTERN ARCHAEOLOGICAL RESEARCH, INC.

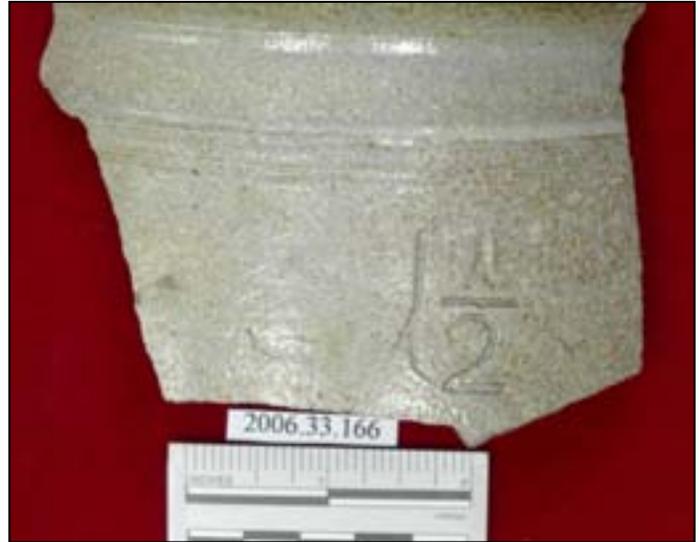
Figure 6.83. "1½" Capacity mark and incised lines (2006.33.166).

These wide-mouth jars are slightly ovoid with a constricting or narrowing of the orifice directly below the rim. Laterally attached handles were applied to the neck immediately below the rim. As with the bottles, incised bands or lines were noted under the rim. One jar bears a “1½” mark that may be a capacity stamp. Others have floral stamps, rouletted stamps, or stars. Figures 6.81-6.85 detail features of these artifacts. See Appendix G, Table G-8 for a full listing of these marks.

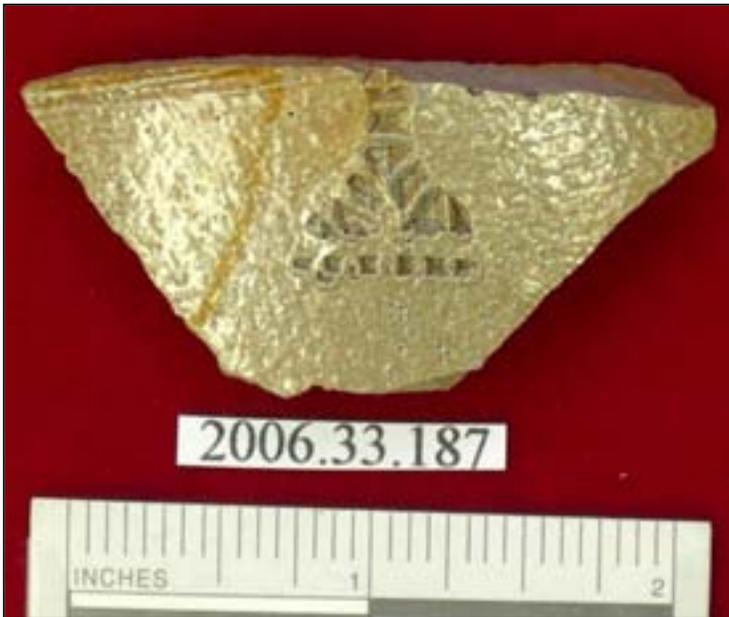
Figure 6.84. Rouletted stamps and incised lines (2006.33.187).

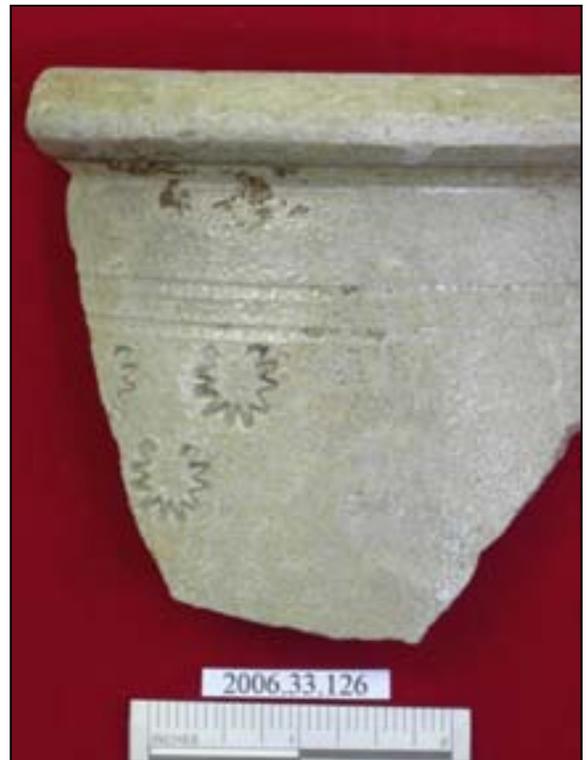
Figure 6.85. Stars and incised lines (2006.33.126).

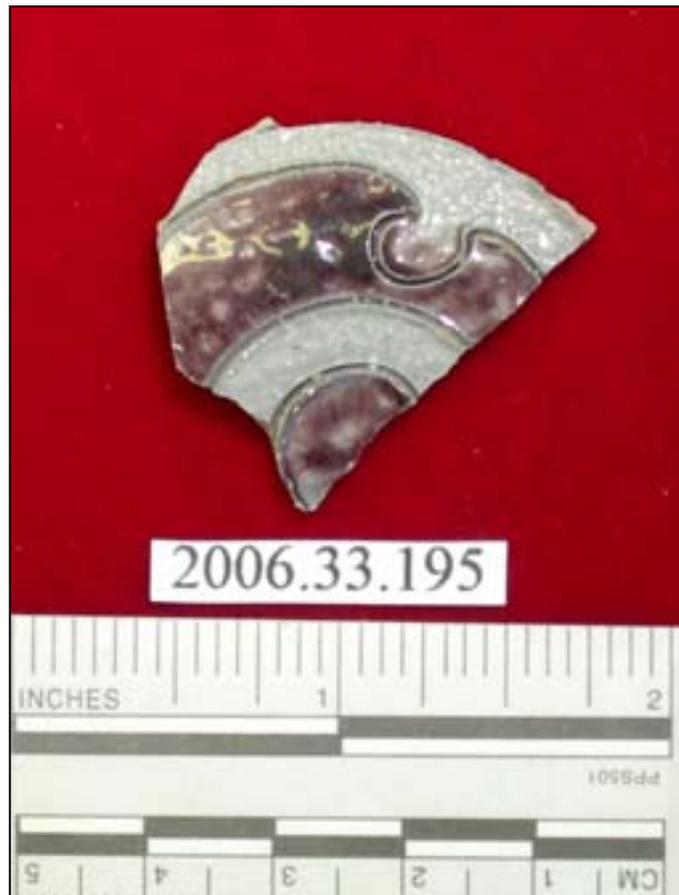
Figure 6.86. Gray and manganese purple decorated Westerwald stoneware (2006.33.195).

Decorative motifs on the Westerwald stoneware are varied within the collection. Cobalt blue is common, with horizontal bands, geometric designs, or floral patterns. One sherd is gray and manganese purple decorated rather than cobalt blue (Figure 6.86). The use of manganese purple on these vessels dates from 1650-1775 (FLMNH Digital Type Collection 2010). Figures 6.87-6.89 offer views of recovered German blue and gray pottery from the Roosevelt Inlet Shipwreck site. Incised designs include rosettes, flowers, a partial stag leg, and geometric patterns, lines, checkerboard, and circular patterns. Stamped floral and other indiscernible designs are also found in the collection. Analysis for MNI concluded that at least 20 separate vessels are represented by the collection (see Appendix G, Table G-10 for a full inventory and details of this analysis).

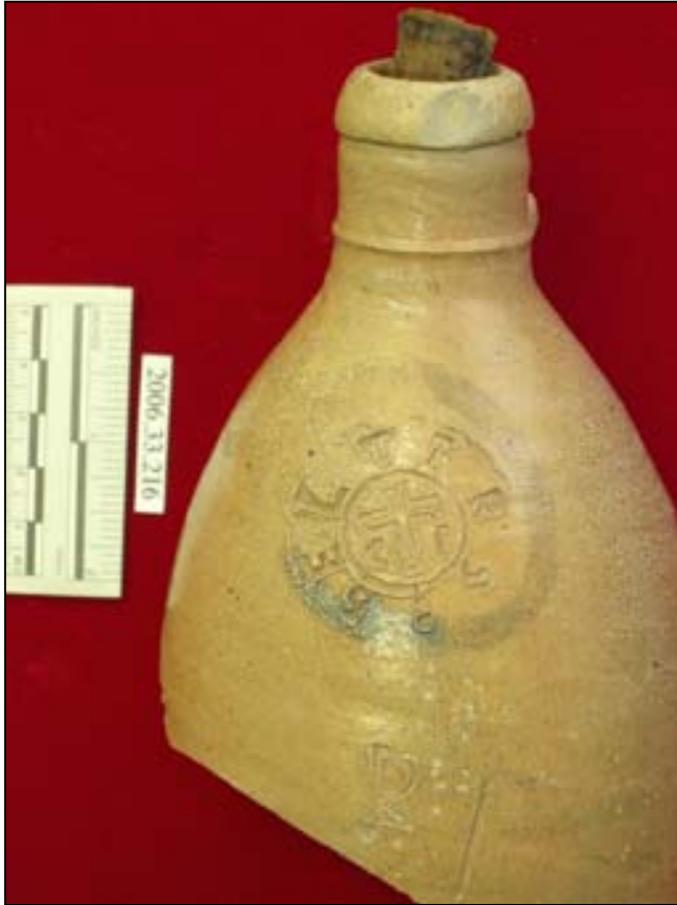
Figure 6.90. Mineral water bottle with "Selters" mark (2006.33.216).

Mineral water bottles from at least two bottling companies in Germany were recovered from the wreck site. Numerous bottles marked “Tolles” or “Selters” on cartouches just below the neck were collected throughout all phases of work at the site (Figures 6.90 and 6.91). Selters is the dominate mark on these bottles (See Table G-11 for a detailed list). German mineral water was thought to possess therapeutic properties and to aid in digestion. The acidic water was popular throughout Europe and the colonies and saw a thriving trade. Packaged in salt-glazed stoneware handled jugs or bottles, whole cases were loaded for shipment. One cache of bottles found during the October 2006 excavations seemed to still be arranged in a case-shaped pile.

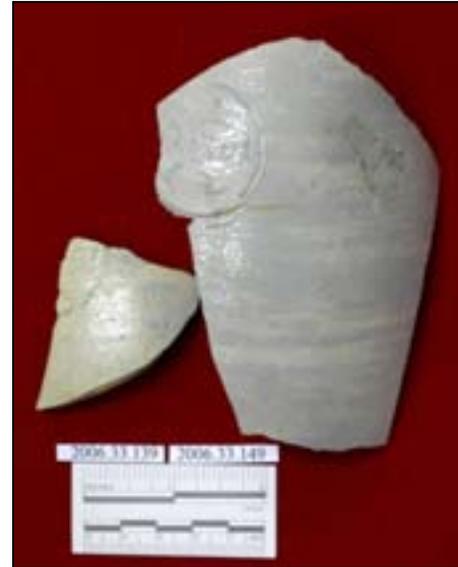
Figure 6.91. Mineral water bottle fragments with "Tolles" mark (2006.33.139 and 2006.33.149).

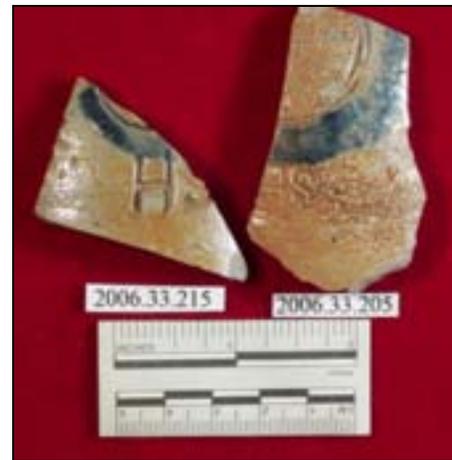
Figure 6.92. Mineral water bottle fragments with "Selters" mark and "HS" stamp (2006.33.215 and 2006.33.205).

In addition to having the name of the bottling company stamped on the seal, these bottles also were stamped with the well number from which they were filled and the town from which they were shipped. Additional research in Germany may reveal much more information regarding this collection of material. Figure 6.92 is a detail of two “Selters” marks with the letters “HS” stamped underneath. Details on the 104 marks noted in this collection as well as attributes such as interior and exterior glaze colors and paste colors, and the presence or absence of a painted ring around the seal are tabulated in Appendix G, Table G-11.

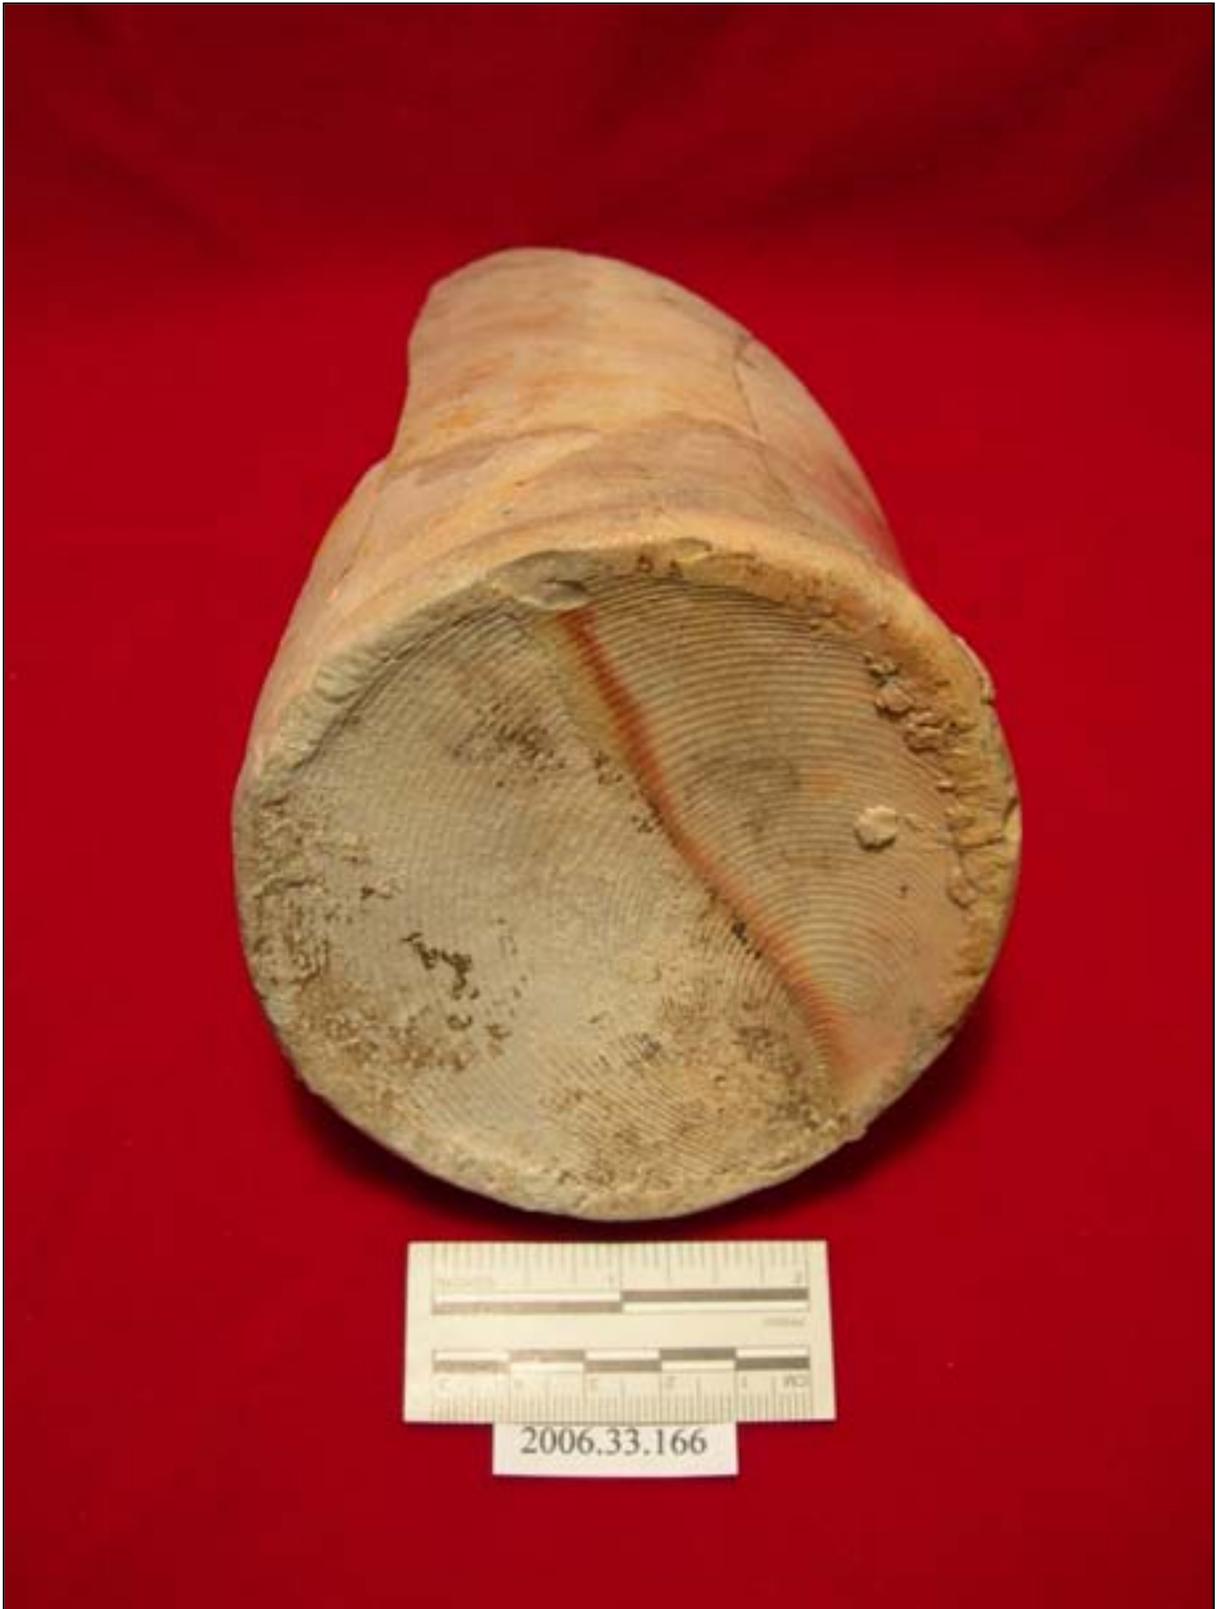
Figure 6.93. Base of a mineral water bottle recovered from the Roosevelt Inlet Shipwreck showing wire cut-off marks.

After 1780, brown bottles become predominant, and the seals have a cobalt blue or manganese purple ring around them. These bottles have typically have wire marks on the base from the clay being cut off the wheel (Bartels 1998). Figure 6.93 shows the base of a brown mineral water bottle recovered from the wreck. Note the wire cut marks in the clay and the presence of a foot ring which, according to Bartels (1998), are no longer extant on mineral water bottles after 1780. After 1800 the bottles are almost cylindrical, and by the second quarter of the nineteenth century their sides are vertical.

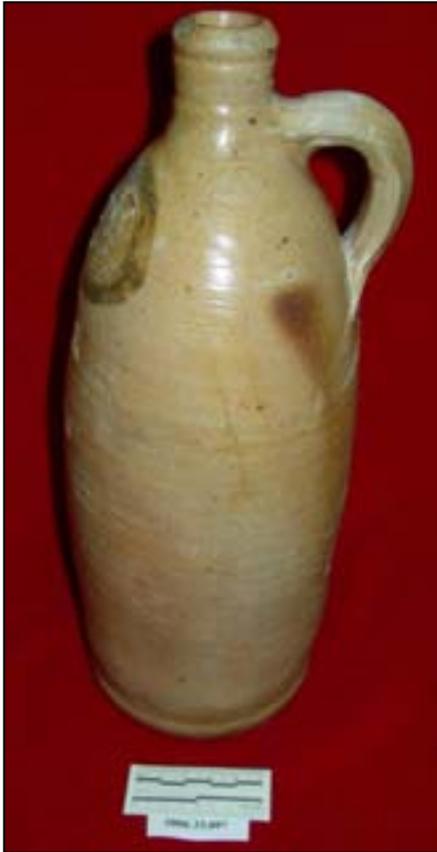
Figure 6.94. Whole mineral water bottle (2006.33.097).

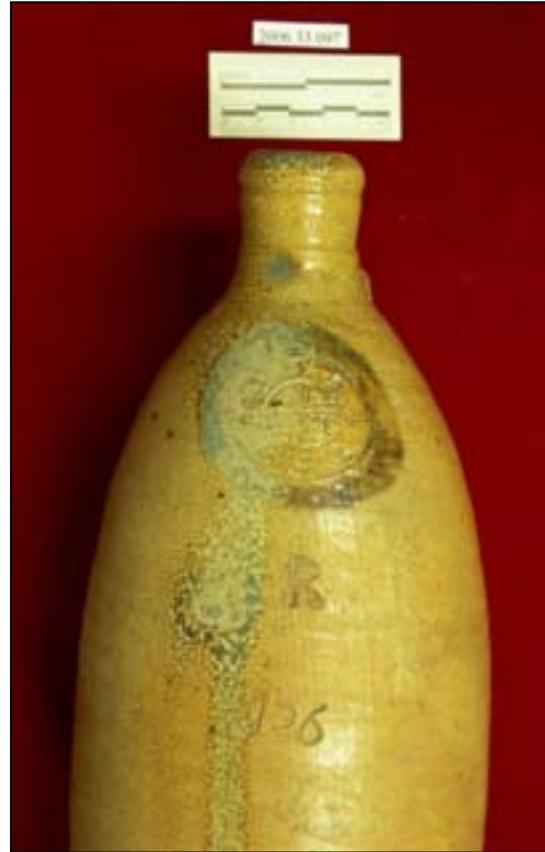
Figure 6.95. Mineral water bottle with Selters mark, "R" and "126"; front view detail of marks (2006.33.097).

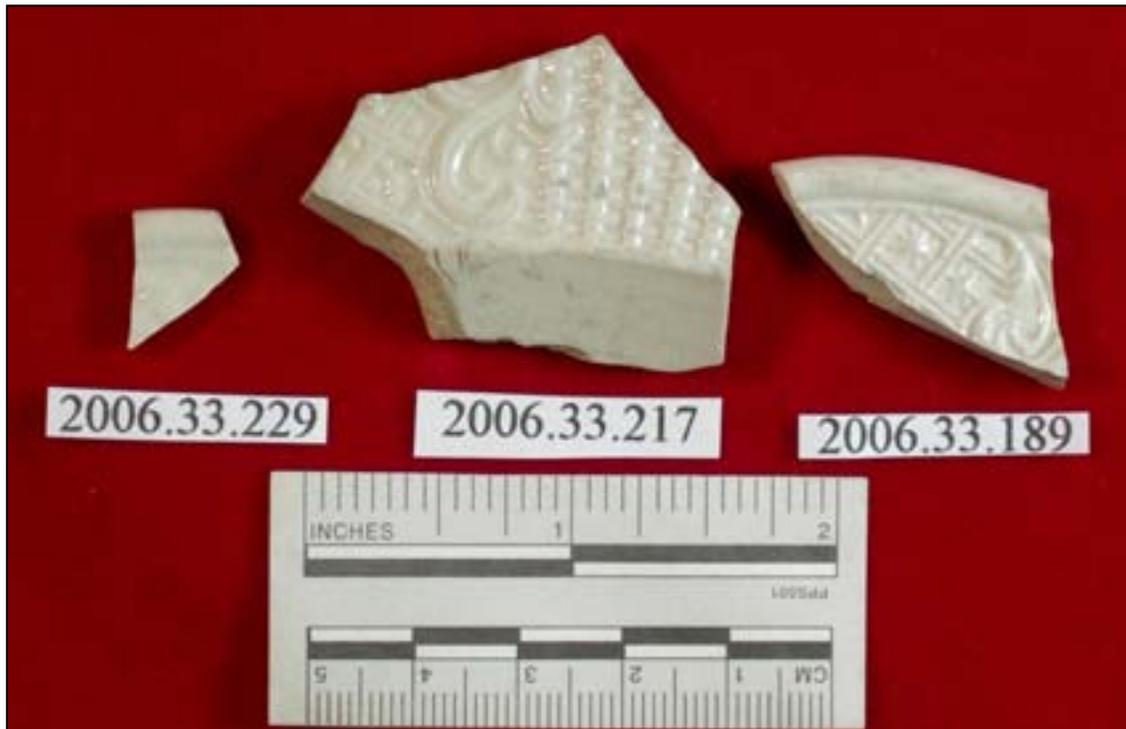
Figure 6.96. Examples of white salt-glazed stoneware sherds.

Of the ten white salt-glazed stoneware sherds recovered, four were base fragments. The collection also includes one body and five rim sherds. All appear to be fragments of flatware: saucers, plates, or chargers. Six of the 10 were edge-molded. Decorations include combinations of lattice-with-star, wicker, floral, and dot-and-diaper. Figure 6.96 provides examples of the artifacts in this group. A full inventory of the white salt-glazed stoneware recovered is presented in Appendix G, Table G-14.

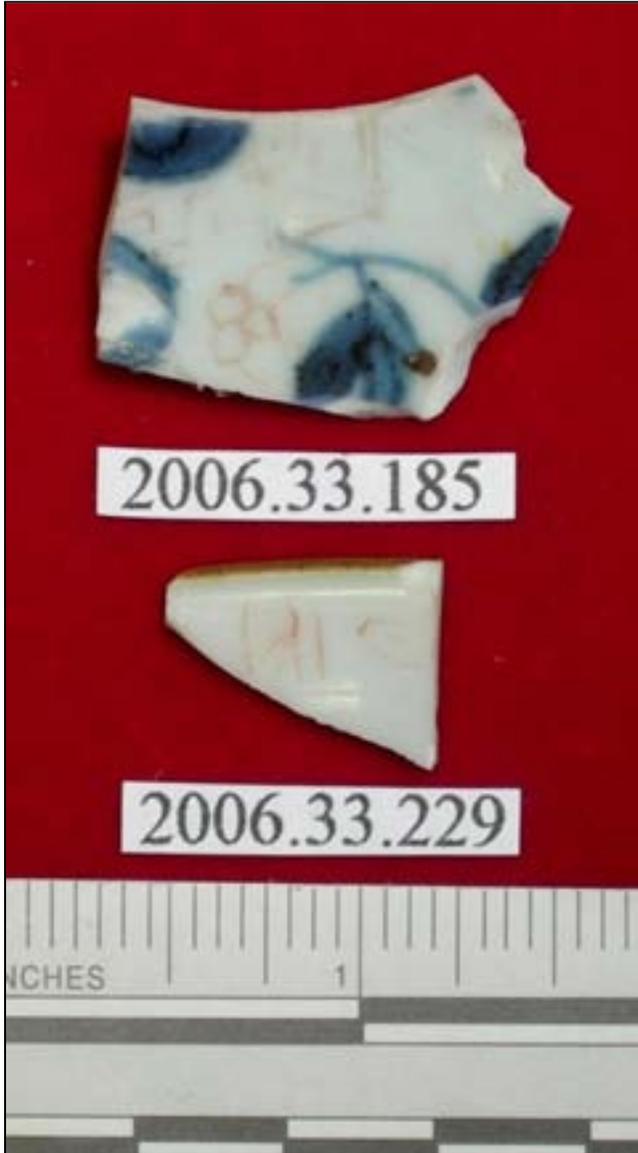
Figure 6.97. Examples of red-painted overglaze porcelain (2006.33.185 and 2006.33.229).

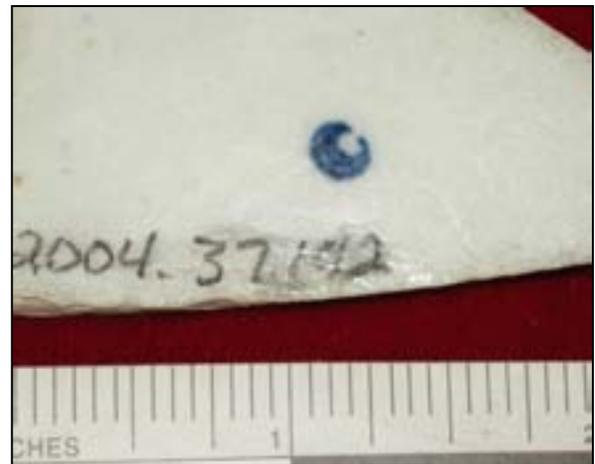
Figure 6.99. Crescent shaped maker's mark on porcelain.

Research into one maker's mark, a blue crescent moon, found it to be most likely either from the Worcester Porcelains Factory, post-1751 or the Caughley Works, circa 1775-1799 (Godden 1991). Both companies used the crescent symbol. Further examination of the mark may determine if it is a hand painted mark or a transfer printed one. Figure 6.97 is an example of red-painted overglaze porcelain. Figure 6.98 is of an Oriental figure hand painted in blue on one fragment, and Figure 6.99 is a view of the single maker's mark found. Figure 6.100 is an example of brown-painted and molded porcelain and Figure 6.101 shows the open fret work basket recovered from the 2006 excavations.

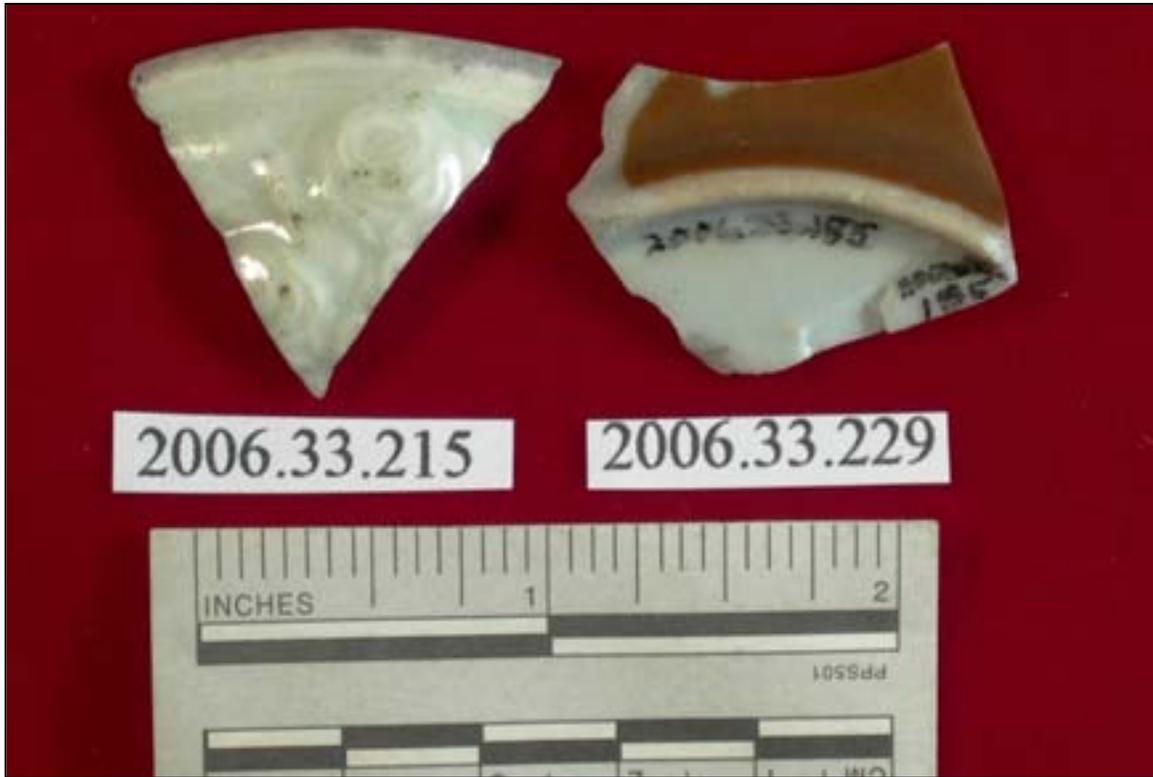
Figure 6.100. Brown-painted and molded porcelain fragments.

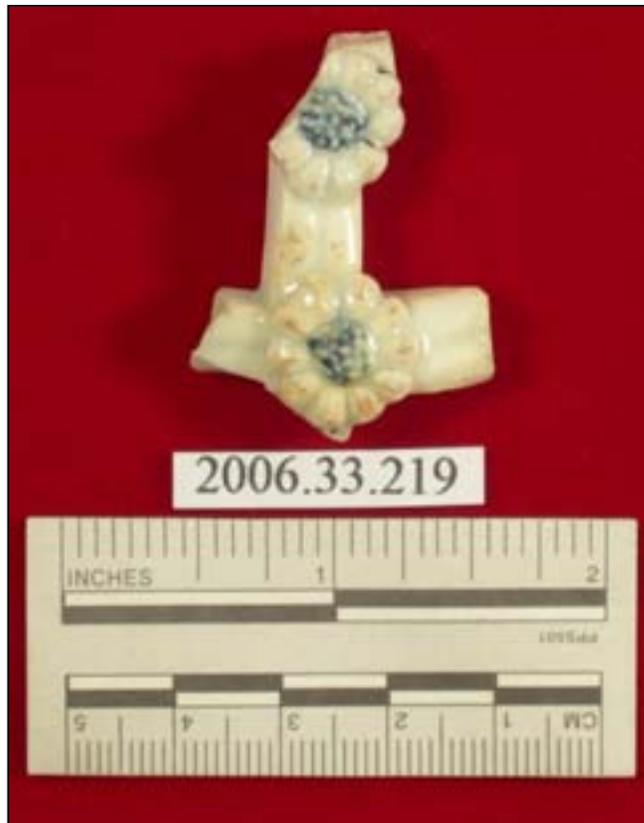
Figure 6.101. Open fret work basket (2006.33.219).

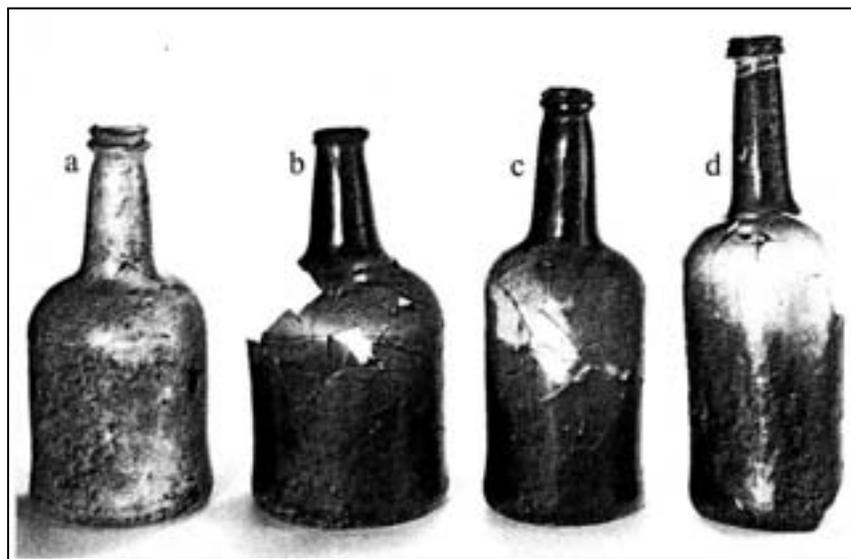
Figure 6.102. Cylindrical beer (a and b) and wine (c and d) bottles of the eighteenth century. (Source: Jones and Smith 1985:17)

Evolution in shape has been led mainly by changes in manufacturing technique. Early mouth-blown bottles were shaped purely by hand tooling and rolling on a marver. Single-piece dip molds began to be used in the early eighteenth century and were common by 1730. Bottles made in this style were by nature either straight or narrower at the bottom than the top so that they would slip free of the mold. Thus, cylindrical bottles became the norm. Figure 6.102 shows cylindrical wine and beer bottles of the eighteenth century (Jones and Smith 1985:17).

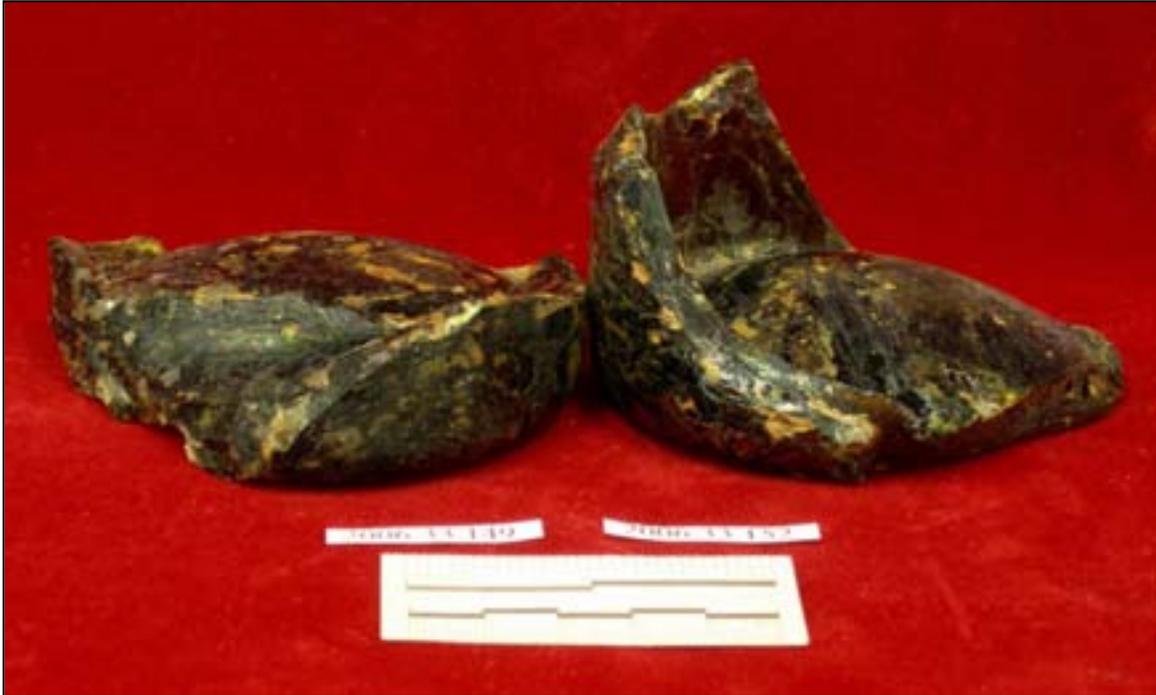
Figure 6.104. Olive green bottle bases.

One thousand six hundred ninety-six (1,696) cylindrical or round olive green bottles glass fragments were recovered from the October 2006 excavations. Of these, 1,396 are body fragments, 191 are base fragments, 99 are neck or finish fragments, and 10 are undetermined. A minimum number of individual (MNI) vessels has been calculated by mending bases where possible and then counting the remaining reconstructed vessel bases with the knowledge that all bottles have a base and no bottle has two. Appendix G, Table G-16 details this analysis. A total of 101 vessels are represented by this assemblage, with a range in color from olive green (n=35), amber-olive (n=35), blue-green (n=9), and dark olive green (n=21). Bottle finish MNI analysis revealed that at least 32 bottles are represented in the collection (by neck and rims). Appendix G, Table G-17 details this analysis and provides additional attribute information such as bore diameter and color. Based solely on color, one may infer that both Dutch and English vessels are represented, but further study is recommended before any determinations can be made. Figures 6.104 and 6.105 show examples of bottle fragments from this category.

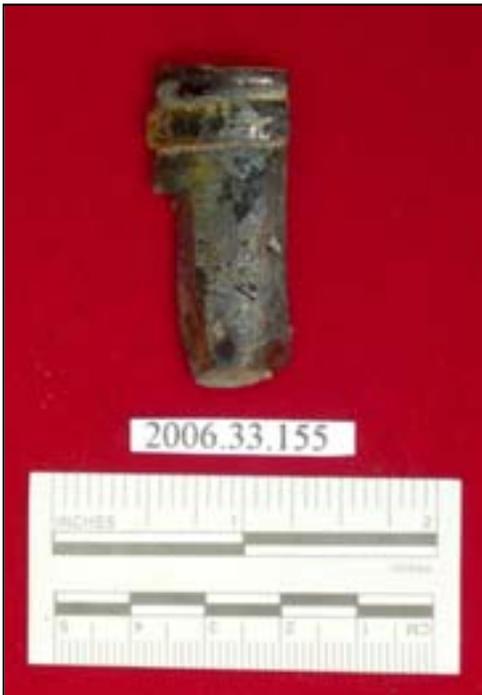
Figure 6.105. Olive green bottle neck and lip (2006.33.155).

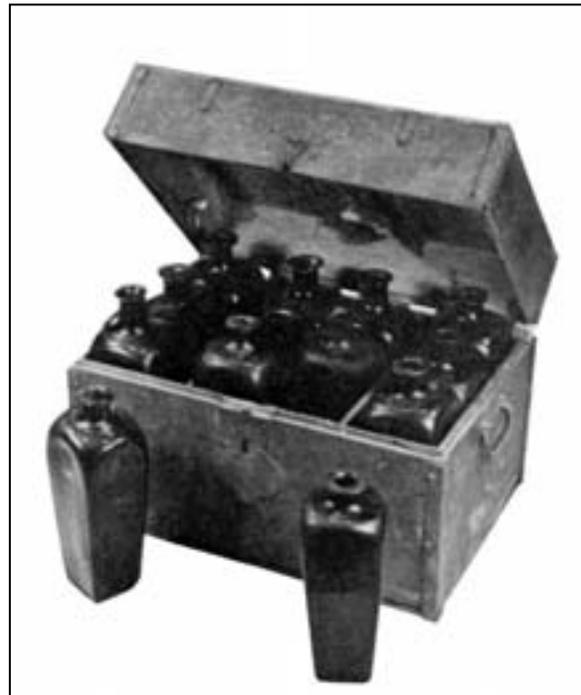
Figure 6.106. Case of square bottles.
(Source: Neumann and Kravic 1989:49)

In addition to round or cylindrical bottles, case (or square) glass bottles, are common to the seventeenth and eighteenth centuries (Figure 6.106). Often referred to as "gin" bottles, these large square bottles were originally manufactured by blowing glass gobs into a square box or case shaped by nailing boards together. This method of manufacture was superseded by the early eighteenth-century invention of the dip mold discussed earlier. Case bottles generally have rounded shoulders and a squat neck with an applied lip. As with cylindrical bottles, style differs between manufacturing centers, but the differences are subtle. Dutch bottles generally are larger at the top and narrower at the bottom and range more toward the amber-olive/yellow-olive color than do English case bottles. Eighteenth-century case bottles tend to be fairly straight in profile with only a slight taper and have arched basal profiles which create a four-point resting surface. Later bottles (post-1860) exhibit a more distinctive tapered shape and flat basal profile (Noël Hume 1969; Jones and Smith 1985).

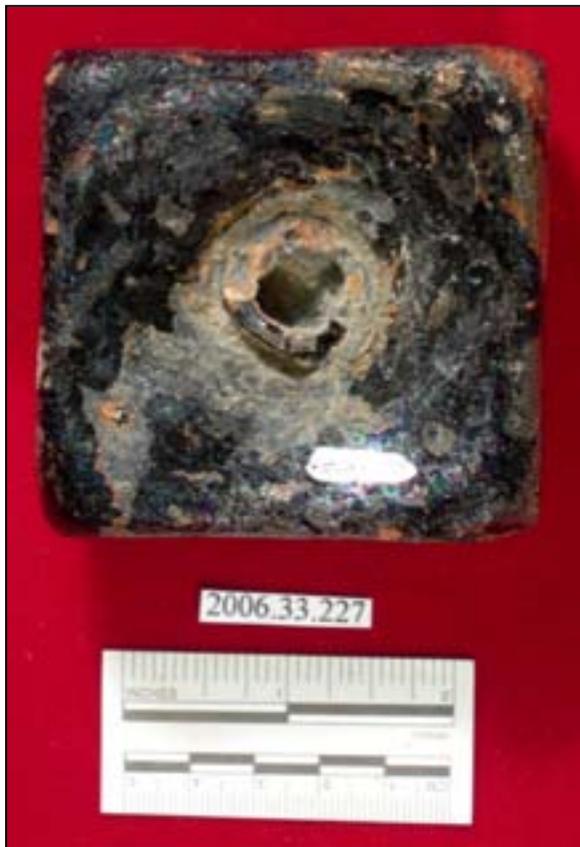
Figure 6.107. Case bottle base, bottom view (2006.33.227).

Four thousand four hundred and fifty-one (4,451) case bottle fragments have been recovered from the October 2006 excavations. Of these, 3,870 are body fragments, 202 are base fragments, 38 are neck/finish fragments, 190 are shoulder fragments, and 151 are undetermined. Analysis to determine MNI for case bottles revealed that at least 81 bottles are represented by this collection (Appendix G, Table G-18). Bottle finish MNI analysis revealed that at least 27 bottles are represented in the collection (by neck and rims). Table G-19 in Appendix G details this analysis and provides additional attribute information such as bore diameter and color. The color range is similar to the cylindrical bottles with blue-green (n=5), blue green-dark olive green (n=2), dark olive green (n=9), olive green (n=17), and olive-yellow (n=48). In addition to color, vessel shape was considered to be diagnostic. Of the 81 bottles identified, only 41 could be determined as to profile. All of these bottles were determined to be tapered and more narrow at the bottom. Both color and shape seem to indicate a possible Dutch origin for the case bottles from this site (Bureau of Land Management 2010; Noël Hume 1969). Figures 6.107-6.109 show examples of case bottles recovered from the Roosevelt Inlet Shipwreck.

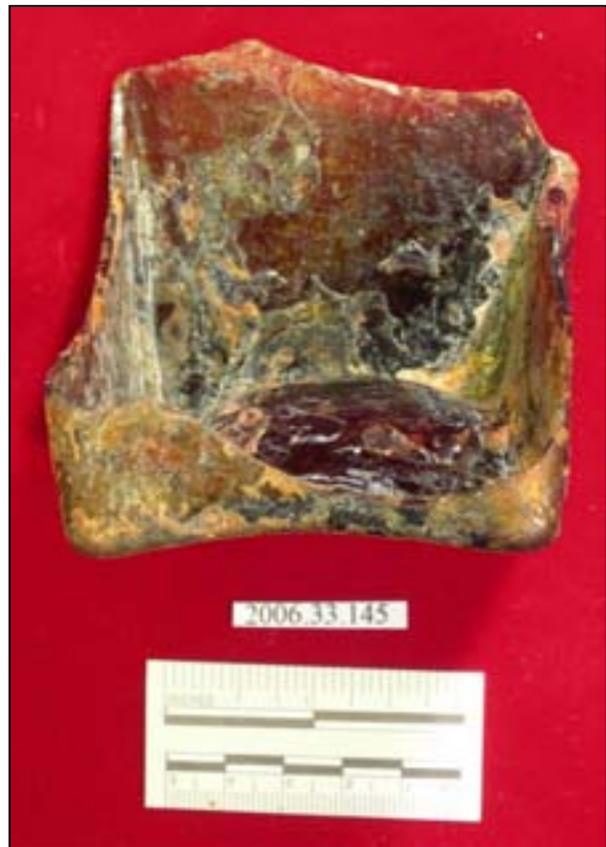
Figure 6.108. Case bottle base, side view (2006.33.145).

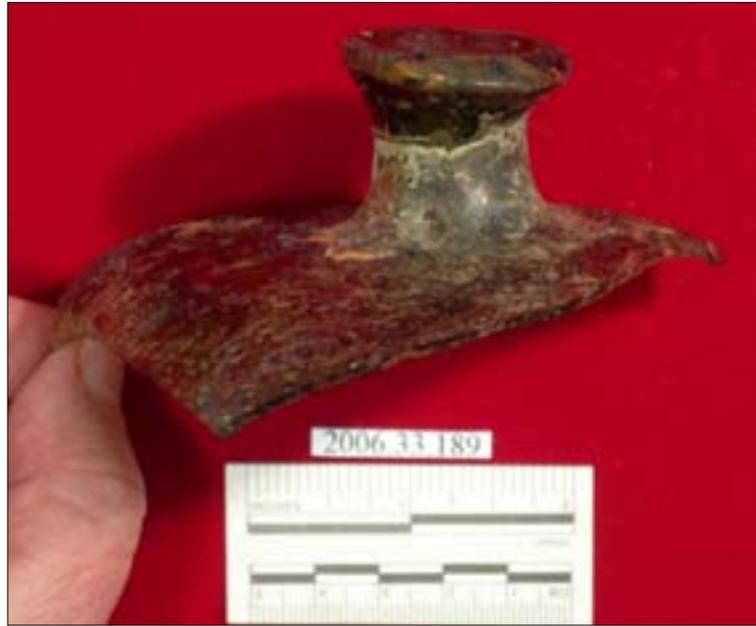
Figure 6.109. Case bottle shoulder, neck, and lip, side view (2006.33.189).

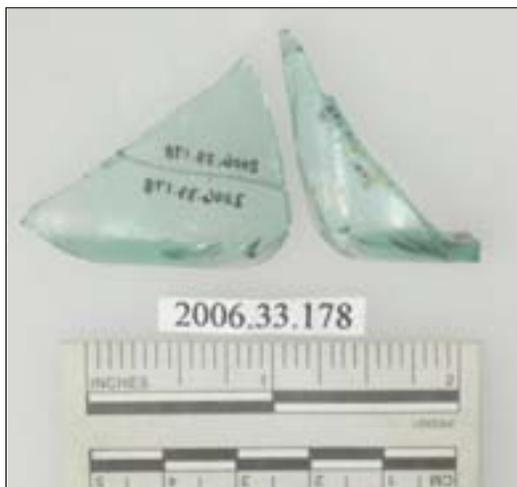
Figure 6.110. Light blue glass (2006.33.178).

Bottles were used for more than wine or spirit storage, however. Many things were stored in bottles from condiments and sauces to medicines and pharmaceuticals such as elixirs. The great upswing in patent medicines came during the nineteenth century and brought with it an explosion in bottle form and number. Other bottle fragments recovered from the wreck site are few (n=87) and non-diagnostic with 13 aqua-colored body fragments, four dark green fragments (all are neck/finish pieces), three light green body fragments, one olive green very thin fragment, and two clear basal fragments. Also recovered but not determined to be round were one light green curved glass fragment, four light blue curved fragments, and six clear flat bottle fragments. Figure 6.110 shows examples of light blue glass recovered from the wreck; Figure 6.111 illustrates the very thin olive green glass.

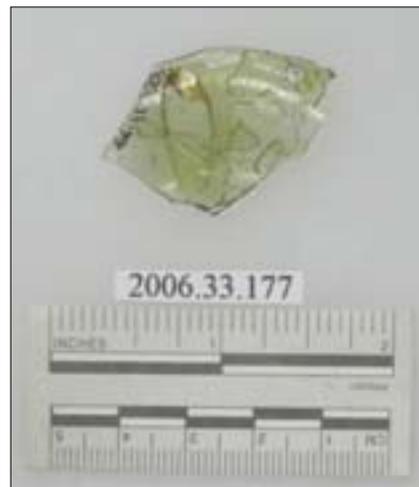
Figure 6.111. Very thin olive green glass (2006.33.177).

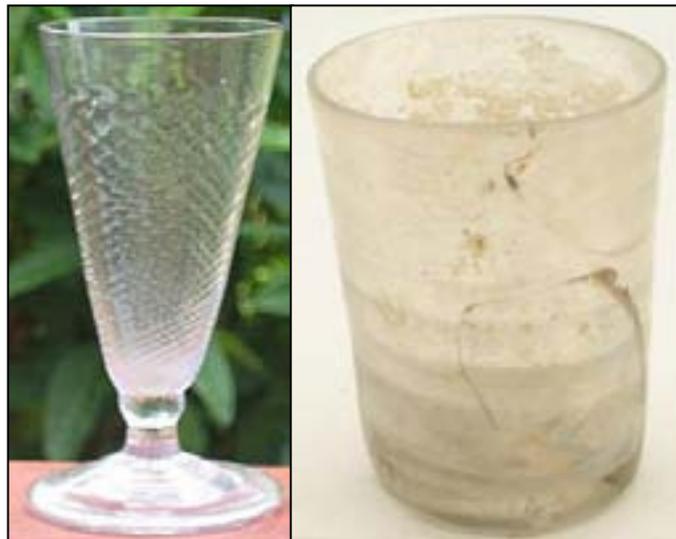
Figure 6.112. Left: Example of a “Wrythen” ribbed goblet. This goblet dates to c. 1760. (Source: <http://www.trocadero.com/stores/scottishantiquesinc/items/925101/item925101.html>) Right: Example of a “Lynn” glass. (Source: <http://www.museumoflongdon.org.uk>)

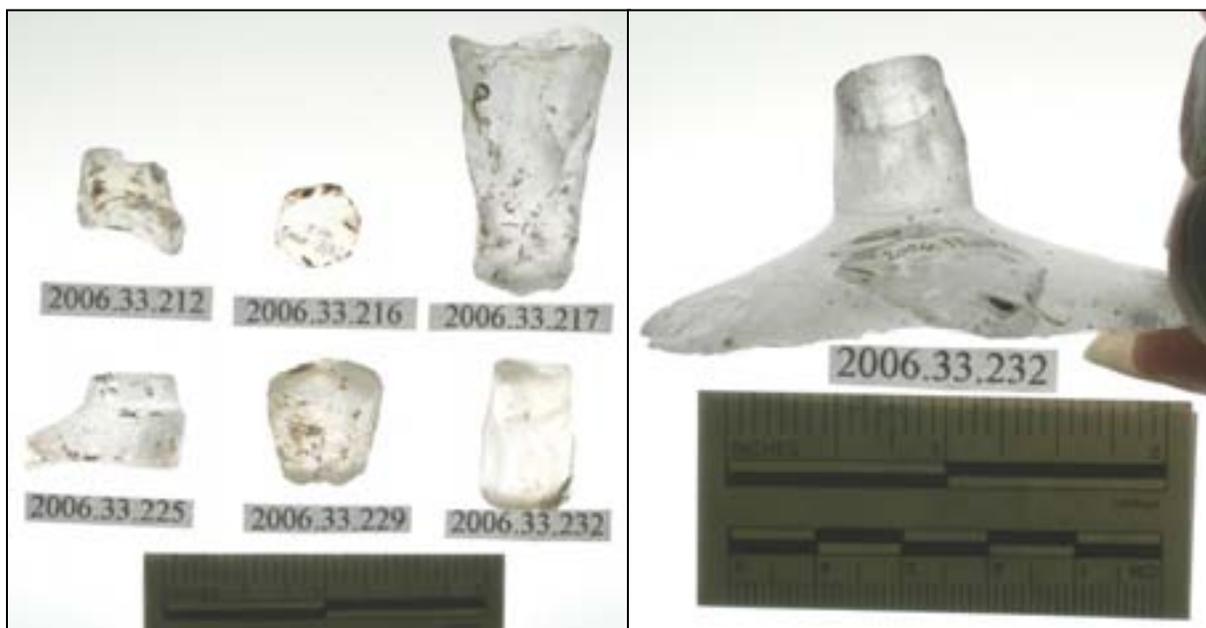
Figure 6.113. Cut stemware fragments with hexagonal facets.

decorated. Nine of these are cut with hexagonal facets (Figure 6.113) and one has a single angular knop and an opaque twist (Figure 6.114). Table G-20 in Appendix G details the stemware analysis for this site. Figure 6.115 is an example of plain stems from the collection. Figures 6.116 shows examples of wheel-engraved stemware recovered from the Roosevelt Inlet Shipwreck. Figure 6.117 illustrates chronological changes of drinking glass stem styles. Consultation with Dr. Hugh Willmott, a scholar from the University of Sheffield, England, was undertaken to try and more narrowly date the glass from this wreck. Based on photographic analysis, he came up with a date of 1775 based upon the inclusion of what he determined to be an air twist stem (2006.33.229), which dates from 1750-1775, and on the faceted cut stems which were most popular from 1775-1780 (Willmott personal communication September 2009, see Appendix F). DH&CA analyst Faye Stocum suggests that this is not an air twist but rather an opaque twist which dates from 1750-1780. Included in Appendix F is a catalogue created by Dr. Willmott which lists his analysis of both the stemware and tumbler fragments recovered from the wreck. Included in this list are several glass fragments which are listed, perhaps erroneously, under furniture in the data inventory. According to Dr. Willmott's analysis these items, identified as chandelier parts in the inventory, are actually the bases of stemmed jelly glasses. Certainly additional scholarly research will shed more light on this topic (Jones and Sullivan 1989; Noël Hume 1969; Ossowski 2008; Sullivan 1986).

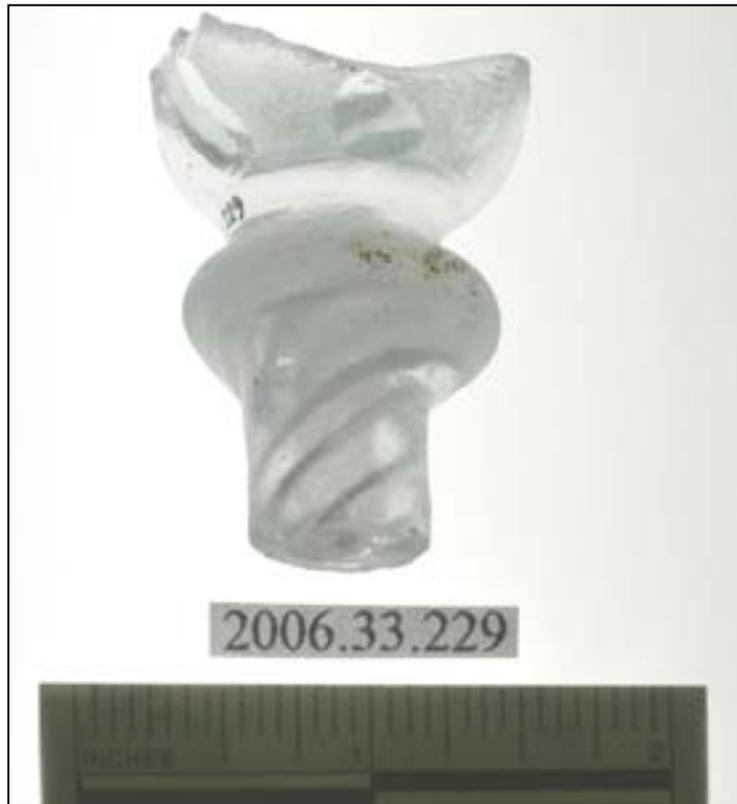
Figure 6.114. Angular knop and opaque twist (2006.33.229).

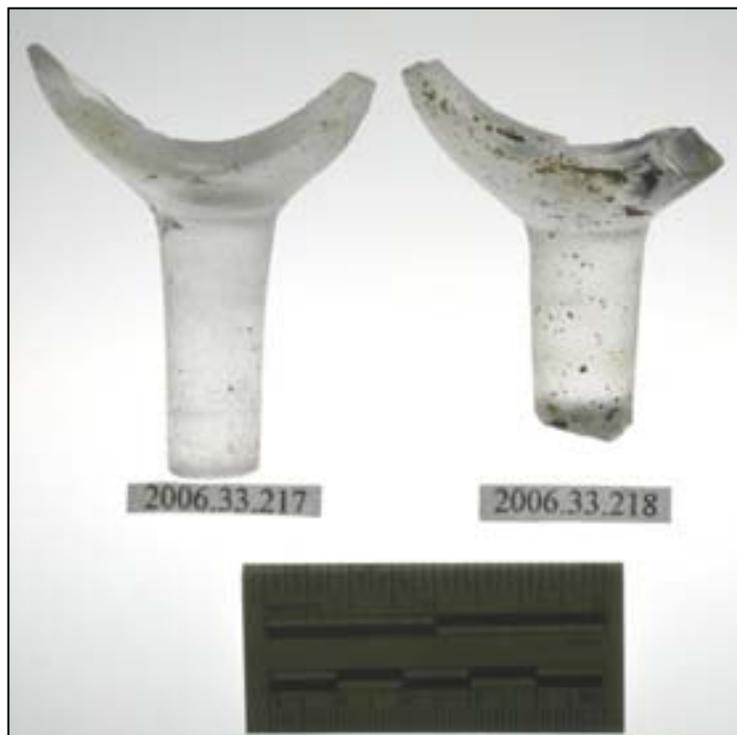
Figure 6.115. Plain stemware (2006.33.217 and 2006.33.218).

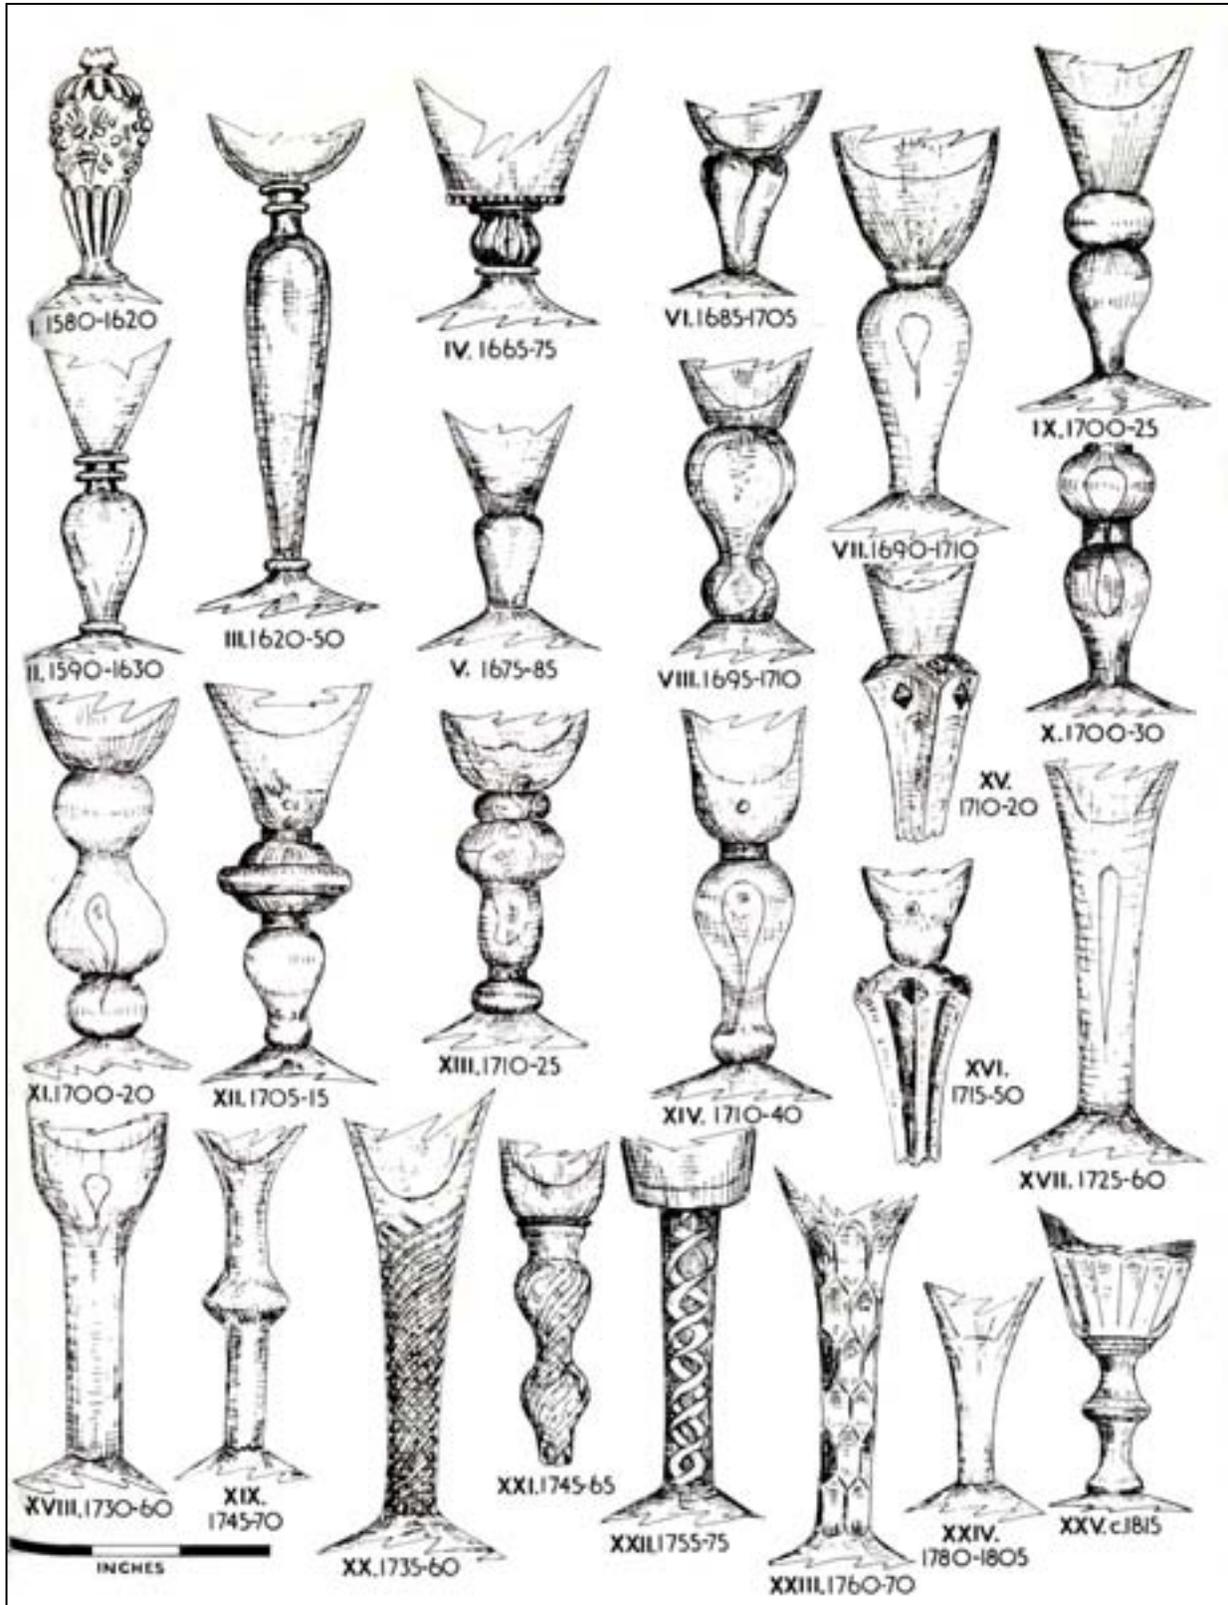
Figure 6.117. Chronological changes in drinking glass stem styles.
(Source: Noël Hume 1969:191)

Eighteenth-century stemware evolved out of the Venetian and Rhenish styles. Bowls were most often trumpet-shaped and the foot, which had been made of folded glass in the seventeenth century, became a single molded piece. Stems themselves provide the glass researcher with the most effective method of determining the age of the vessel. At the beginning of the eighteenth century glass tableware reflected the elaborate and heavy baroque designs that were popular in furniture and architecture. Stems were constructed of hollow knobs and balusters with buttons and collars. This transitioned into cleaner balusters and into airy, Rococo-inspired designs as the century progressed. By the mid-eighteenth century stems had evolved into clean, single solid baluster designs. Decoration of these simpler stems became more elaborate with an air twist (by 1745), cut pattern (by 1760), and single or double tear drops (by 1745). Etched or wheel-engraved designs on the bowls began to appear by mid-century and are found with increasing prevalence after 1740 in archaeological contexts within the United States (Noël Hume 1969:194, Jones and Sullivan 1989).

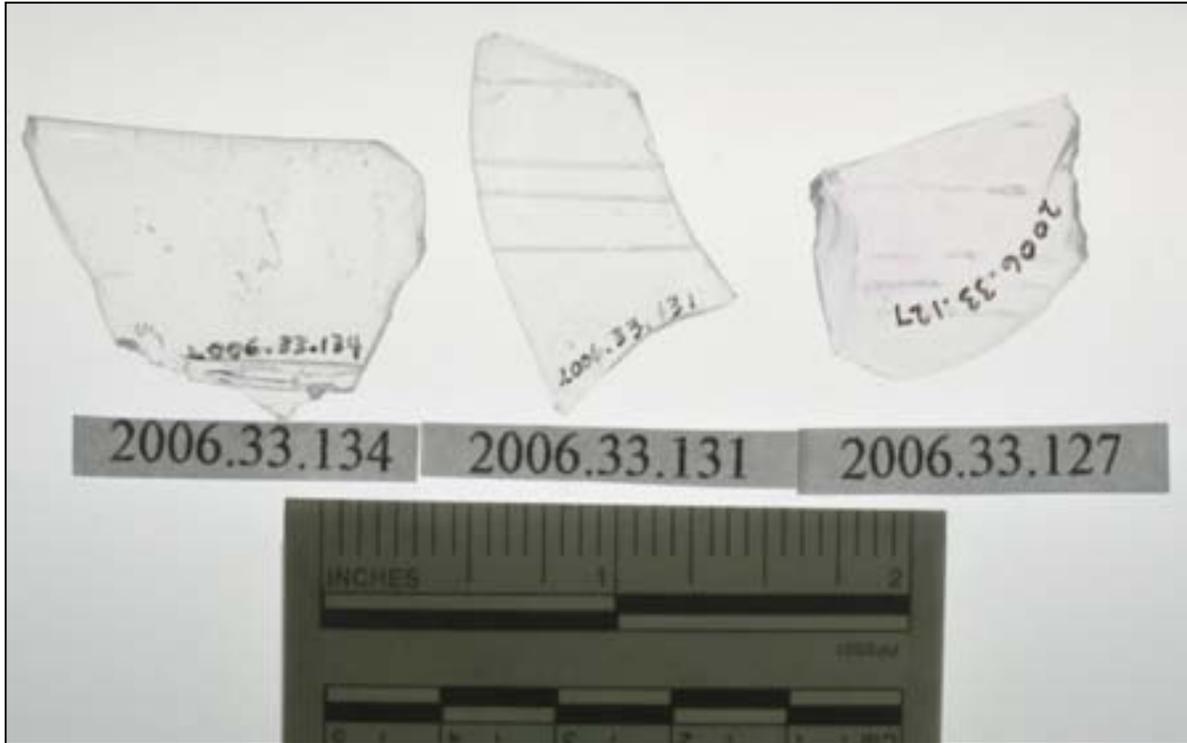
Figure 6.118. Applied glass string decorated tumbler fragments.

tumblers are barrel-shaped, 9 are cylindrical, two are either barrel or cylindrical, one is flared, and one is tapered. Forty-two fragments, representing 33 individual vessels, are decorated. This decoration consists of applied glass string (n=10), cutting (n=3), etching (n=3), etching and molding (n=2), and molding (n=15). Decoration is similar in motif to the stemware designs. Figures 6.118-6.120 are examples of tumblers in this collection. Tumbler fragments recovered from the shipwreck include two bases with roughly ground
