UNDERWATER ARCHAEOLOGICAL INVESTIGATION OF THE ROOSEVELT INLET SHIPWRECK (7S-D-91A)

VOLUME 1: FINAL REPORT

State Contract No. 26-200-03
Federal Aid Project No. ETEA-2006 (10)

SOUTHEASTERN ARCHAEOLOGICAL RESEARCH, INC.

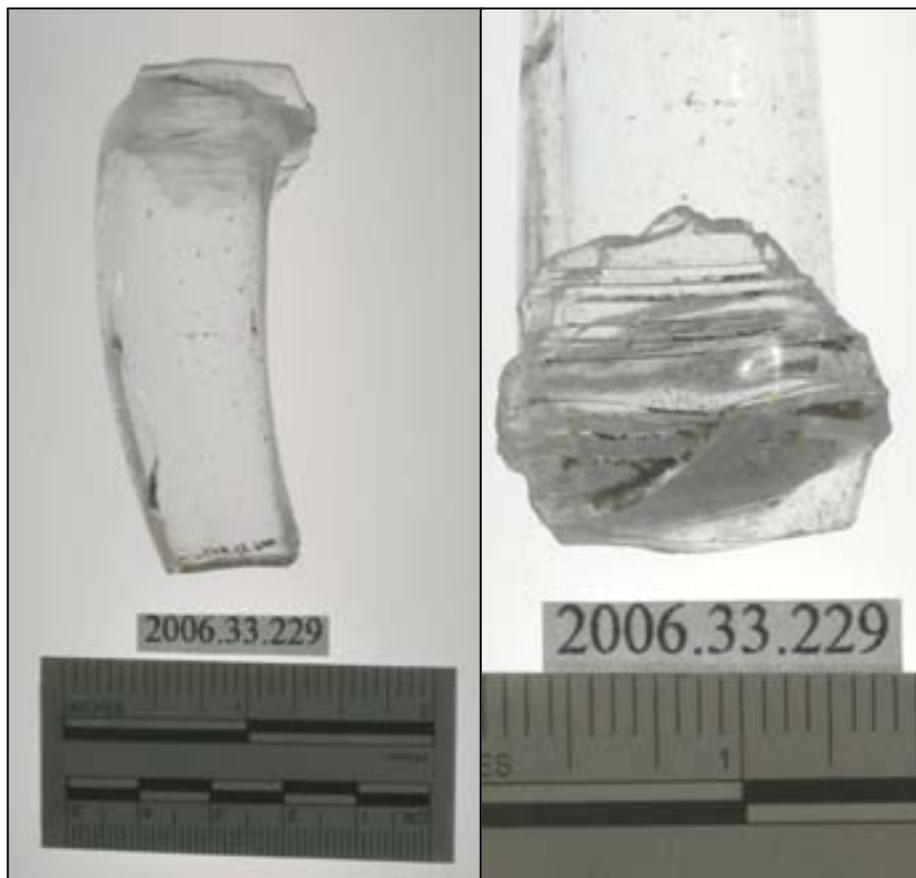
Figure 6.121. Left: Glass cup or mug handle fragment.
Right: Detail view (29006.33.229).

pontils evident in the “grayish-white and scratched” surface with” bits of the pontil mark still remain(ing)” (Figures 6.119 and 6.120). According to Jones and Sullivan (1989:129) this attribute usually is attributed to a Continental manufacturing origin. Figure 6.121 shows a glass handle fragment and a close-up of the same. Appendix G, Table G-21 details the tumbler analysis for the Roosevelt Inlet Shipwreck (Jones and Sullivan 1989).

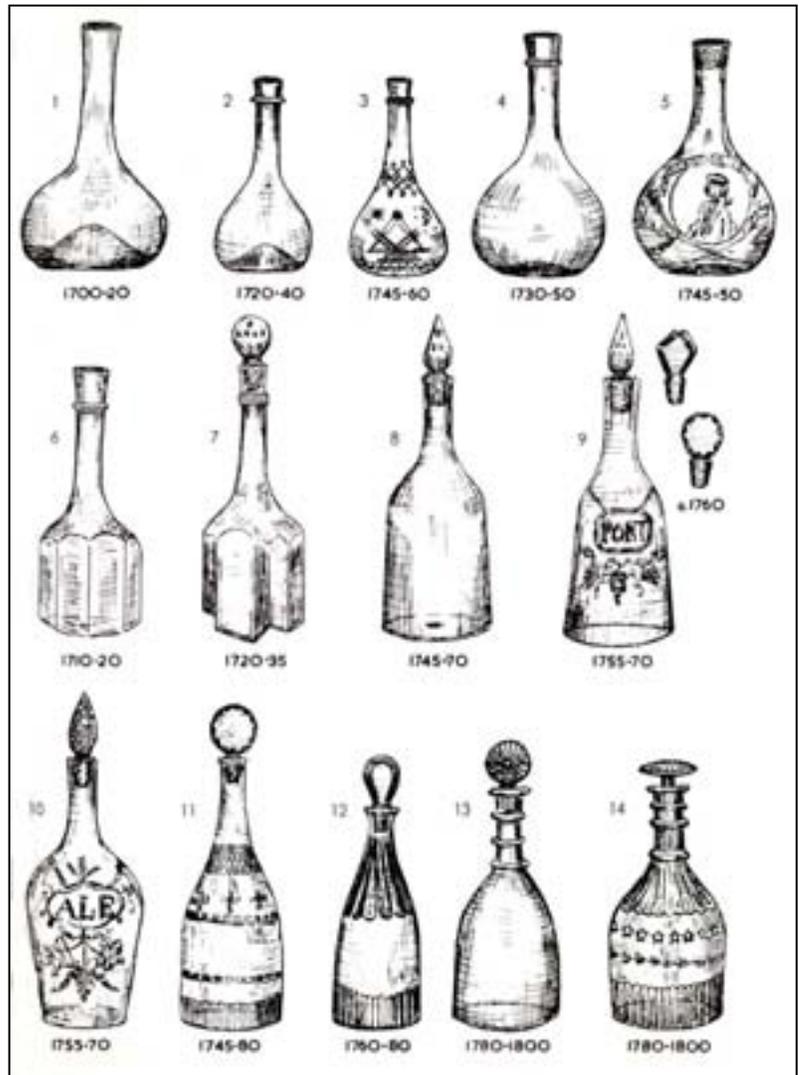
Figure 6.123. Chronological changes in eighteenth-century lead glass decanter styles. (Source: Noël Hume 1969:196-7)

Glass serving pieces recovered from the shipwreck have been limited to decanters. These elegant liquor containers evolved out of the wine/spirit tradition and originally were basically olive green wine bottles with handles attached. By 1720, however, these crude forms had been replaced with clear lead glass forms. Both the body shape and the glass stopper closure styles changed over time. Only two confirmed decanter fragments have been recovered from the site. Both are spire-shaped glass stoppers and are faceted in the mid-eighteenth century style (Figure 6.122). Figure 6.123 shows decanter forms throughout the eighteenth century (taken from Noël Hume 1969:196-7).

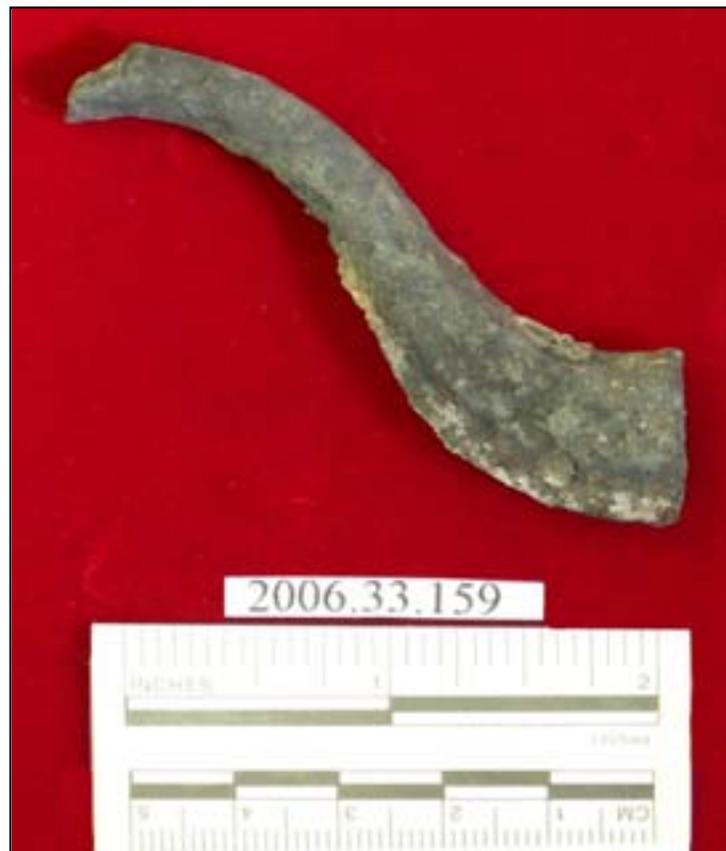
Figure 6.124. Pewter teapot spout (2006.33.159).

Also in the kitchen category are metal objects used for preparing, serving, and eating food. Sixteen food preparation/serving/storage items were recovered from the wreck. These consist of a teapot and spout, two teapot base rings, two mug or tankard lids with hinges, two vessel hinges, three plate warmers (one whole and pictured in Figure 6.129 and two fragments), one bottle closure (that attaches a cap for glass container), and one jug lid, all made of pewter. One vessel hinge of indeterminate metal and six copper alloy objects (two U-shaped pot handles, one ornamented handle with an anthropomorphic head at the top, two U-formed handles, and one knob), were also recovered. Additionally, small rivets were recovered from various portions of the wreck which may be associated with kitchen metal wares such as kettles or pots. Figures 6.124-6.129 are photographs of examples of these objects.

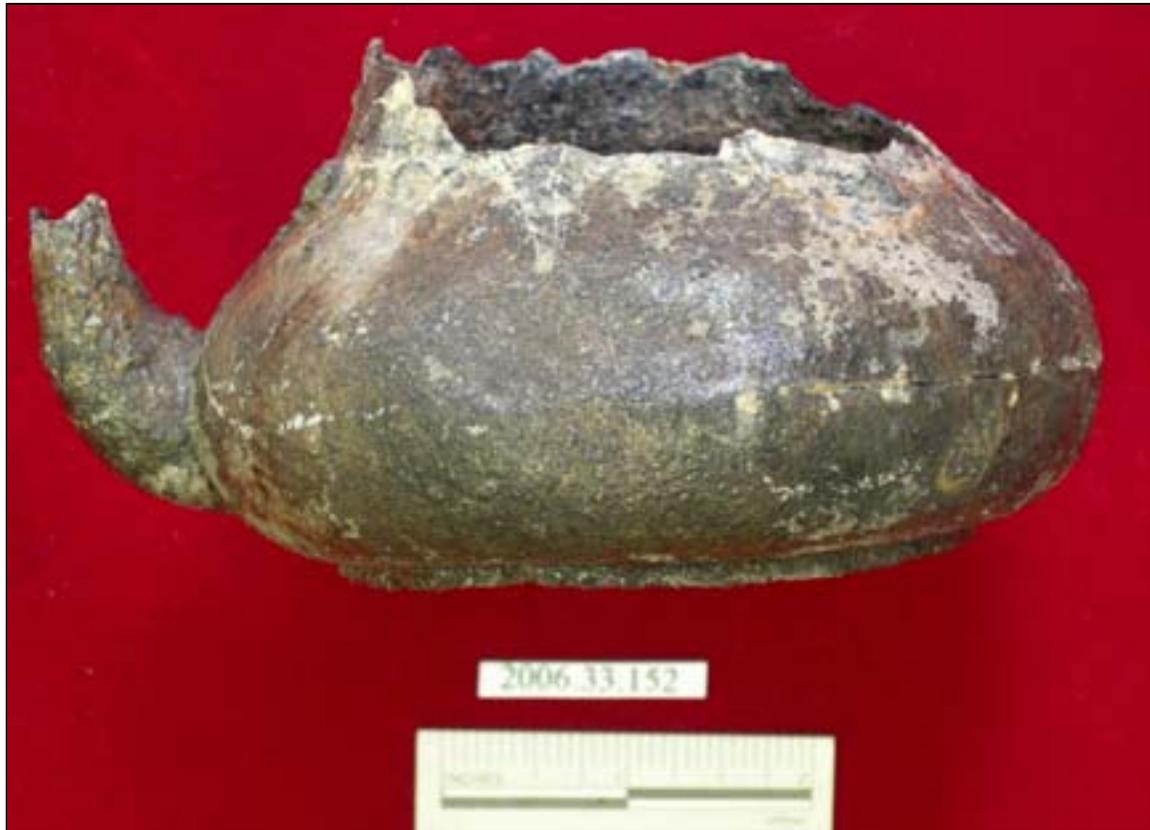
Figure 6.125. Pewter teapot (2006.33.152).

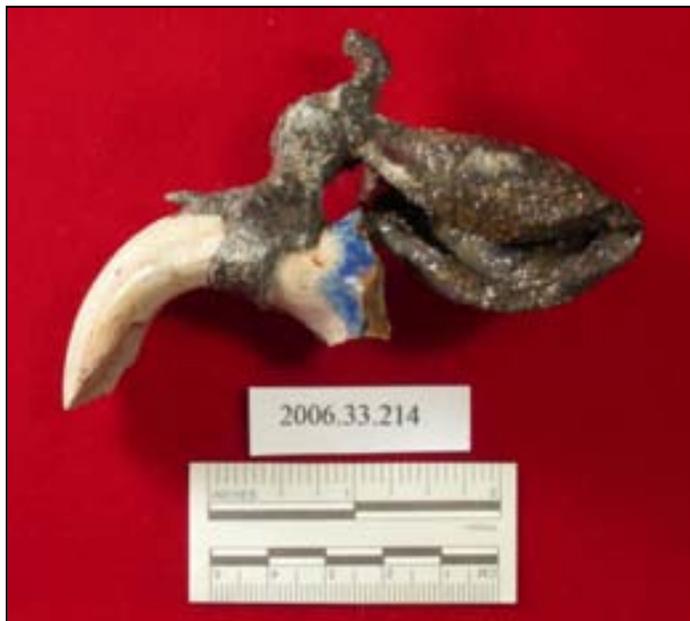
Figure 6.126. Fragment of a jug or ewer lid, hinge, and blue and gray stoneware handle (2006.33.214).

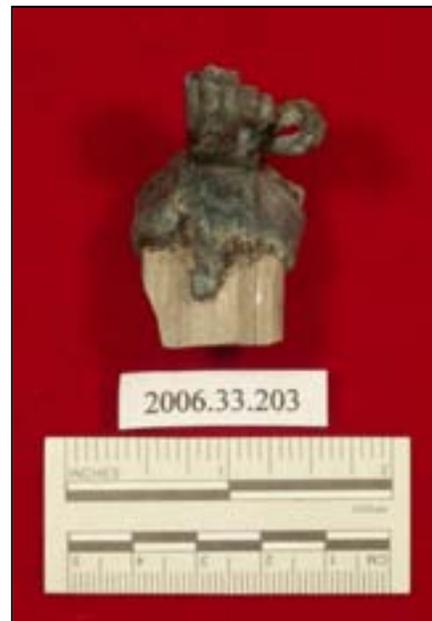
Figure 6.127. Lid hinge on gray stoneware handle (2006.33.203).

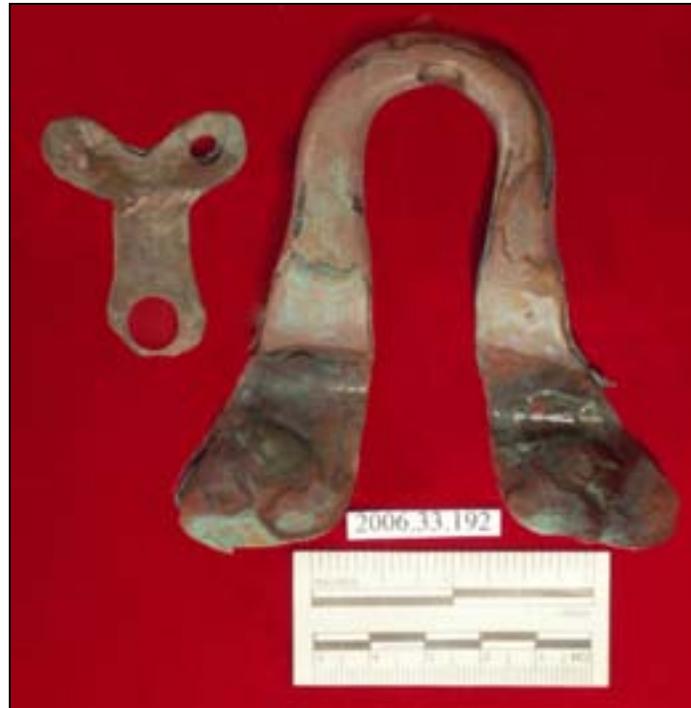
Figure 6.128. U-shaped metal handle (2006.33.192).

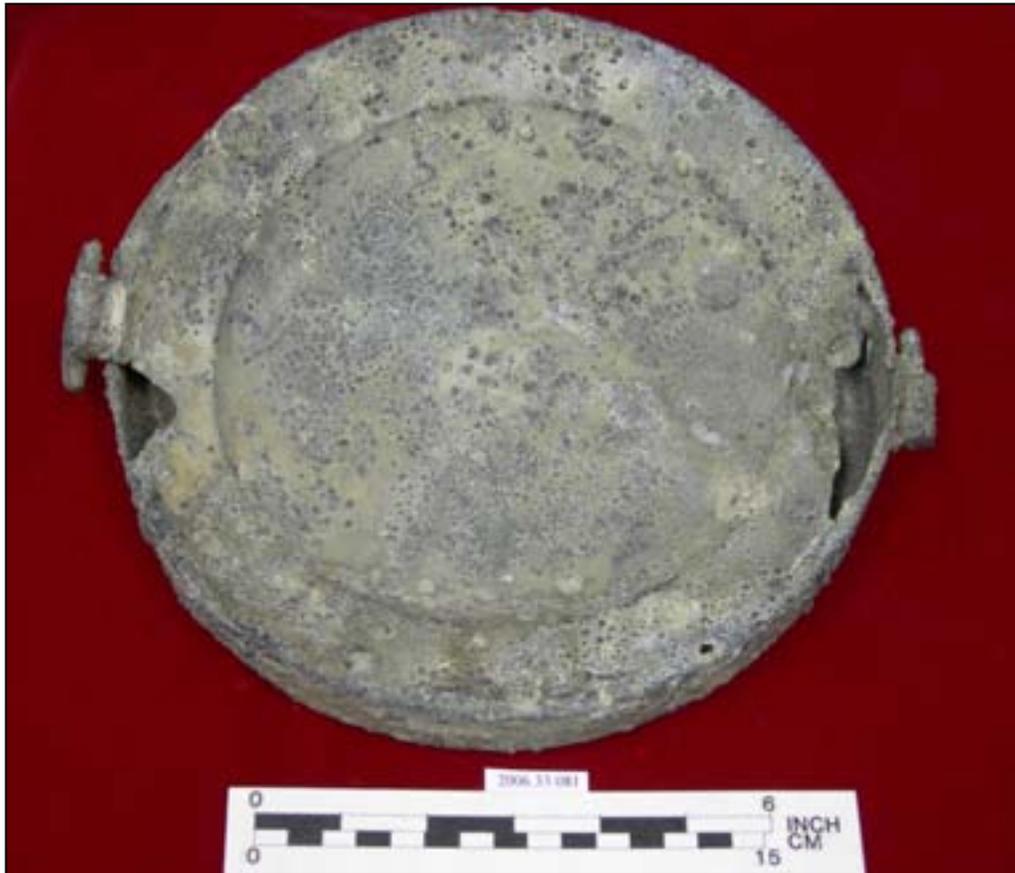
Figure 6.129. Pewter plate warmer (2006.33.081).

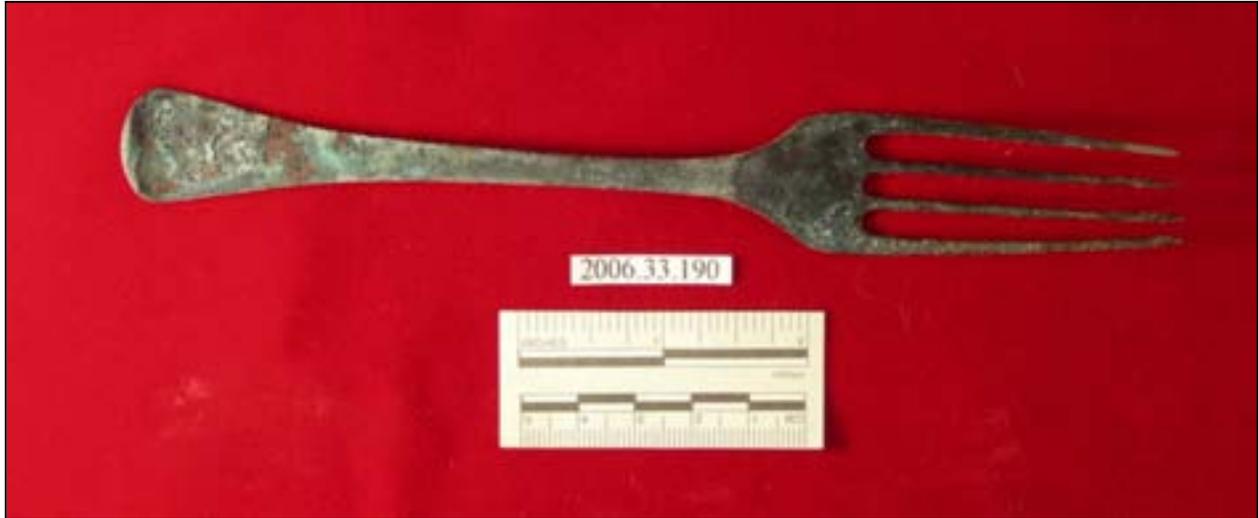
Figure 6.130. Solid copper alloy four-tined fork (2006.33.190).

Two solid copper alloy metal forks, both four-tined in the mid- to late-eighteenth century fashion (Figure 6.130); six pewter spoons, one of which is a serving spoon (Figures 6.131 and 6.132); five standard tableware spoons (Figure 6.133); and four probable spoon handles, all pewter (Figure 6.134), were also recovered. One probable knife handle constructed of either maple (*Acer sp.*) or birch (*Betula sp.*) wood and decorated with an elaborate pewter cage (Figures 6.135 and 6.136), and one Whieldon ware ceramic knife handle made in the mid-eighteenth-century pistol grip style (Figure 6.137) were also found in the wreck (Noël Hume 1969; University of Delaware 2008).

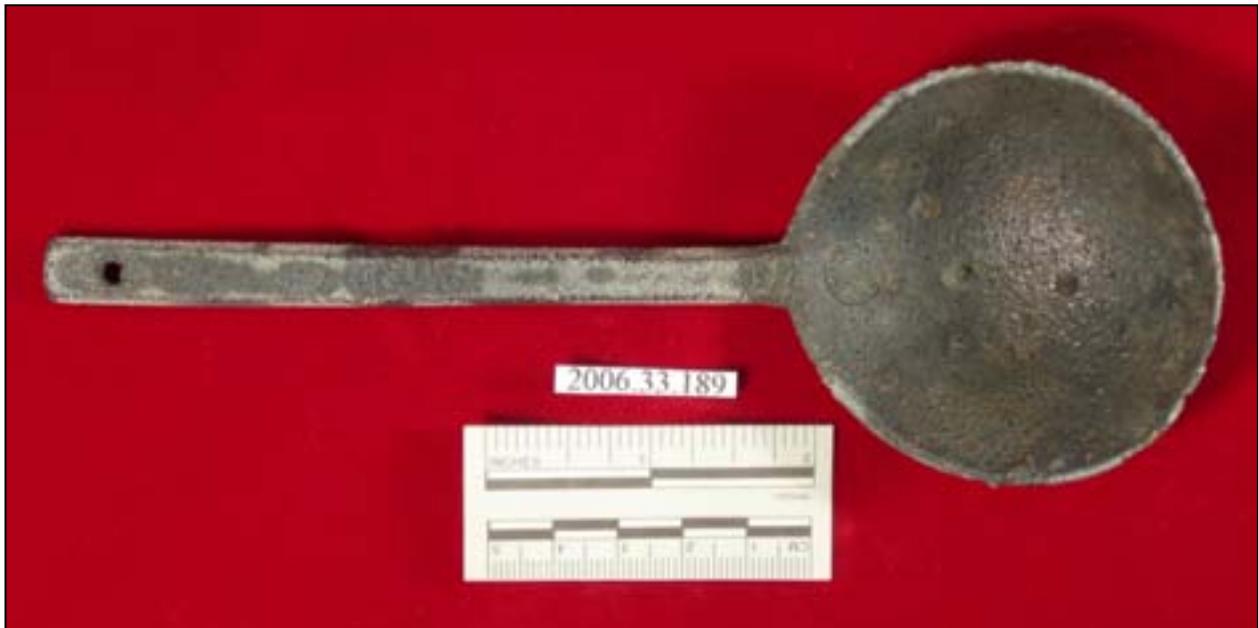
Figure 6.131. Pewter serving spoon (2006.33.189).

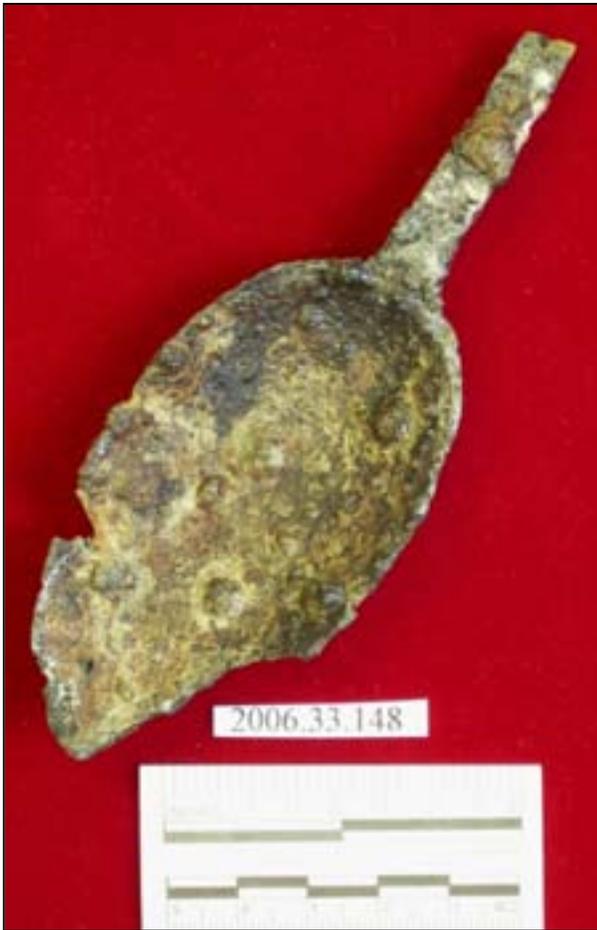
Figure 6.133. Pewter tableware spoon (2006.33.148).

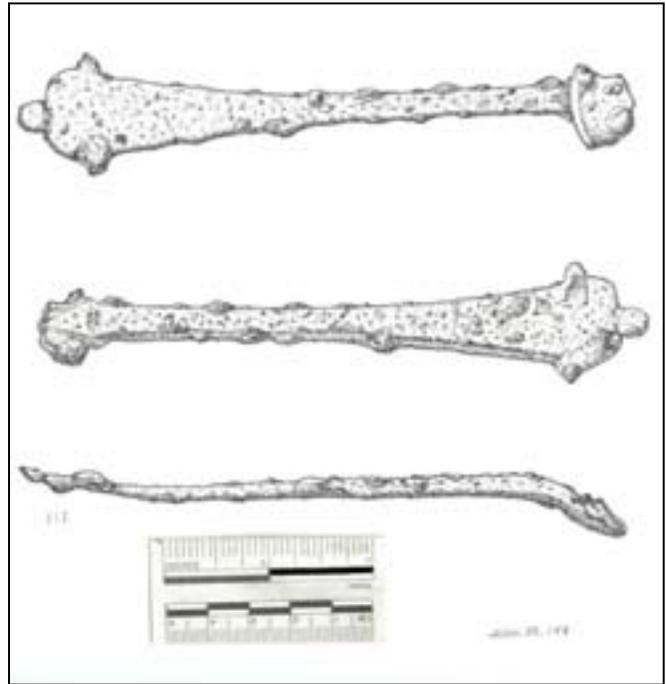
Figure 6.134. Detail illustration of pewter spoon handle (2006.33.148) (by Sharyn Murray).

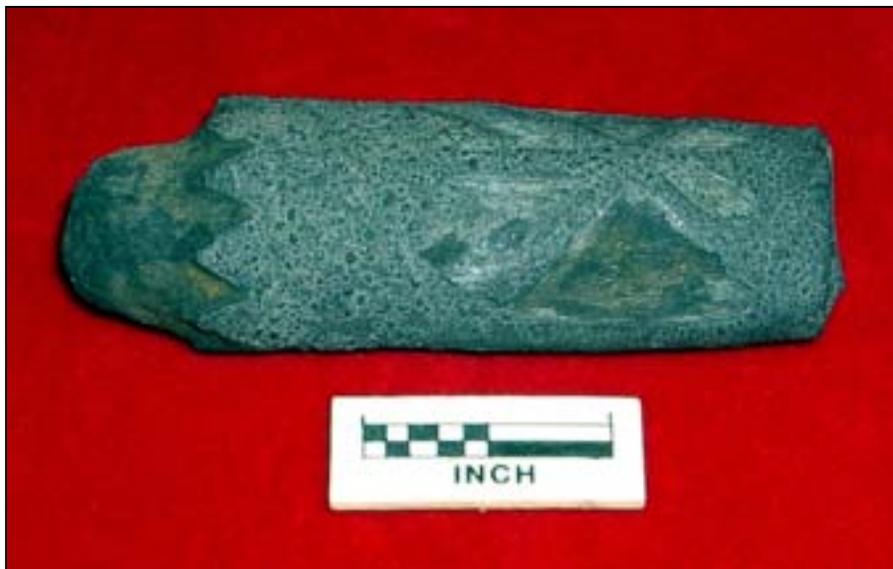
Figure 6.135. Wooden knife handle with pewter cage (2006.33.212).

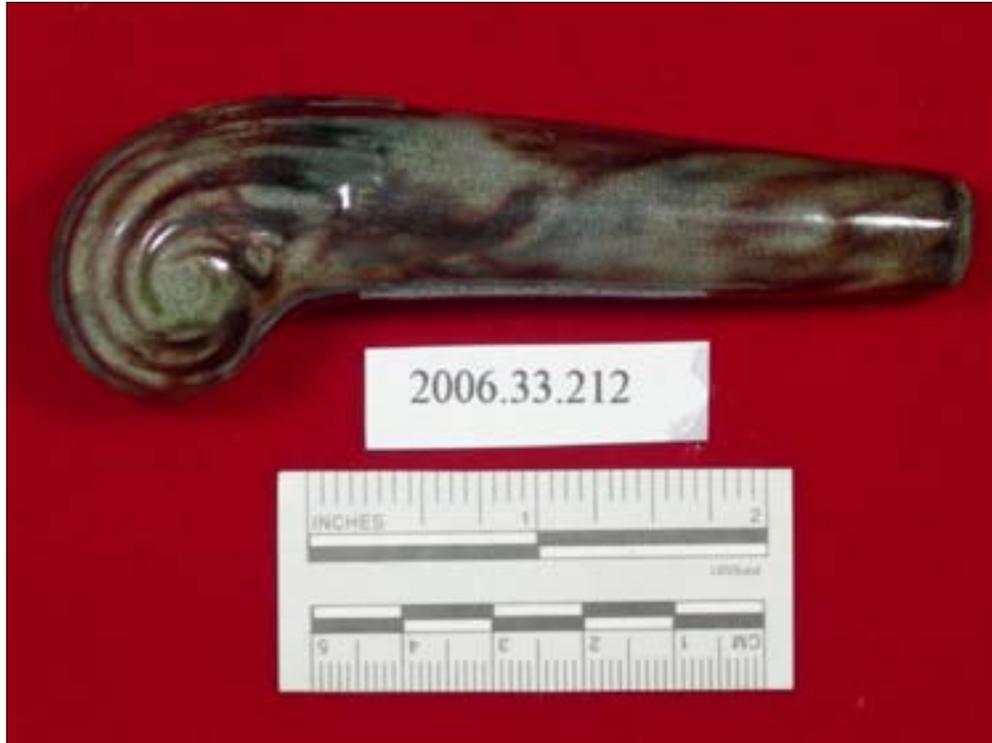
Figure 6.137. Mid-eighteenth-century Whieldon ware ceramic knife handle (2006.33.212).

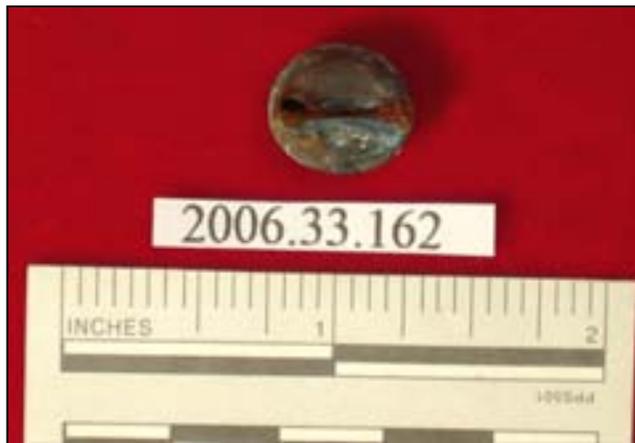
Figure 6.138. Copper alloy rumbler bell (2006.33.162).

with circular punches on the other side, with a pea or iron pellet/ball on the inside. These bells can be cast or made of sheet metal. Sheet metal rumpers are distinguished by the method in which they were constructed. This construction method changed over time and can serve as a tool for helping date a site. Lapped edge (1492-1575), flanged edge (1650-1850), or flush edge (1600-1850) are the terms used to describe the seams where the two halves join (Brown 1979; Deagan 2002:140-147; Noël Hume 1969:58-59).

Two copper alloy bells were recovered during the October 2006 excavations. One, a two-piece spherical copper alloy rumbler or sleigh bell, measures .47" in diameter at the seam and appears to be of the flush edge variety (Figure 6.138). The second, also described as a spherical bell with a slot opening, is also of copper alloy but the variety is indeterminate as it has not been photographed.

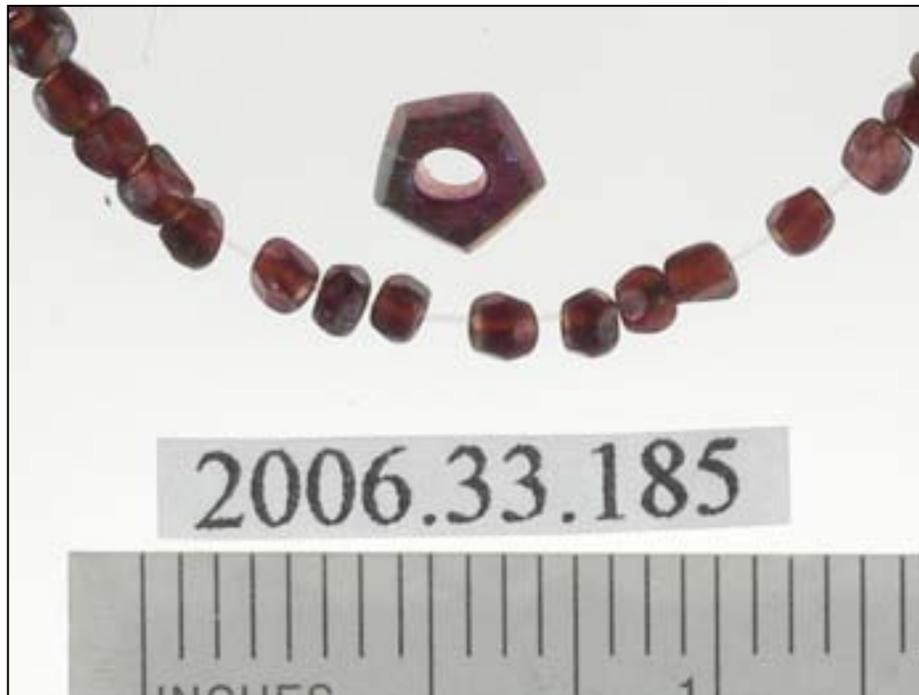
Figure 6.140. Cranberry red/dark purple beads (close-up) (2006.33.185).

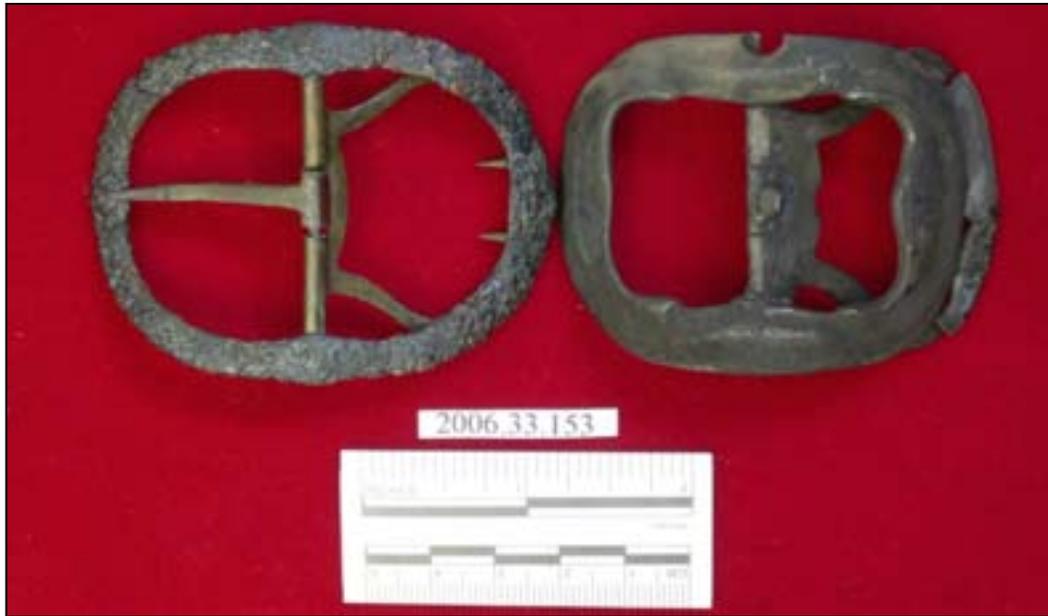
Figure 6.142. Buckles recovered from the Roosevelt Inlet Shipwreck site (2006.33.153).

One hundred and forty-four (144) buckles and buckle fragments, along with two copper alloy chape fragments were recovered from the wreck. Of these, 107 were identified as shoe buckles (pewter n=94, copper alloy n=8, uid metal n=5), ten were identified as knee buckles (pewter n=9, copper alloy n=1) and the remainder were fragments or unidentified as to type. Undoubtedly, some of these buckles may be identified with further analysis. The full inventory of buckles and buckle fragments recovered from the site, including additional details and location of recovery may be found in Volume 3. Figures 6.141 and 6.142 show photographic examples of buckles recovered from the Roosevelt Inlet Shipwreck. Figure 6.143 is a detailed line drawing of knee buckles from the October 2006 excavations. Similar and well-preserved examples of knee and shoe buckles have been recovered from the 1785 wreck of the British merchant vessel *General Carleton*, in Poland; some examples are provided below for comparison with buckles recovered from the Roosevelt Inlet site. Figure 6.144 is an example of knee buckles recovered from that 1785 wreck, and Figures 6.145-6.147 are detailed line drawings of shoe buckles recovered from the Roosevelt Inlet site. Figure 6.148 shows examples of shoe buckles in the Artois style from the British merchant vessel *General Carleton*. Figure 6.149 is an example of probable hat buckles, while Figure 6.150 shows examples of other base metal buckles recovered from the merchant vessel *General Carleton*.

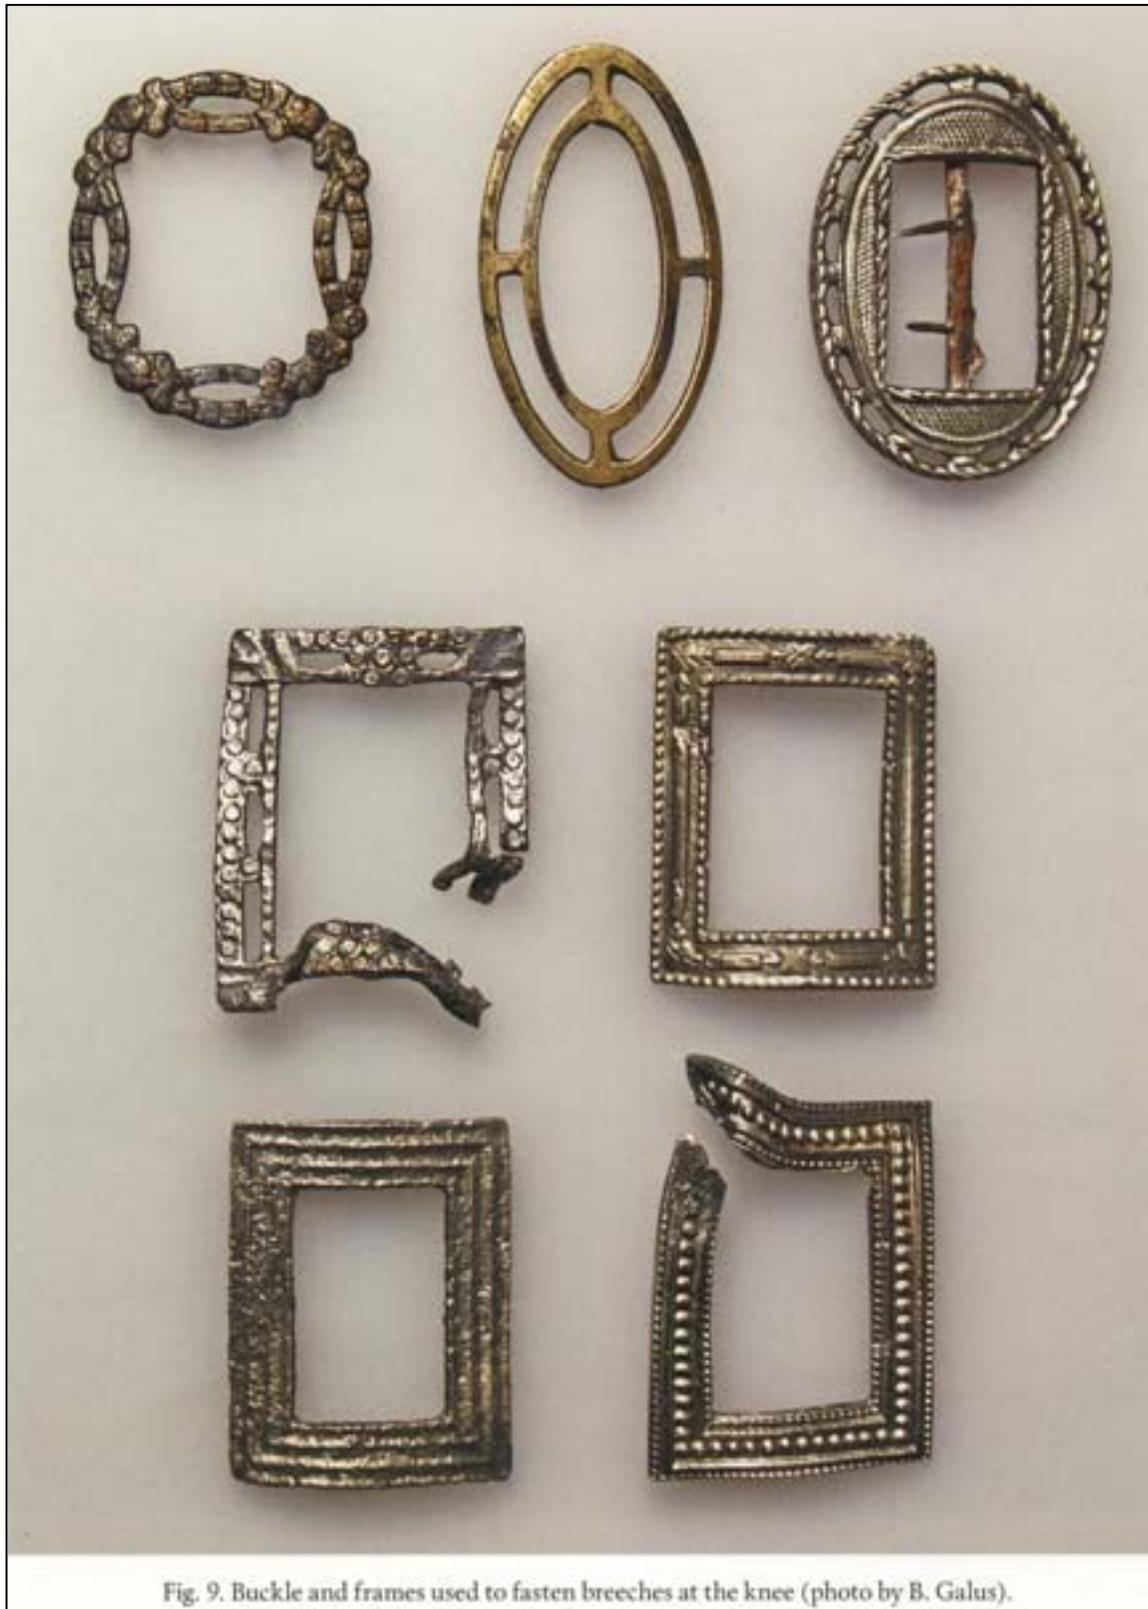
Fig. 9. Buckle and frames used to fasten breeches at the knee (photo by B. Galus).

Figure 6.144. Knee buckles recovered from the 1785 shipwreck of the British merchant vessel General Carlton in Poland. (Ossowski 2008)

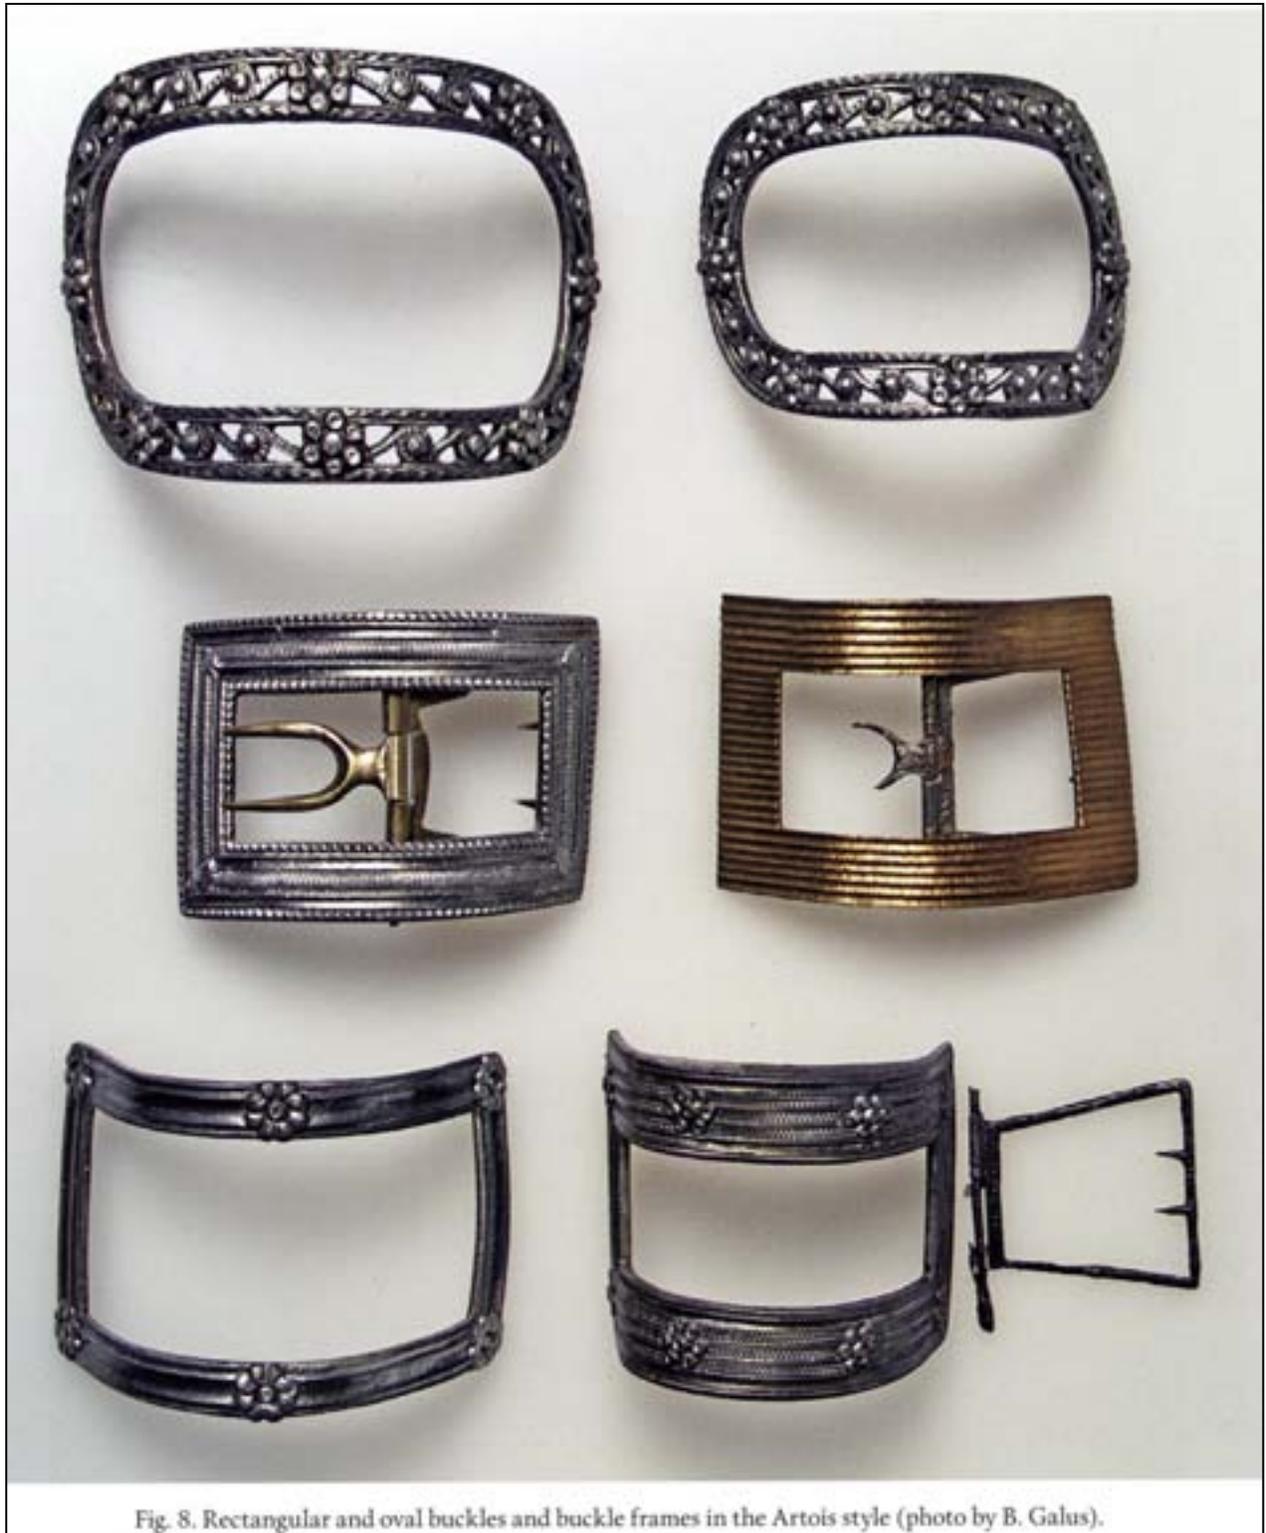
Fig. 8. Rectangular and oval buckles and buckle frames in the Artois style (photo by B. Galus).

Figure 6.148. Artois style shoe buckles from the *General Carleton* shipwreck.

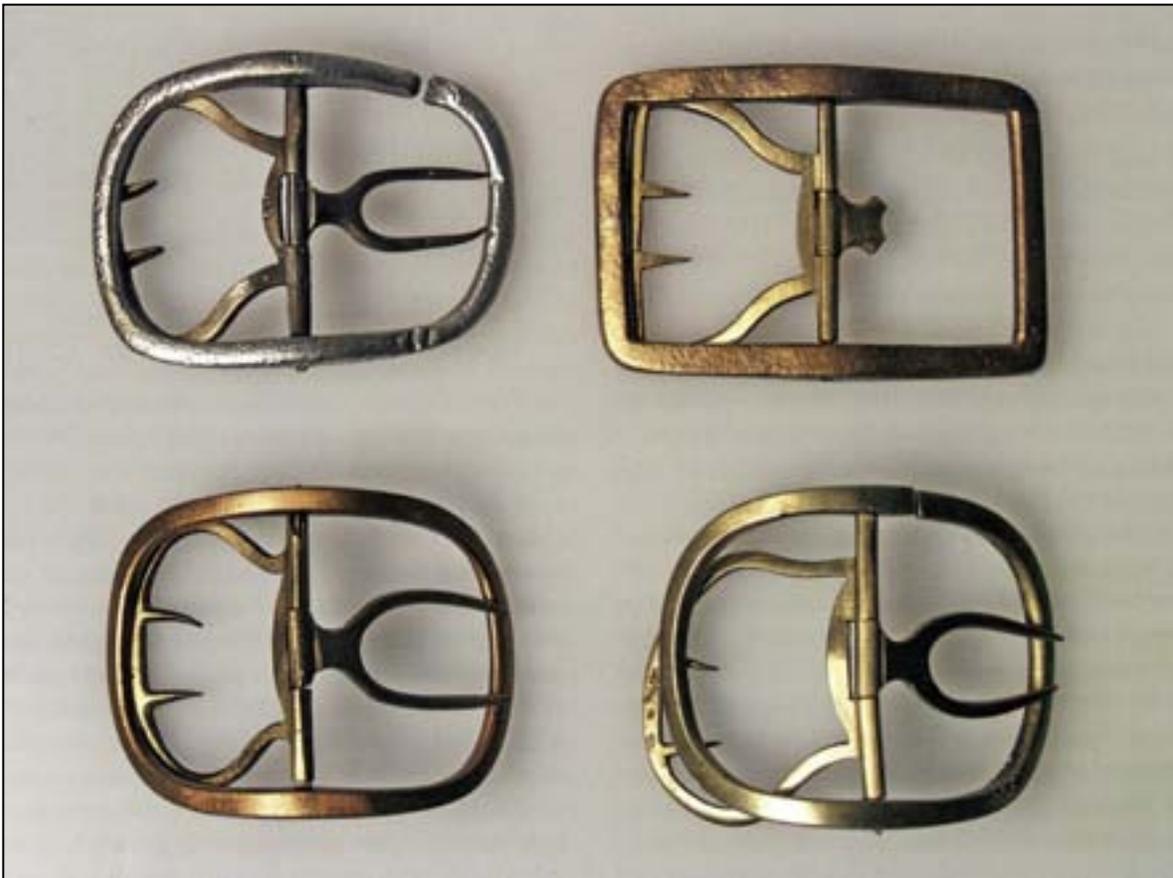
Figure 6.150. Additional buckles from the *General Carleton* shipwreck.

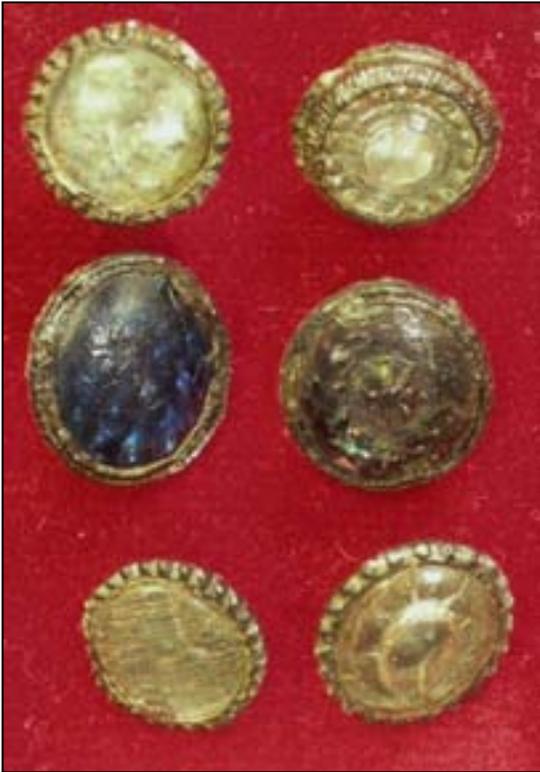
Figure 6.152. Jewel buttons from the Roosevelt Inlet Shipwreck site.

Paste or glass “jewel” buttons were also popular in the eighteenth century (Figure 6.152). Glass insets were set in frames of copper alloy, gold, silver, or pewter in imitation of earlier gemstone buttons. Measureable jeweled round buttons from the Roosevelt Inlet Shipwreck (n=38) range from 5.842 to 17.2 mm in diameter with a mean of 12.72 mm. Also recovered were 38 loose flat pressed glass button insets (Figures 6.153-6.155 and Appendix G, Table G-22) and twelve copper alloy settings with evidence of foil backing for the glass inset. These foils were used to create a range of variability in the color of jeweled buttons (White 2005). For example, artificial opals were created using a pink foil under a milky or cloudy glass inset (Evans 1998). There are three blue, 31 clear, two green, and one purple inset in the assemblage.

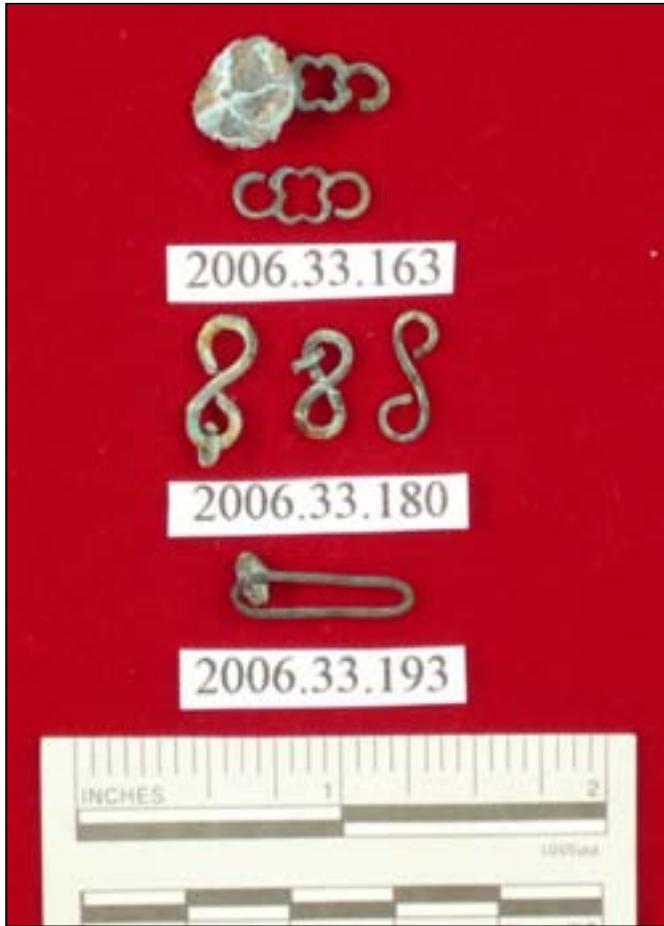
Figure 6.156. Representative examples of sleeve button links recovered from the site. Note quatrefoil design of link in 2006.33.180.

One hundred and thirty-nine (139) buttons and 74 sleeve button links were recovered during the October 2006 excavations (Figure 6.156, 6.157, and 6.158). Of these, 53 are of pewter, 33 of which have glass insets; 82 are copper alloy, nine of which have glass jewel insets, and one possesses a mother-of-pearl inset. Fourteen copper alloy sleeve button links, four “S” shaped, and the remainder link type, were also recovered. Only three bone and one wooden button were recovered (Figures 6.157 and 6.158). The full button inventory which lists all buttons, sleeve buttons, and button links recovered from the shipwreck and details decorative motif, size, and shape is presented in Volume 3.

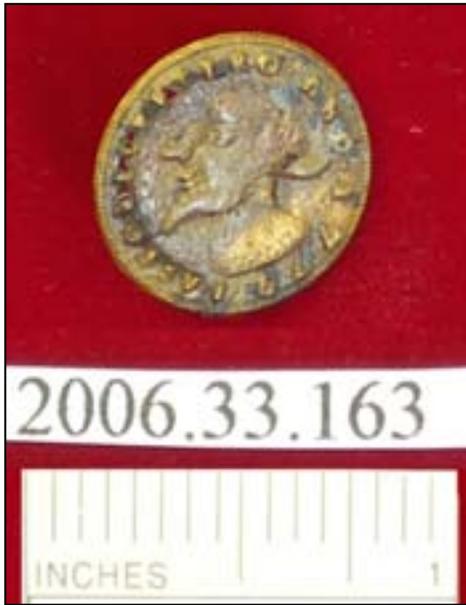
Figure 6.159. Photograph of the cast button with the caricatured profile of a man.

Of particular interest are two very distinctive copper alloy buttons from the collection. One, a one-piece cast button with a drilled shank, has an inscription that reads “PASEO DEL RETIRO - ANO - 1772” on the face and has the grotesque profile of a man with a long beard. The Paseo del Retiro is a section of the Jardines del Buen Retiro, a prominent park and promenade in Madrid, Spain. Whether this button was a memento from a European tour or some type of souvenir is not known; however, it is one of the few artifacts which are dated. Figure 6.159 is a photograph of the button while Figure 6.160 is a line drawing illustration which shows greater detail.

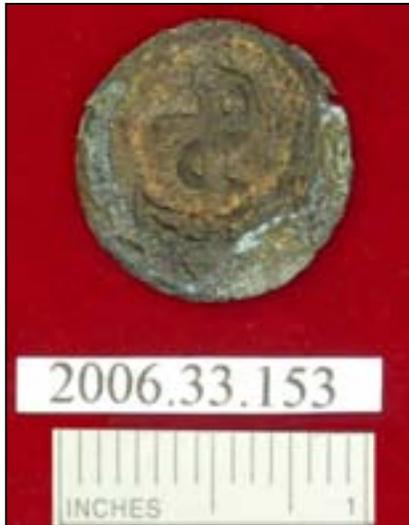
Figure 6.161. Fouled Anchor button from the Roosevelt Inlet Shipwreck site.

The second button of particular note, also a cast disk, has a fouled anchor as the motif (Figure 6.161). The fouled anchor insignia is a common motif used on navy and maritime uniforms from 1774 (Burt 2009; Troiani 2001). Bingemann and Mack (1997) report that seven fouled anchor buttons were recovered from the wreck of the HMS *Invincible*, which sank in 1758. The examples from the *Invincible* have a roped edge. Stocum (2009) states that upon reexamination of the fouled anchor button from Roosevelt Inlet, remnants of rope trim can be made out. The reporting of these buttons from the *Invincible* is evidence that the fouled anchor motif was in use prior to the standard published date range. In addition to having a fouled anchor design, one of these buttons also is back-stamped with the name “I Nutting & Son, Kings St, Covent Garden.” This is a problematic association as records show that John George Nutting registered the I Nutting & Son mark in 1803 (Bingeman and Mack, 1997:49). Burt (2009) indicates that this fouled anchor design on a plain background dates between 1774 and 1787 with later examples having a wreath or raised edge addition to the face. There are many variations on the theme – with the rope or chain in curving around the shaft in different configurations, the arms being curved or straight, the shank represented at a right angle or not, and the eye varying in size. Examples of British Navy (1774-1860) and French Navy buttons with this motif can be seen in Figures 6.163-6.165. A similar button recovered in Burial 6 of the African-American Burial Ground in New York City is shown in Figure 6.162. Burial 6 is that of an African-American male interred after 1776 (Perry, et al. 2006).

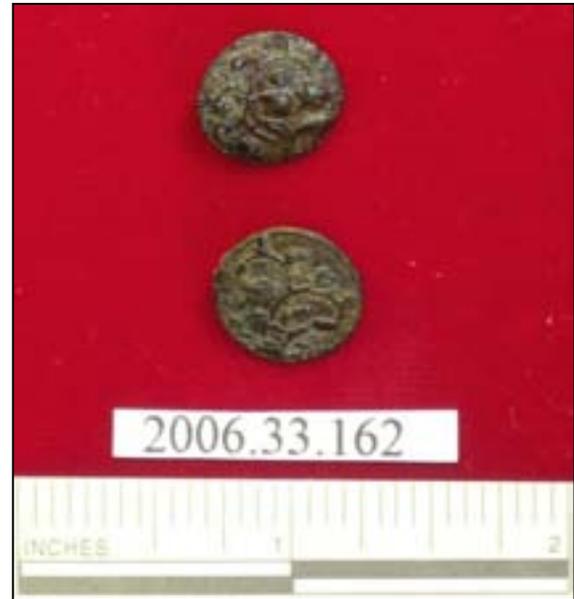
Figure 6.167. Buttons from the Roosevelt Inlet Shipwreck site (2006.33.162).

Figure 6.166 is a salesman’s sample card from the 1780s which illustrates examples of button styles current to that era. Figures 6.167 and 6.168 are examples of similar buttons recovered during the October 2006 excavations at Roosevelt Inlet. Figures 6.169 and 6.170 are examples of sleeve buttons or links also recovered from the wreck.

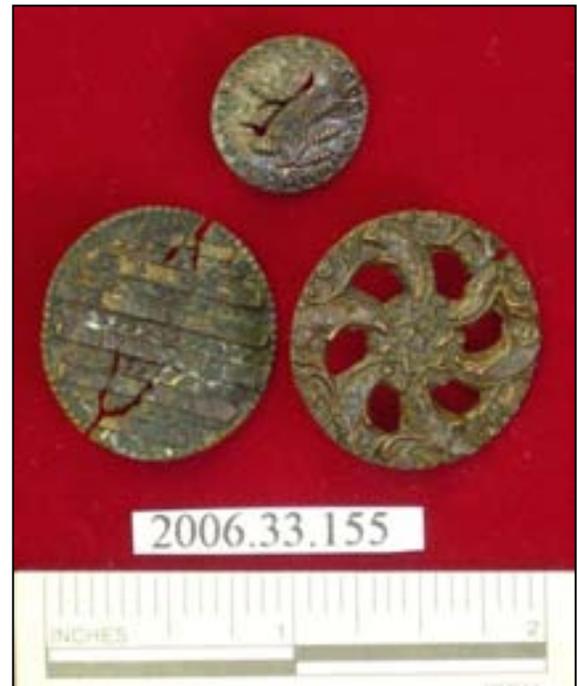
Figure 6.168. Buttons from the Roosevelt Inlet Shipwreck site (2006.33.155).

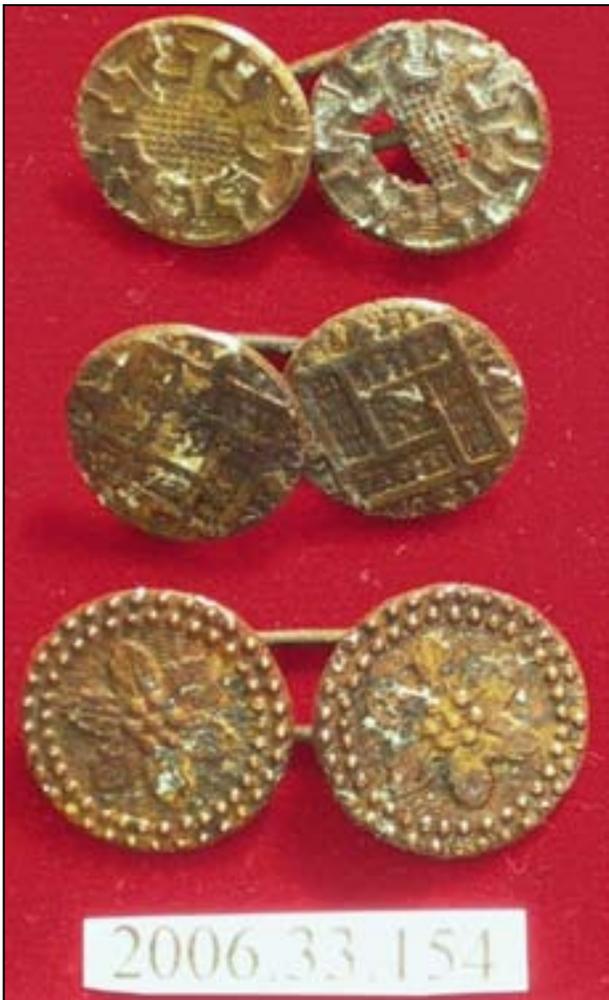
Figure 6.169. A variety of sleeve buttons from the Roosevelt Inlet Shipwreck site. See Figure 6.170 for scale.

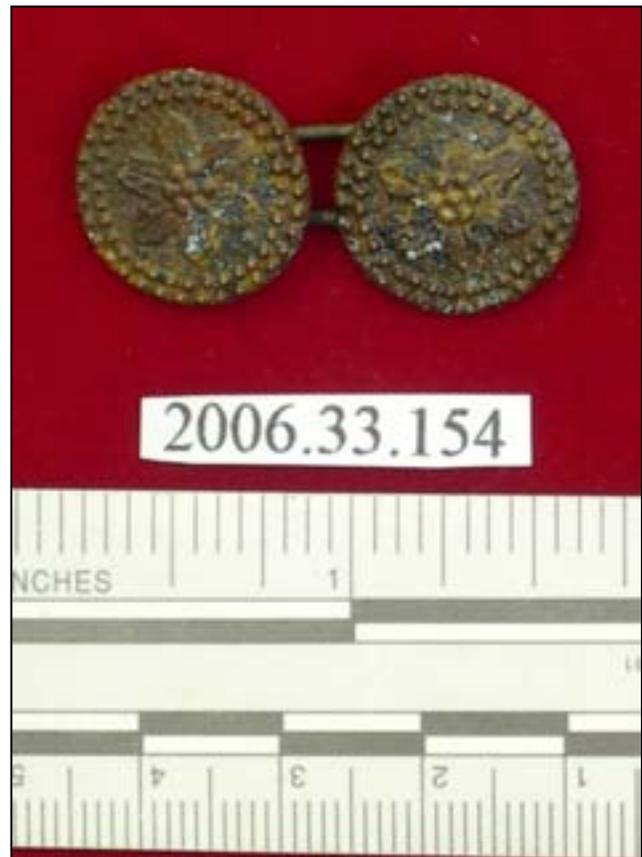
Figure 6.170. Sleeve buttons, or links, from the Roosevelt Inlet Shipwreck site.

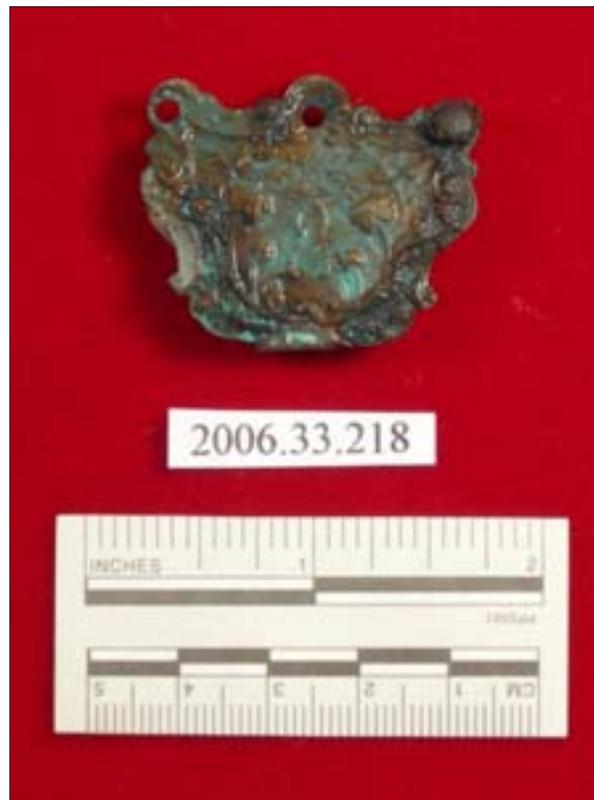
Figure 6.172. Neck stock clasp with scrolled floral motif (2006.33.218).

Both the gemstones and the button insets may be better suited to the Activities, Industry and Transportation categories as they are most likely raw material being sent to local manufacturers. However, as they are also items of adornment, they have been placed in the “Personal” category. Also in the adornment group is one copper alloy neck stock clasp with a scrolled floral motif over fine cross hatchings (Figure 6.172).
