UNDERWATER ARCHAEOLOGICAL INVESTIGATION OF THE ROOSEVELT INLET SHIPWRECK (7S-D-91A)

VOLUME 1: FINAL REPORT

State Contract No. 26-200-03
Federal Aid Project No. ETEA-2006 (10)

SOUTHEASTERN ARCHAEOLOGICAL RESEARCH, INC.

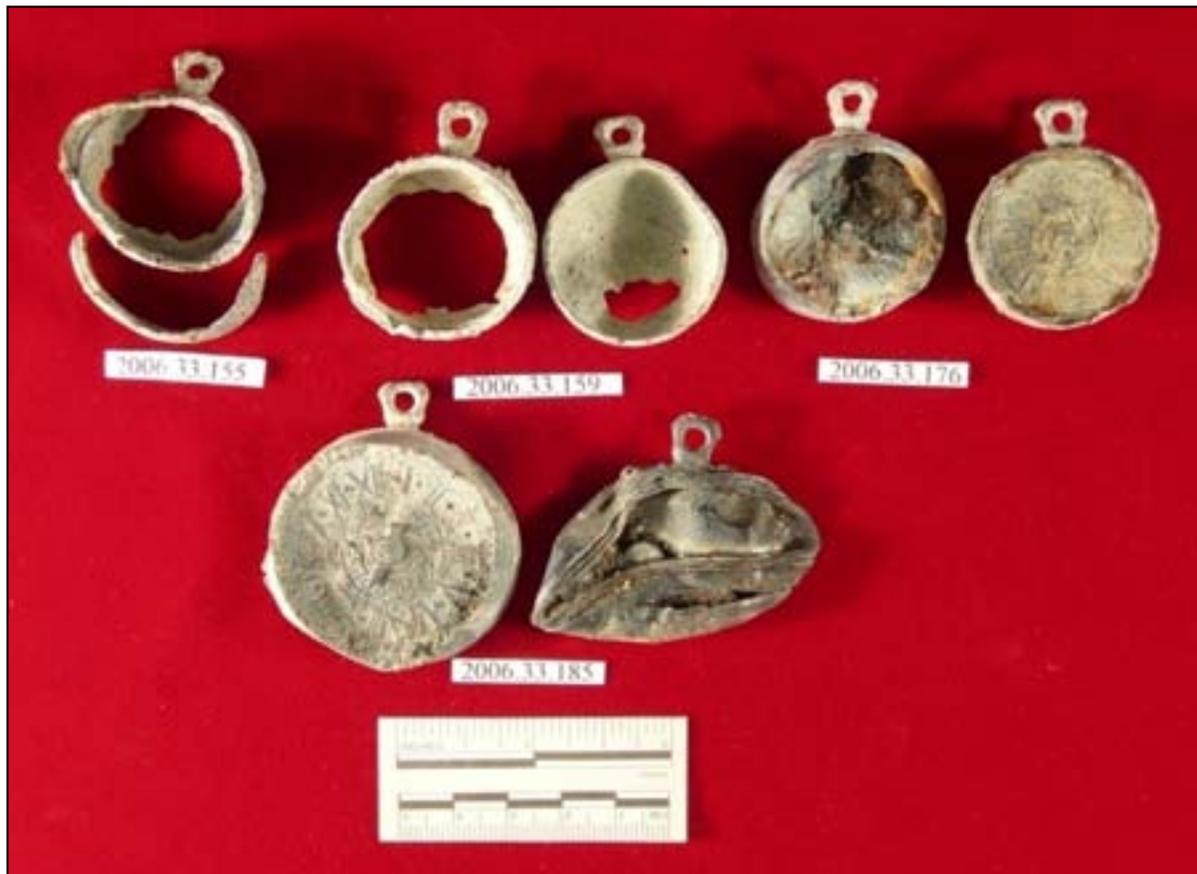
Figure 6.173. Pewter false watches.

Late in the eighteenth century watches became a popular status symbol, to the point that it became the fashion to wear two at once. Both men and women followed this fashion trend with the second watch often being a “fausse montre” or false watch. Very realistically cast with hands and a glass cover, these watches were worn on chains with fobs and placed in the vest pockets of men and on the chatelaine or waist chains of women. Ten pewter false or toy watches were recovered from the RIS. These items may represent toys, but given the trend toward the wearing of false watches in the last quarter of the eighteenth century, it is probable that these represent “fausse montre” (Evans 1970:161-162; White 2005:132). Figure 6.173 shows examples of these items recovered from the October 2006 excavations at the Roosevelt Inlet Shipwreck.

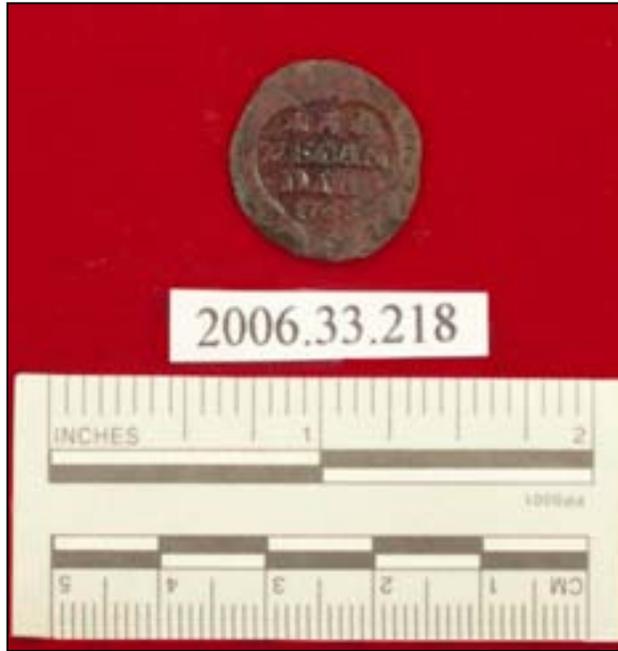
Figure 6.174. Photograph of the 1768 Zelandia province coin (2006.33.218).

Uniformly, the jettons are stamped, badly worn metal (n=10), and all are copper alloy with the exception one which is identified as pewter. The coin recovered from the wreck site is stamped Zelandia 1768 and is from the Netherlands province Zelandia. Figure 6.174 is a photograph of the coin while Figure 6.175 is an illustration which shows the coin in detail. Figure 6.176 is an example of jettons recovered from the site, many of which bear the likeness of Britain's King George II (1727-1760) (Griffith 2009). Figure 6.177 is an example of a Louis XV jetton with a lion and the words "RECHEN PFENING" ("reckoning penny" in German) on the reverse side (UK Detector Finds 2005). This example was recovered from the beach prior to the excavation of the wreck but is identical to one recovered from the wreck which has not been photographed as of this date (Stocum personal communication 2010). According to Stocum all of the jettons have the initials "JAD" or "IAD" on the reverse side (Stocum personal communication 2010). Research into this mark reveals two Nuremberg jetton manufacturers with the initials JAD: Johann Adam Dietzel and Johann (Hans) Albrecht Dorn, both guild masters in the eighteenth century. Dietzel was made master in 1746 and died between 1762 and 1768; Dorn was made master in 1732 and died in 1789 (UK Detector Finds 2005). Table 6.3 details the information that can be gleaned from these items.

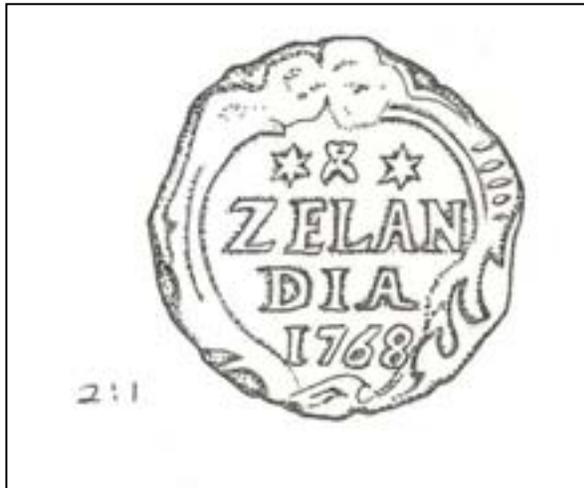
Figure 6.175. Illustration of a 1768 coin from the Zelandia province of the Netherlands (2006.33.218) (by Sharyn Murray).

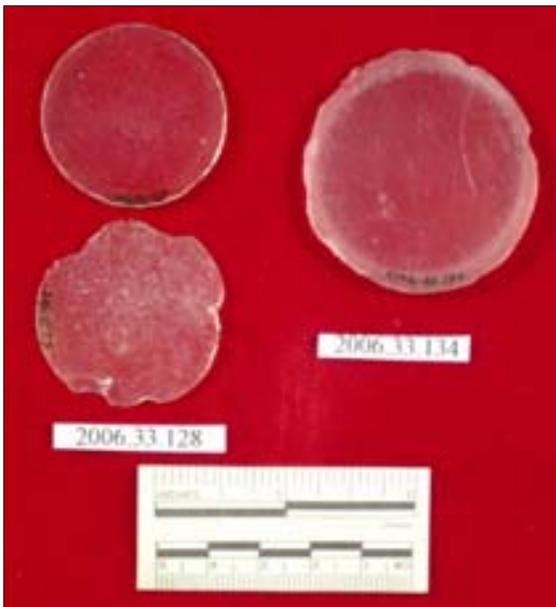
Figure 6.178. Examples of glass lenses recovered from the Roosevelt Inlet Shipwreck.

Also recovered were 43 glass lens fragments. These items appear to be optic glass and are either meant for use in eyeglasses, microscopes, or telescopes (Figure 6.178). One lens in particular (Figure 6.179) appears to have a convex shape that strongly suggests it was ground for extreme magnification purposes. Lacking any frames or mounting hardware, it is not possible to distinguish exact style or usage. Table G-24 in Appendix G details the glass lenses in the Roosevelt Inlet Shipwreck collection.

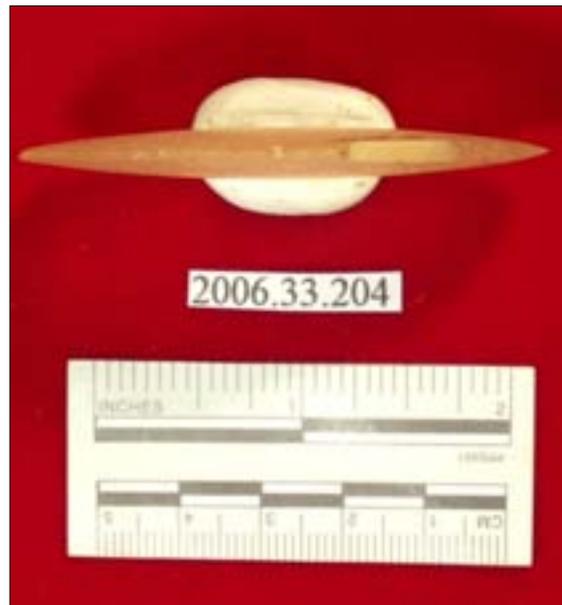
Figure 6.179. Side view of a glass lens illustrating the convex shape (2006.33.204).

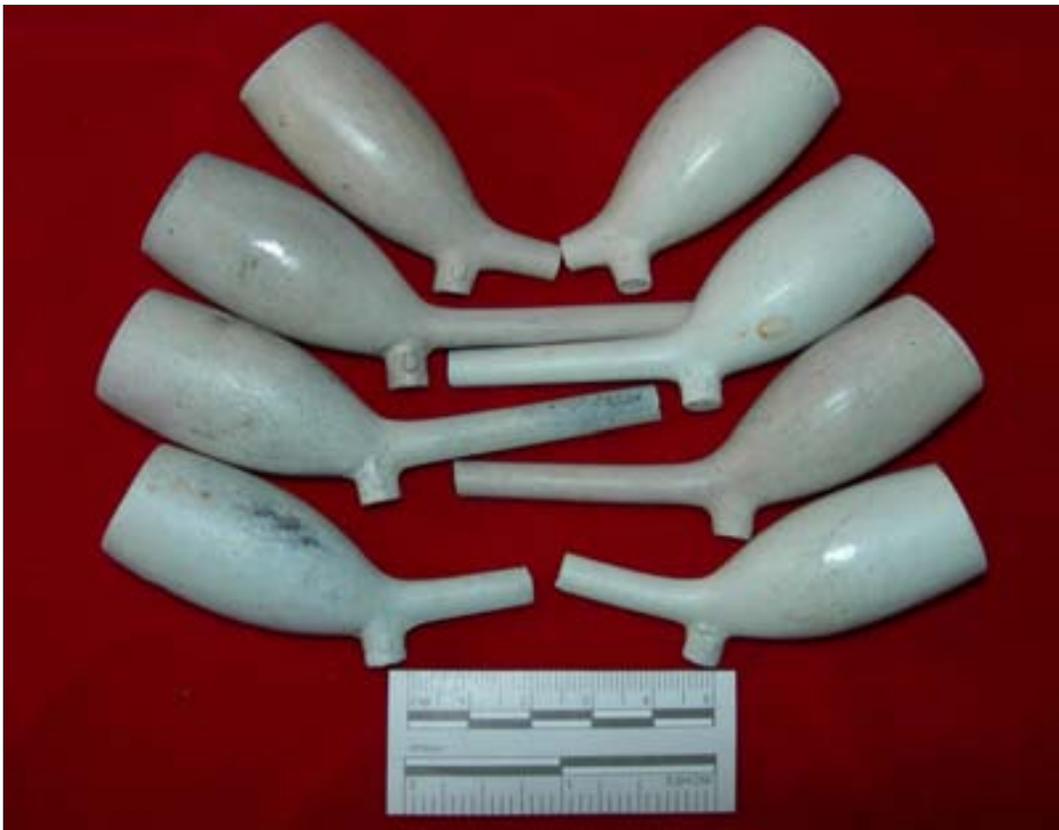
Figure 6.185. Dutch kaolin pipe bowls recovered from the Roosevelt Inlet Shipwreck.

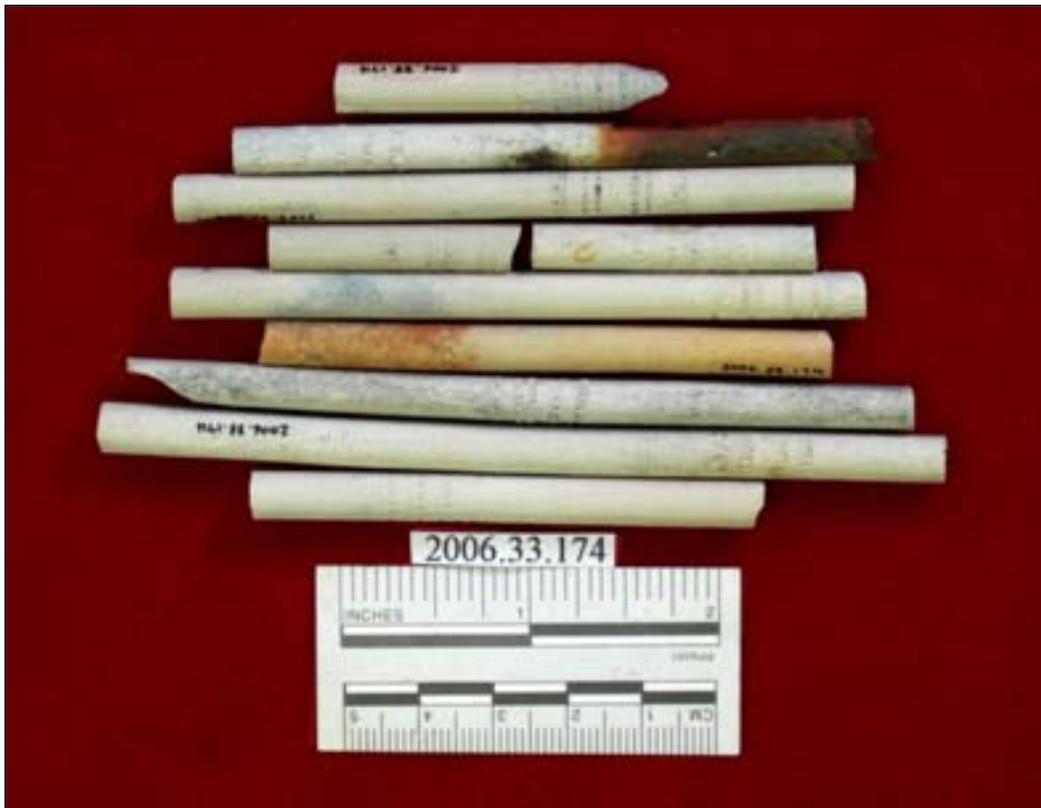
Figure 6.186. Linear decorated and stamped pipe stems.

In addition to maker's and quality marks, Gouda pipe makers began to decorate the stem. By the second quarter of the seventeenth century stem stamps consisted of various linear designs. Beading or circles, zig-zags, stripes and lines were used in addition to the maker's name and the words "IN GOUDA" (Figure 6.186). Often set in two groups of four lines, these motifs could be used together or alone. This style continued to the nineteenth century. Figure 6.187 provides a schematic of common pipe styles for the eighteenth century (van der Meulen 2003). The majority of pipes recovered from the site appear to be of the #25 type, which was common from 1750 to the end of that century. After 1750 stems are seen with flower-and vine-decoration beginning immediately after the more ovoid bowl (Figures 6.188 and 6.189). Pipe bowls continued to get larger until the 1850s. By 1900 few pipe makers remained in Gouda and the industry collapsed.

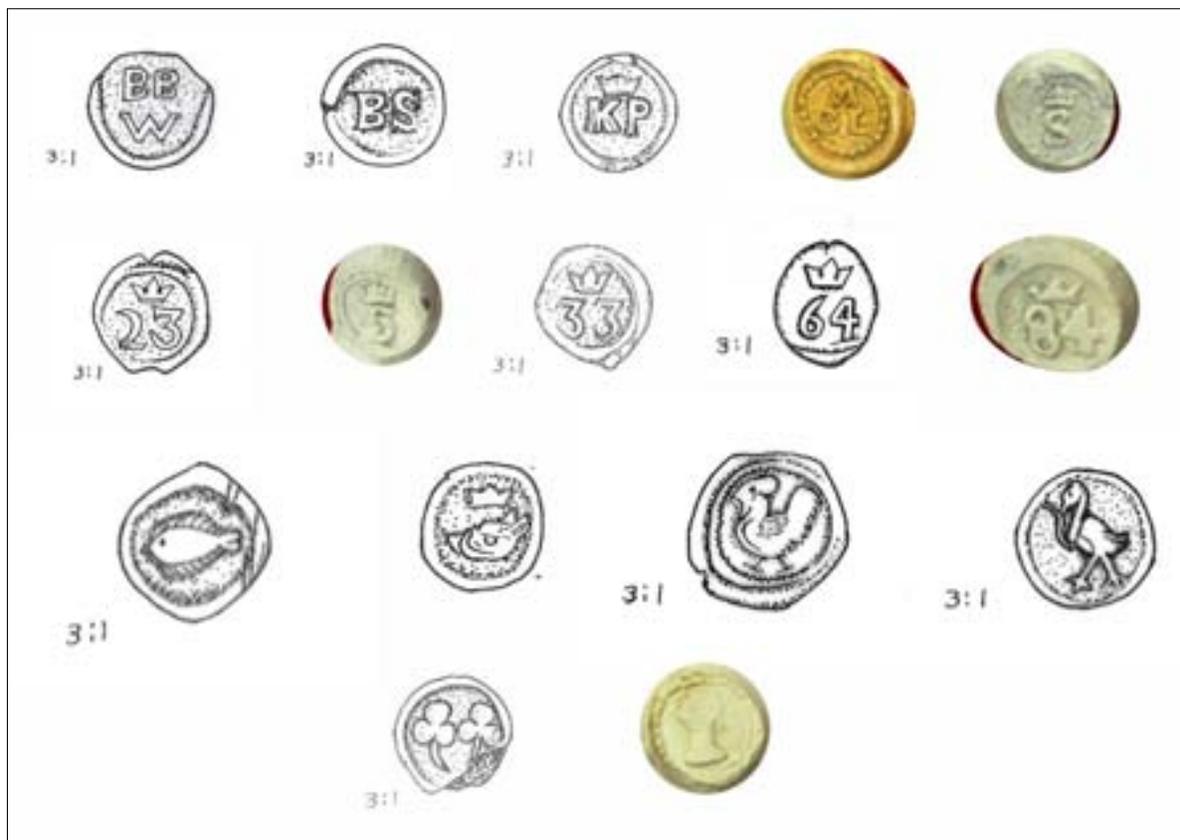
Figure 6.190. Maker's marks from Dutch pipe bowls. Drawings by Sharyn Murray.

Four thousand, five hundred and seventy three (4,573) pipe bowls, stems, and fragments were recovered during the October 2006 excavations. One hundred and eighty-one (181) of the bowl fragments (n=870) had maker's marks. These marks were cross-checked with the online database at <http://www.goudapipes.nl/>. This invaluable site has digitized and fully searchable marks published by J. van der Meulen in his *Goudse Pippenmakers en hun merken* (Gouda Pipemakers and their Marks) (2003). Although this excellent source is in Dutch, online technology allowed for a translation of the text. Table 6.4 details this research while Figure 6.190 illustrates the marks identified by this study. Marks were re-licensed when no longer used by their original owner. This fact can lead to two or more licensees being listed for a mark. In an attempt to not bias the data, bracketed mark holders are referenced. One example of this is with the "BS" mark. Originally licensed to Benjamin Schoute from 1733 - 1746, this mark was vacant until Adrianus Spernaay took it in 1782. Only four pipes with this mark were recovered but a pipe stem with rouletted lines and "SPERNAAY" stamped on it indicates that this pipe was indeed one from his factory. The only other Spernaay licensed near that time is Hendrik Spernaay, who was making pipes from 1774-1787 but with the "Crown 95" mark. None of the marks recovered from the site, either during the October 2006 excavations or earlier collections from the site, are of that type. This pipe may serve as a TPQ of 1783 for the site. Figure 6.191 shows a plot of the date ranges for all marks recovered from the Roosevelt Inlet Shipwreck. The majority of marks overlap between 1770 and 1785. Additional research in the Pipe Makers Guild records in the Netherlands may shed further light on the marks identified from the wreck. Further research into the pipe makers and the transportation and marketing of Dutch pipes may also help to definitively identify the Roosevelt Inlet Shipwreck.

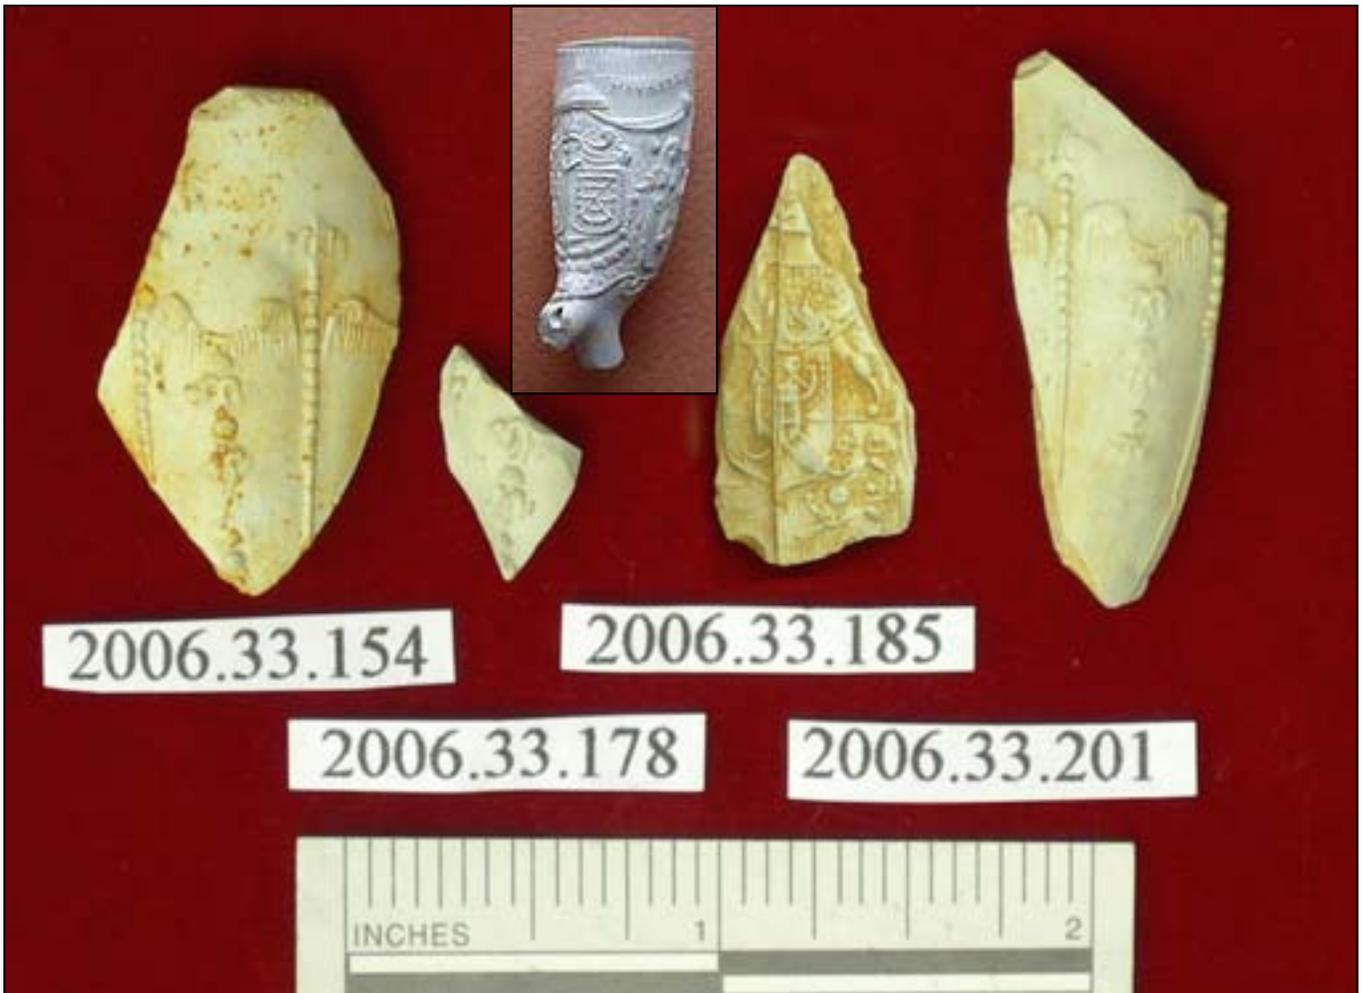
Figure 6.192. Examples of molded pipe bowls recovered from the Roosevelt Inlet Shipwreck. Inset is a circa 1750 molded pipe bowl from Gouda with a similar shield design to 2006.33.185.

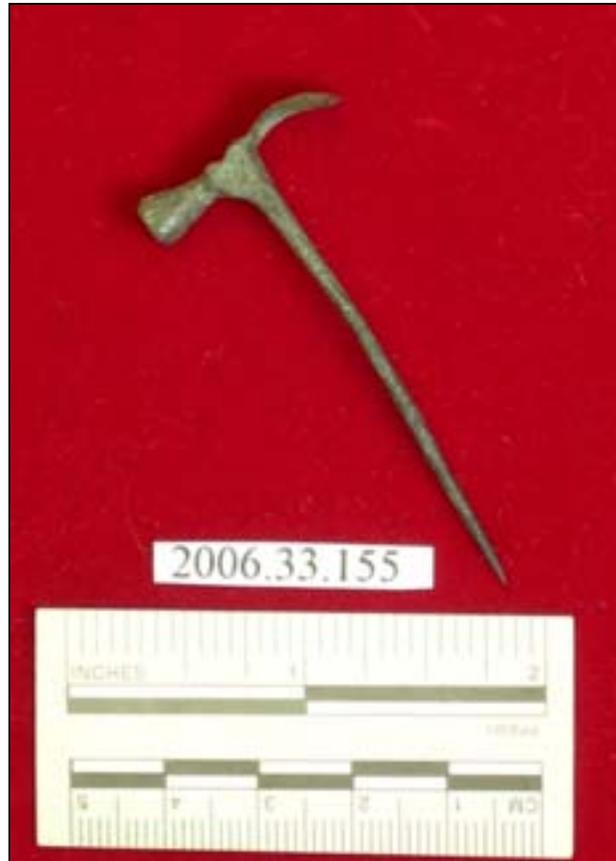
In addition to the pipes themselves, two other tobacco-related artifacts were recovered from the excavations. The first, a copper alloy smoker's companion or pipe tool is shaped like an adze and has a sharp pointed handle for breaking up charred tobacco. The head end would be used to tamp down fresh tobacco for steady burning. Also recovered was a polished agate snuff box lid. This flat rectangular artifact has a beveled edge and was found in two pieces in adjoining quadrants at Test Unit N10/E60 (NE and SE Quads) and has been reconstructed. Figures 6.193 and 6.194 display these items.

Figure 6.193. Copper alloy smoker's companion (2006.33.155).

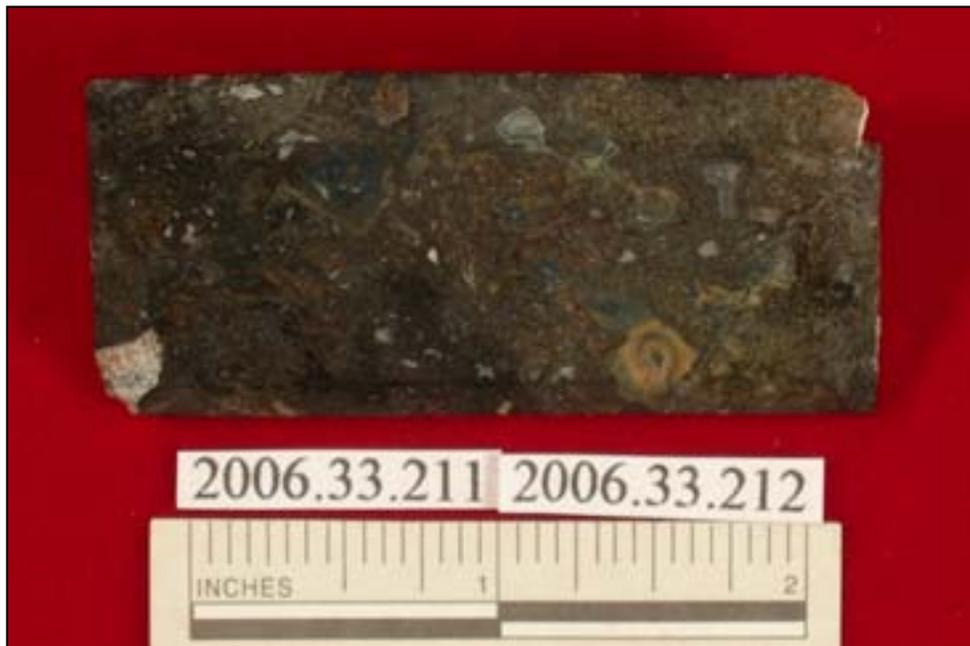
Figure 6.194. Polished agate snuff box lid, recovered in two sections and reconstructed.

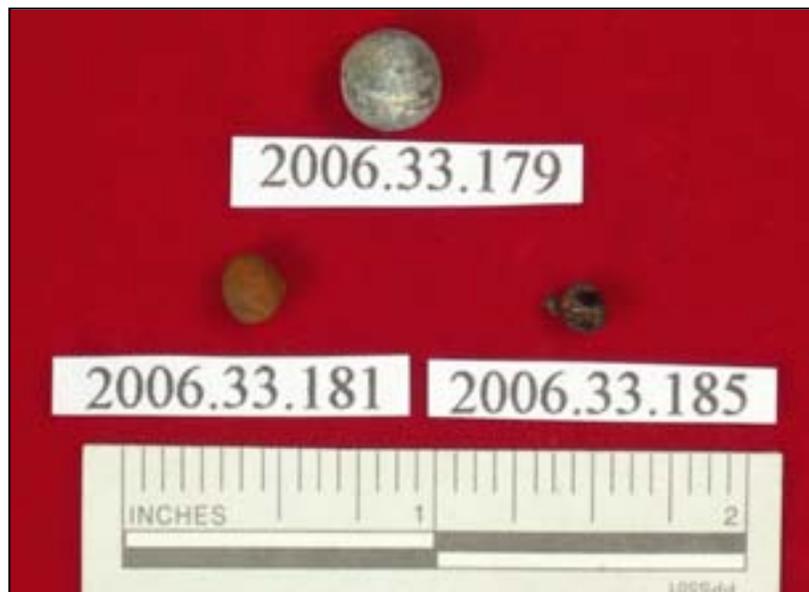
The third piece of shot found at the site has been identified as a lead cast ball, 8.12 mm in diameter, with a slightly off-set mold seam and sprue still visible. Analysis of the lead ball determined that this is probably buckshot, due to its small size and material (Figure 6.195). As to the origins of the artifact, it has been noted that, among the variety of shot and ball munitions recovered from colonial sites in the U.S.:

Figure 6.195. Examples of shot recovered during the October 2006 excavations.

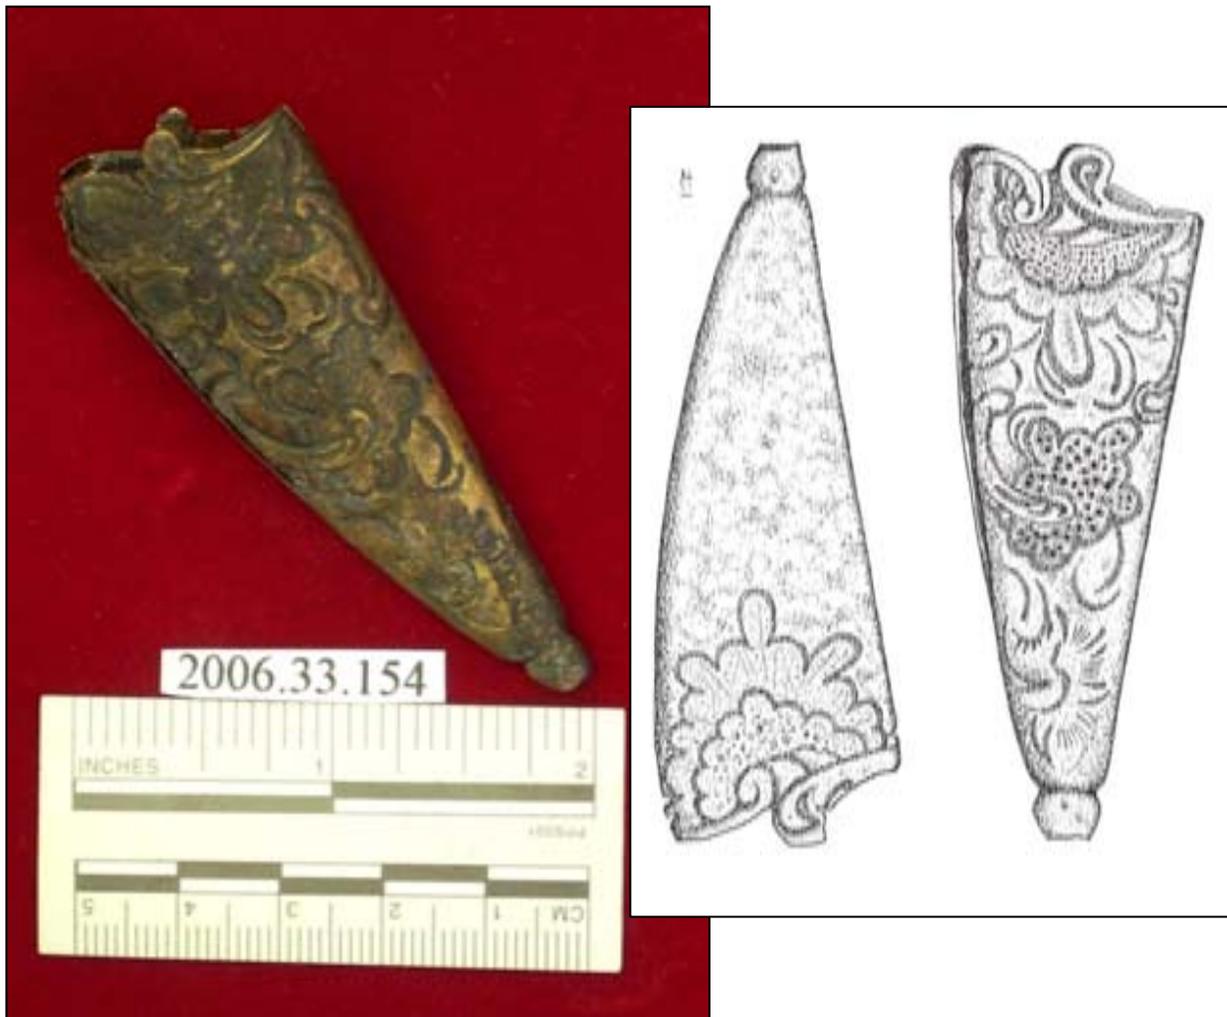
One metal scabbard tip was also recovered at the Roosevelt Inlet Shipwreck. Manufactured from a copper alloy, probably pinchbeck or brass, this tip was engraved with a floral or scroll design, and the shape of the scabbard incorporates the rounded edges of a leaflet at its base as well as a rounded, bead/ball addition on the tip. The general shape of the scabbard and the ball at its tip bears great similarity to known examples of French and German scabbards being manufactured during the late eighteenth century (Neumann & Kravic. 1975:39). Figure 6.196 shows a hand-drawn illustration of the scabbard tip showing the decoration in detail, as well as a photograph of the artifact (note the reddish color of the material, which is indicative of a high copper content in the alloy).

Figure 6.196. Illustration and photograph of copper alloy sword scabbard tip (2006.33.154). Drawing by Sharyn Murray.

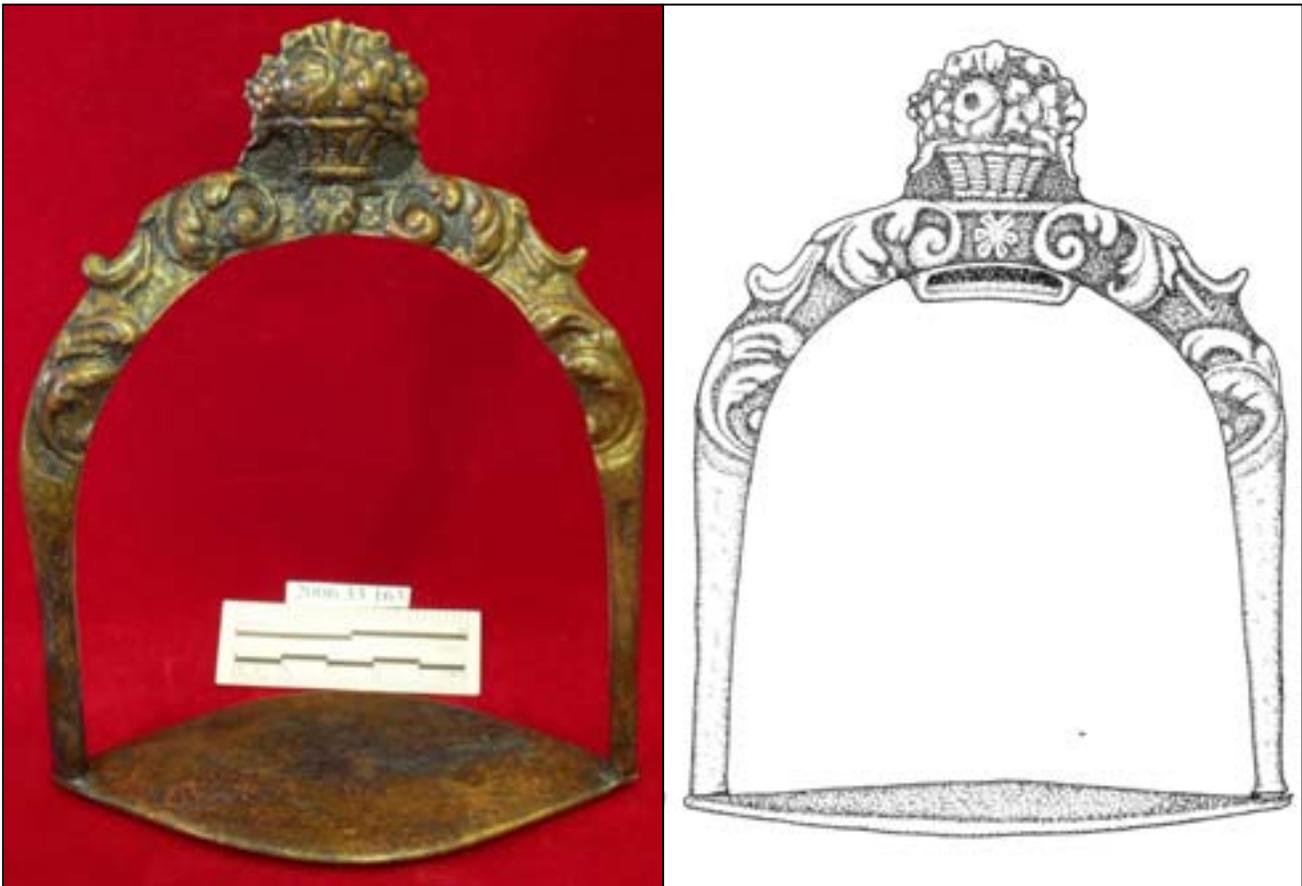
Stirrups are primarily utilitarian in that they are meant to provide support for the weight of the rider and typically have a loop in which the foot rests and a swivel or fixed loop at the top to connect them to the saddle. Stirrup design changes with function; for example, versions intended for use by the regimental cavalry are often made of iron and very simple in shape. Seventeenth and eighteenth-century stirrups exhibit a wide range of variation, ranging from simply utilitarian to ornate based upon not only their intended function but also their intended user. The copper alloy stirrup recovered from N50/E80 is very ornate, with a cast basket and flowers at the fastener end and leaf work descending down each side, and a solid foot platform (Figure 6.204). Research has not revealed the origin of this piece; it is similar in elaborate decoration to one identified as circa 1770-1810 by Neumann and Kravic (1989). Given the decorative motif of basket and flowers, and its small size, however, it is highly likely that this stirrup was intended for use by a female.

**Figure 6.204. Cast copper alloy stirrup (2006.33.163); photograph and detailed illustration.
Drawing by Sharyn Murray.**

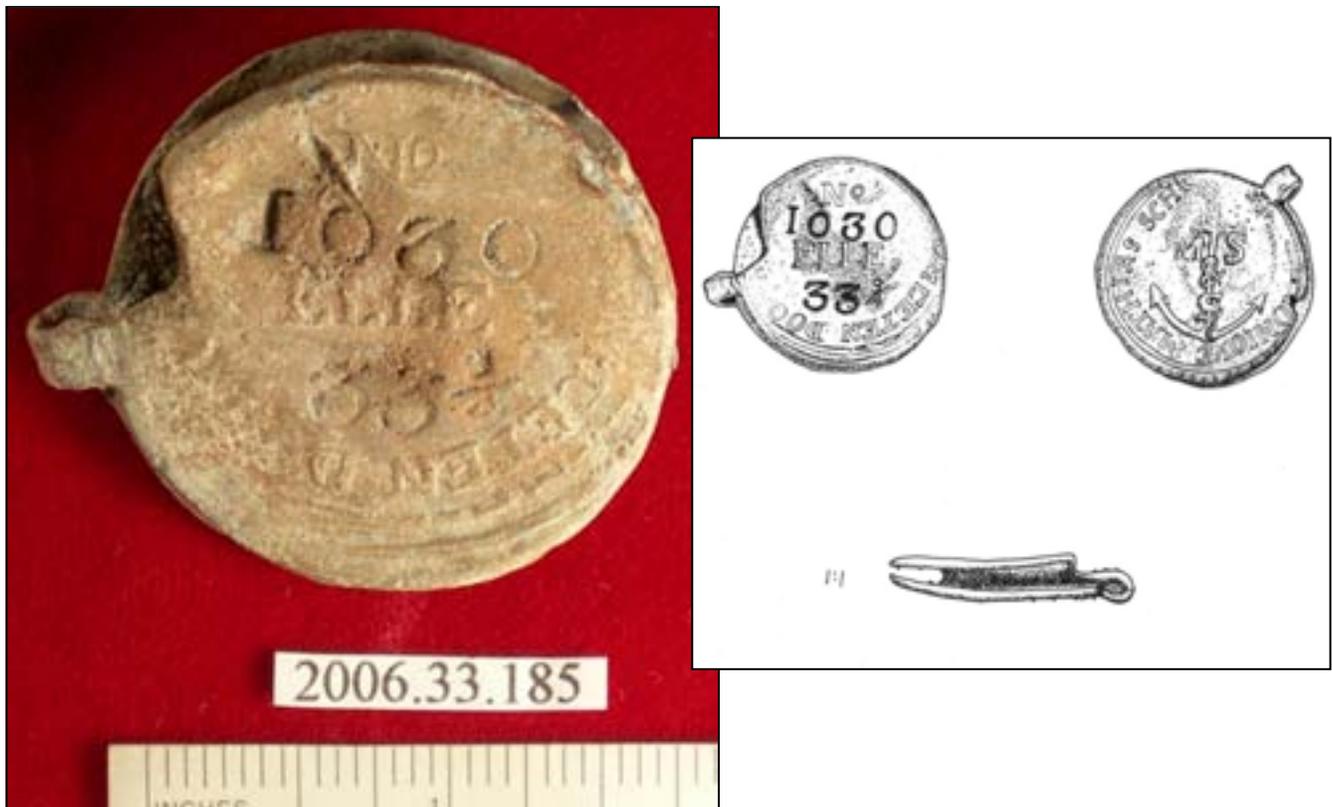
The seal recovered from the October 2006 excavations is stamped “No 1030 Elle 33 $\frac{3}{4}$ ” on one side with the letters “..MCETEN DOO..” and on the other side, “ ..ONIOYE MATHIAS SCH..” surrounding a central anchor with “M S & S” in the middle of it (Figure 6.206). An “ell” is a former unit of measurement for cloth. An English ell equals 45 inches (114 cm); exact measurements varied by country. Probably a merchant or manufacturer seal of the cloth, it is folded in the middle at the strap and does not seem to be have been opened as it is not warped or torn. The nearly 42.2 yards of cloth this seal demarcated has long since disintegrated.

**Figure 6.206. Lead bale seal (2006.33.185); detailed illustration and photograph.
Drawings by Sharyn Murray.**

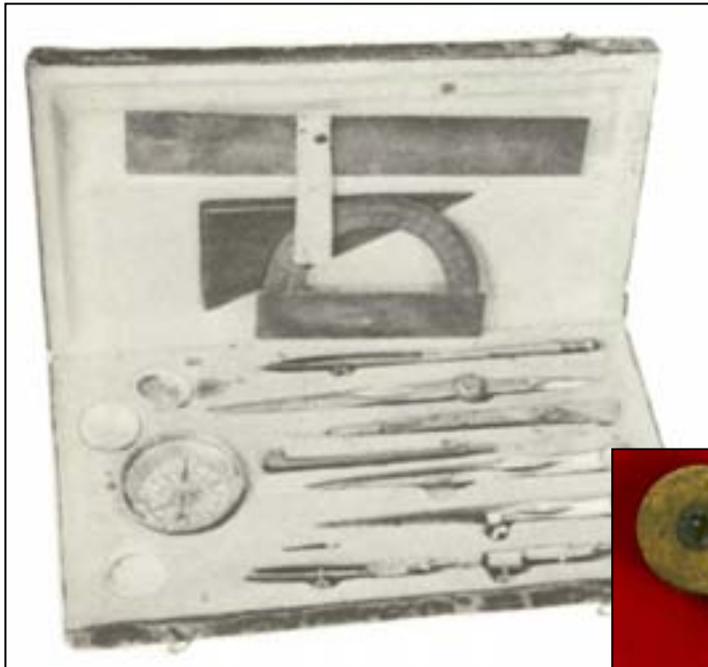
Figure 6.207. Drafting set. (Source: Neumann and Kravis 1989:251)

Several items were recovered that fall into this category. Drafting points and dividers, a pewter ink well liner, and perforated stone quill rest were all collected during the 2006 excavations. Figures 6.207-6.210 show examples of a navigation set and similar items found on the vessel. Figure 6.211 is a photograph of the ink well. Figures 6.212 and 6.213 include the quill rest recovered from the site and examples of intact versions of this object.

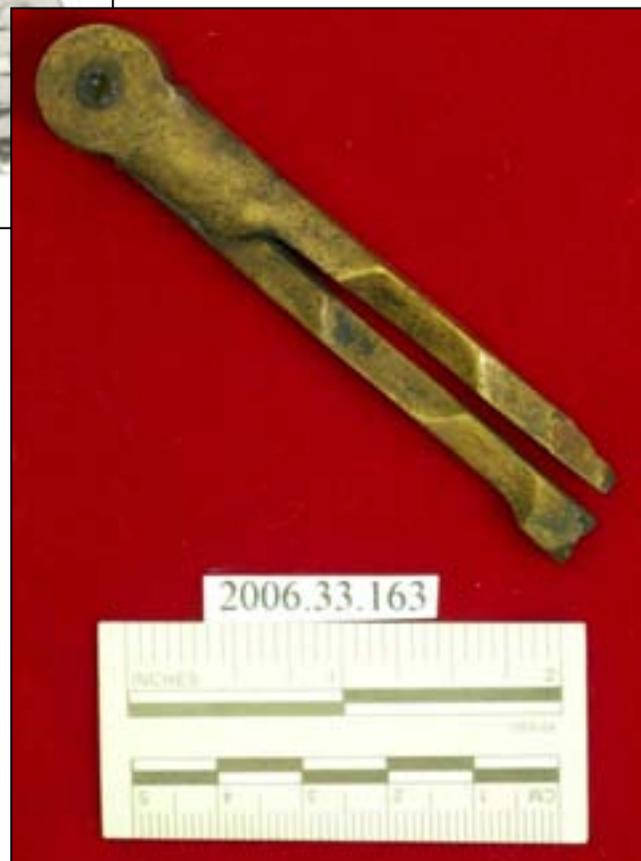
Figure 6.208. Divider from the drafting elements recovered from the site.

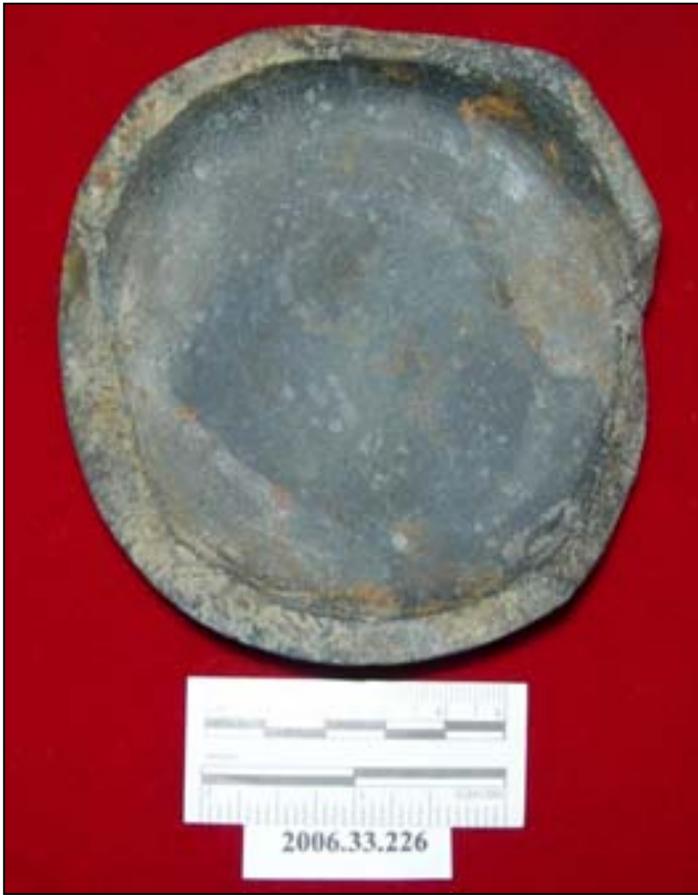
Figure 6.214. Example of serpentine mortar, interior base (2006.33.226).

Four stone mortars and six pestles were collected during the October 2006 excavations. The mortars are of a large straight-sided open form with evidence of lathing still extant; the pestles have flared ends rather than a knob for grinding. A geological study consisting of X-ray diffraction analysis (XRD) and lithic thin sections was undertaken for these artifacts to determine the type of stone from which they were carved and possible source material locations (Appendix I). Stone characteristics include a greasy or waxy luster, color ranging from light green to dark gray, a soft consistency that is easily scratched with a knife, and the inclusion of marble-like veins or platy crystal clumps (Kennedy

2005:2-3) Examination of the thin section revealed that the majority of the rock was a serpentinite or rock made up primarily of serpentine. XRD analysis proved that the mineral composition of the tested mortars and pestles consisted of “lizardite, clinochrysotile, orthochrysotile,” which are all types of serpentine, with crystalline mineral inclusions made up of “clinocllore, and forsterite.” Serpentinities are one of the most common of metamorphic rocks and occur throughout the world. European outcrops of serpentine are located in Ireland, England, Italy, France, Germany, Sweden, Norway, Poland, and Austria. One significant outcrop of lizardite is at Lizard Point, Cornwall, England; chlorite-rich jades and serpentines are found in Austria; and clinocllore and lizardite are commonly found in much of Europe (Kennedy 2005:6-7; <http://www.mindat.org/min-1071.html>; <http://www.mindat.org/min-1584.html>). Given the widespread availability of this material, a determination of source has not been definitively made although Kennedy states that “given these objects found on the ship were probably being imported from England, a likely place for the serpentine source mine would be Cornwall, England...” while “jade type localities, such as in Austria or China...would be a second place to look for the source rock” (Kennedy 2005:7). Further study of these artifacts may be a topic for future research. Figure 6.214 is an example of the mortars recovered while Figure 6.215 shows the pestles.

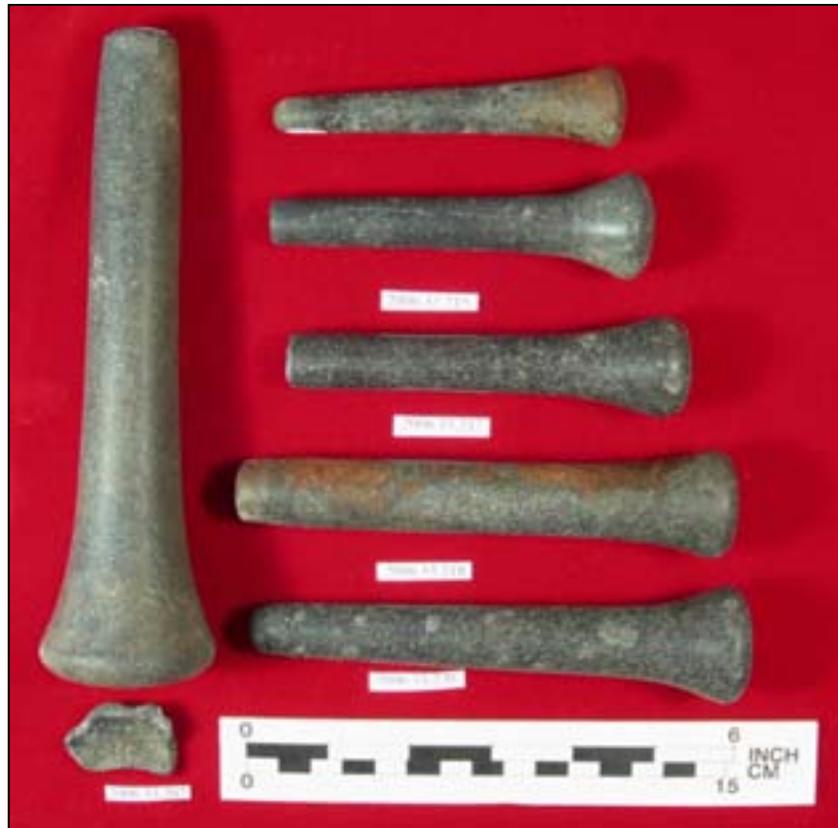
Figure 6.215. Serpentine pestles; note the waxy luster.

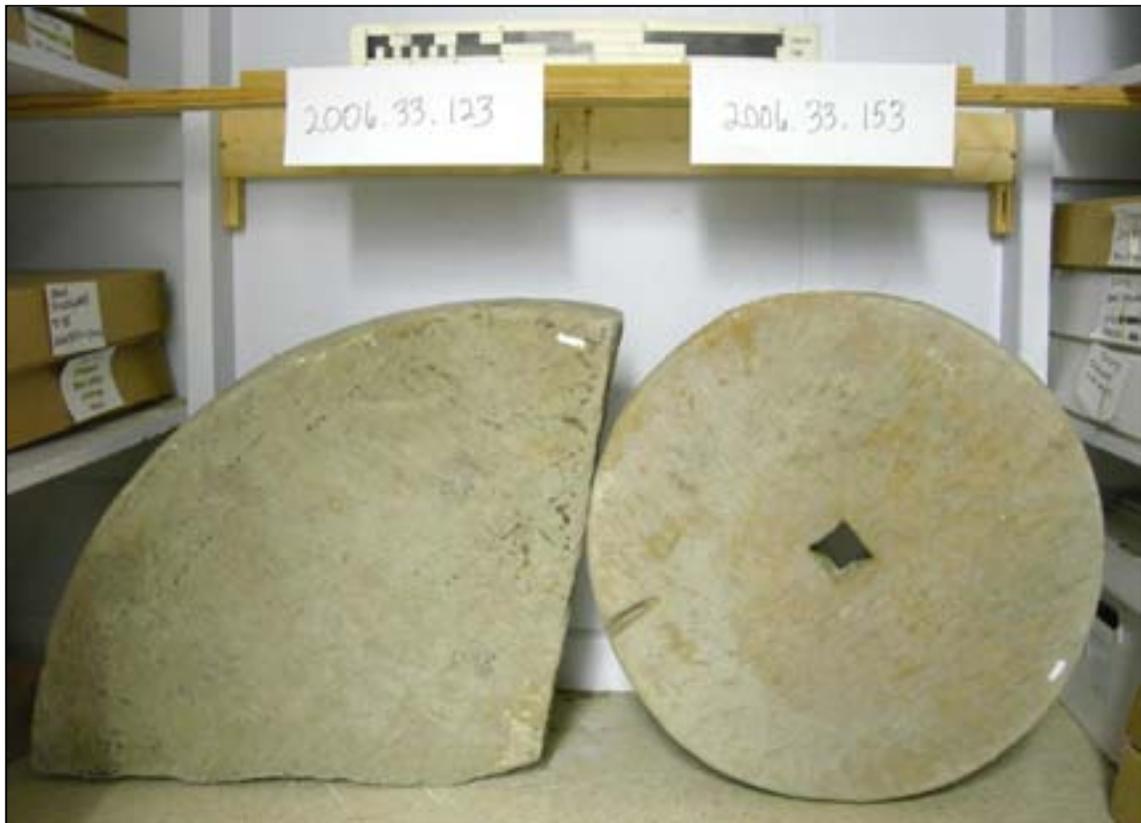
A task that has changed little since the day the Roosevelt Inlet Shipwreck sank is the milling of grain. Even with the industrialization of much of the modern world, one can still find artisan millers who operate just as their ancestors did two hundred years ago. Millstones are perhaps the most important piece of the process after power. Several millstones were identified during fieldwork at the Roosevelt Inlet Shipwreck. These fell into two distinct types: monolithic or traditional, and composite stones. Arguably the most popular type of millstone in the eighteenth century was the composite stone. This type of millstones is easily distinguished from traditional monolithic millstones because they were made from several smaller pieces banded together with iron straps to form a wheel and are thus easier to transport and replace when needed (http://gsa.confex.com/gsa/2009NC/finalprogram/abstract_154478.htm). Traditional millstones were fashioned into the shape of a wheel from a single stone. As a result, they are considerably heavier and difficult to transport and harder to replace. When new, a millstone is smooth and it must have furrows cut into it in order for it to have a grinding surface. The stones must be periodically sharpened or “dressed” to keep it grinding efficiently. The average millstone is about 4 feet across. Figure 6.217 shows both a composite and a monolithic millstone recovered from the shipwreck. Note how much larger the diameter of the composite stone would be if completed. Both stones are gray sandstone and is possibly of English origin. Note also that both stones are smooth and were lost prior to their being dressed for use.

Figure 6.217. Composite millstone, left; and monolithic millstone, right. These are two of several millstones that were identified from the wreck. Others were not collected but remain stable at the site.

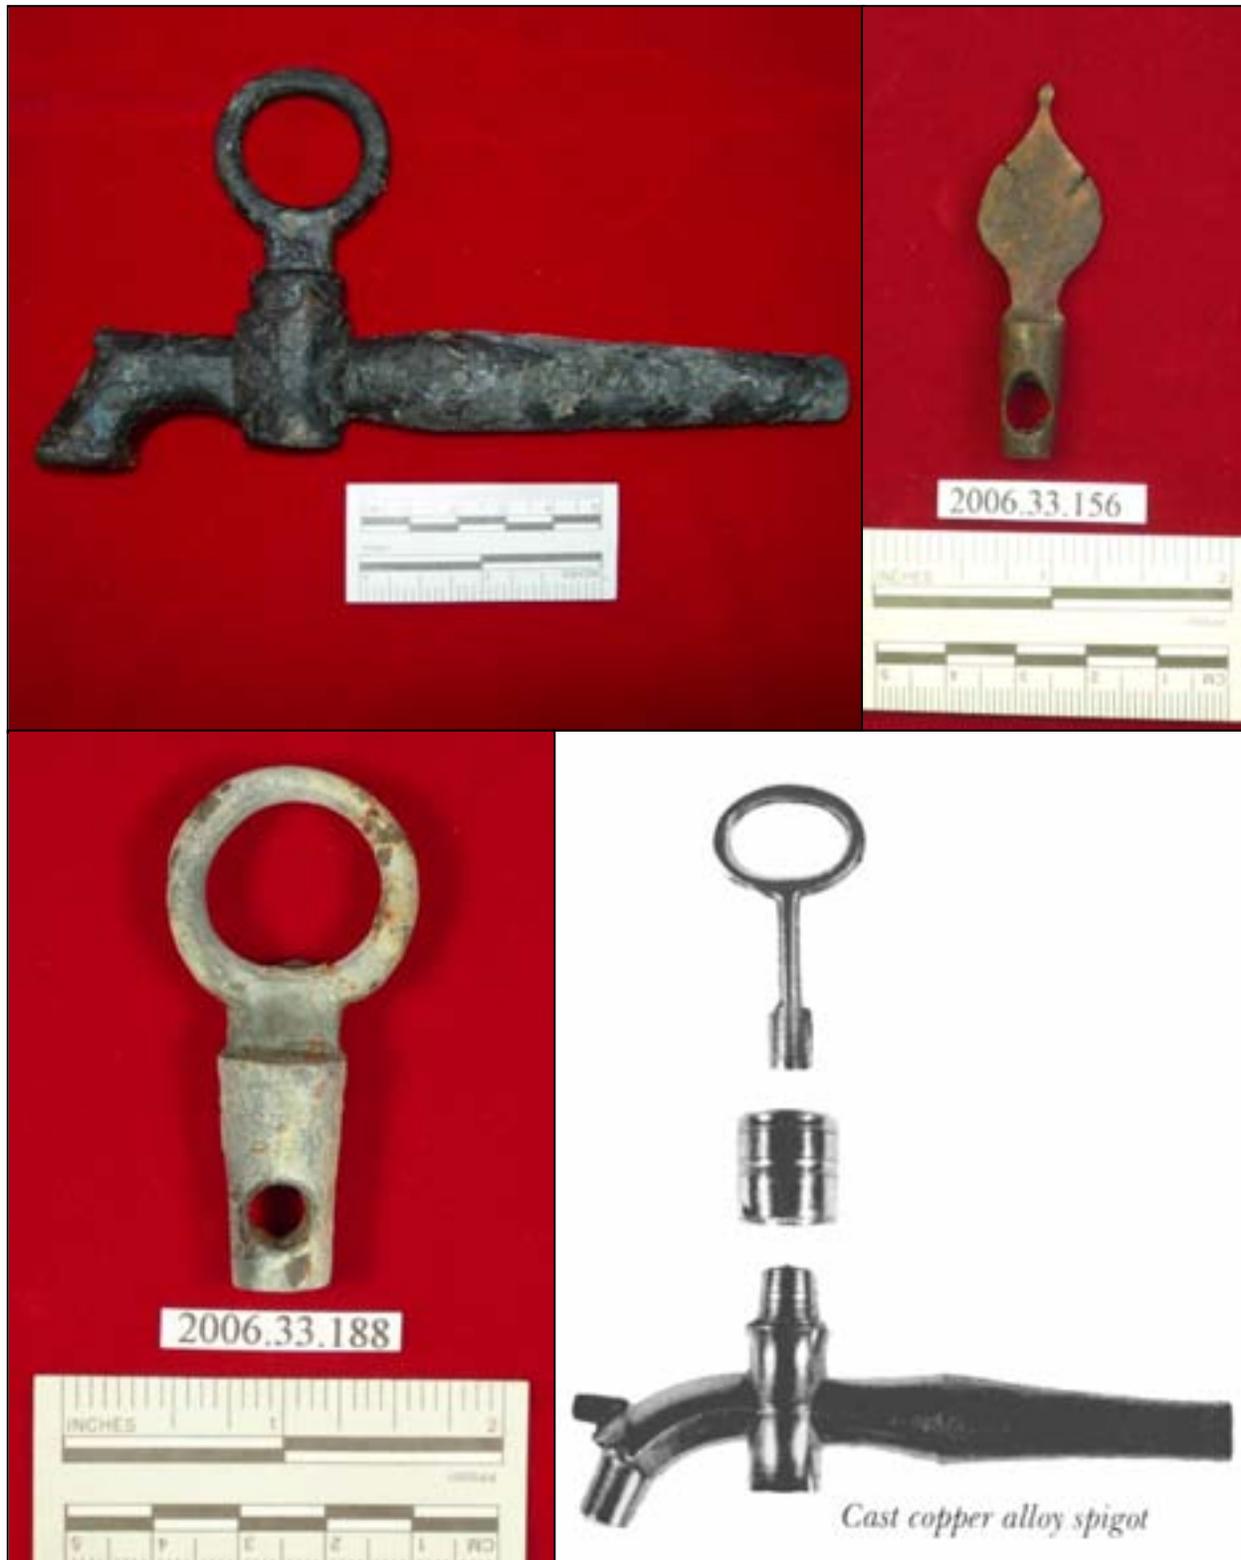
Iron hoops (n=2) as well as two sections of wood that may be cant or head pieces for a cask or barrel were identified during data analysis (Figure 6.218). In addition, one copper alloy spigot was recovered from the excavations in 2006. Used to dispense beverages from kegs and small casks, spigots were typically made of brass or iron (Neumann and Kravic 1989:249). The overall design of spigots in the eighteenth century remained the same; there was a handle which held the stopcock and a rear extension used to penetrate the keg (Figure 6.219). Figure 6.219 includes a photograph of a similar spigot from the *Machault*, which sank in 1760 (Sullivan 1986:60). There does appear to be some variation in stopcock design in this time period. The spigot recovered from the 2006 field investigations retained its stopcock. Two other stopcocks were also recovered. One has a large loop handle and the other is a flat leaf design (see Figure 6.219).

Figure 6.219. Cast copper alloy spigot and two stopcocks recovered from the wreck; photographic example of a similar spigot from the *Machault*, lower right (Sullivan 1986:60).

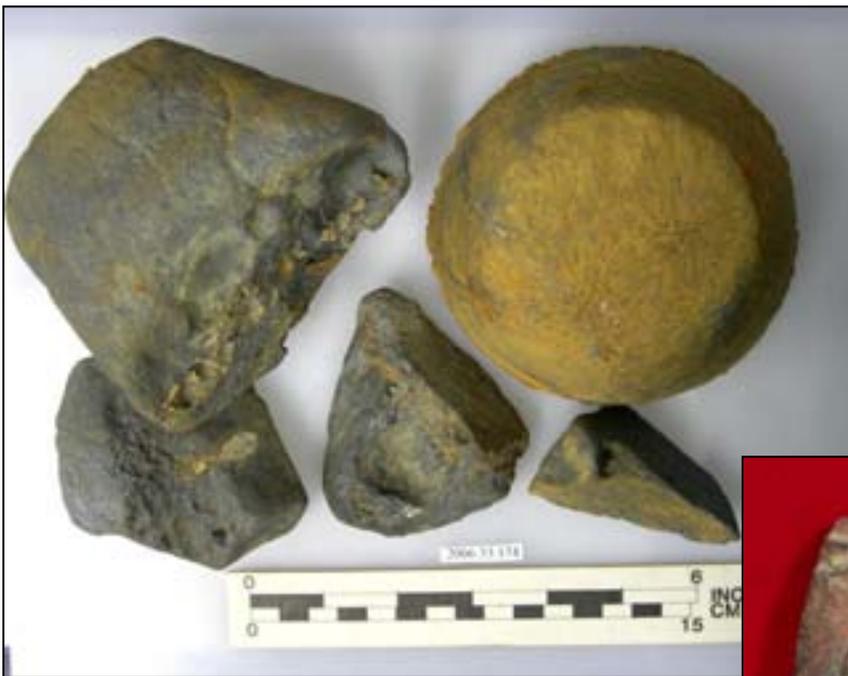
Four hundred and seventeen (417) antimony ingots and ingot fragments weighing more than 66.38 kg were collected during the October 2006 excavations at Roosevelt Inlet (Figure 6.220). In addition, seven lead ingots weighing 2.135 kg (Figure 6.221) were recovered. These two raw materials have many uses, both together and singularly. Both can be used in the production of pewter. High-quality pewter is 85-95% tin mixed with copper or antimony. Antimony can also be used in the manufacture of paint as well as glass and ceramic. Low-quality, bluish pewter has lead mixed in along with the other ingredients. Lead and antimony alloys are stronger than lead but more flexible than antimony alone. This shipment may have been intended to go to pewtersmiths in the mid-Atlantic regions. Antimony is found natively in many areas but also occurs in Bohemia, as well as other locations in central Europe and in Cornwall, England (Wang 1919).

Figure 6.220. Antimony ingots (2006.33.174).
