UNDERWATER ARCHAEOLOGICAL INVESTIGATION OF THE ROOSEVELT INLET SHIPWRECK (7S-D-91A)

VOLUME 1: FINAL REPORT

State Contract No. 26-200-03
Federal Aid Project No. ETEA-2006 (10)

SOUTHEASTERN ARCHAEOLOGICAL RESEARCH, INC.

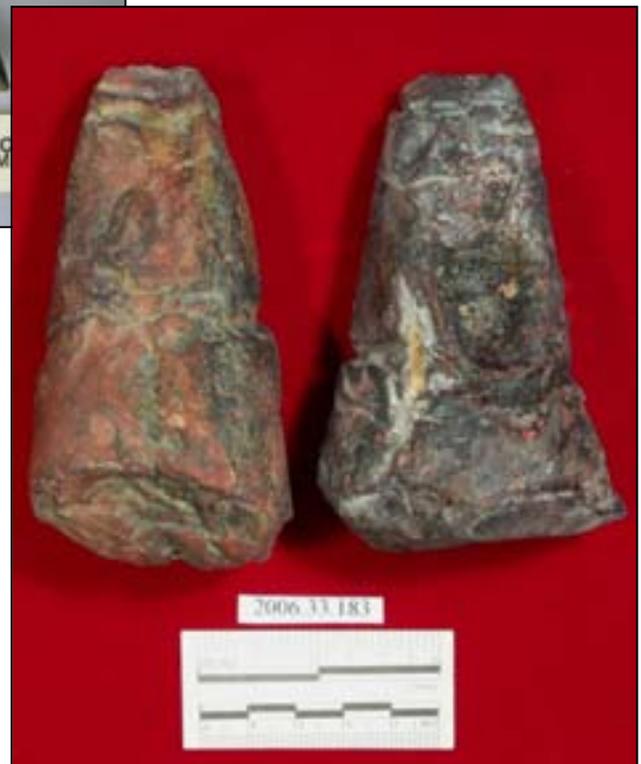
Four hundred and seventeen (417) antimony ingots and ingot fragments weighing more than 66.38 kg were collected during the October 2006 excavations at Roosevelt Inlet (Figure 6.220). In addition, seven lead ingots weighing 2.135 kg (Figure 6.221) were recovered. These two raw materials have many uses, both together and singularly. Both can be used in the production of pewter. High-quality pewter is 85-95% tin mixed with copper or antimony. Antimony can also be used in the manufacture of paint as well as glass and ceramic. Low-quality, bluish pewter has lead mixed in along with the other ingredients. Lead and antimony alloys are stronger than lead but more flexible than antimony alone. This shipment may have been intended to go to pewtersmiths in the mid-Atlantic regions. Antimony is found natively in many areas but also occurs in Bohemia, as well as other locations in central Europe and in Cornwall, England (Wang 1919).

Figure 6.221. Lead ingots (2006.33.183).

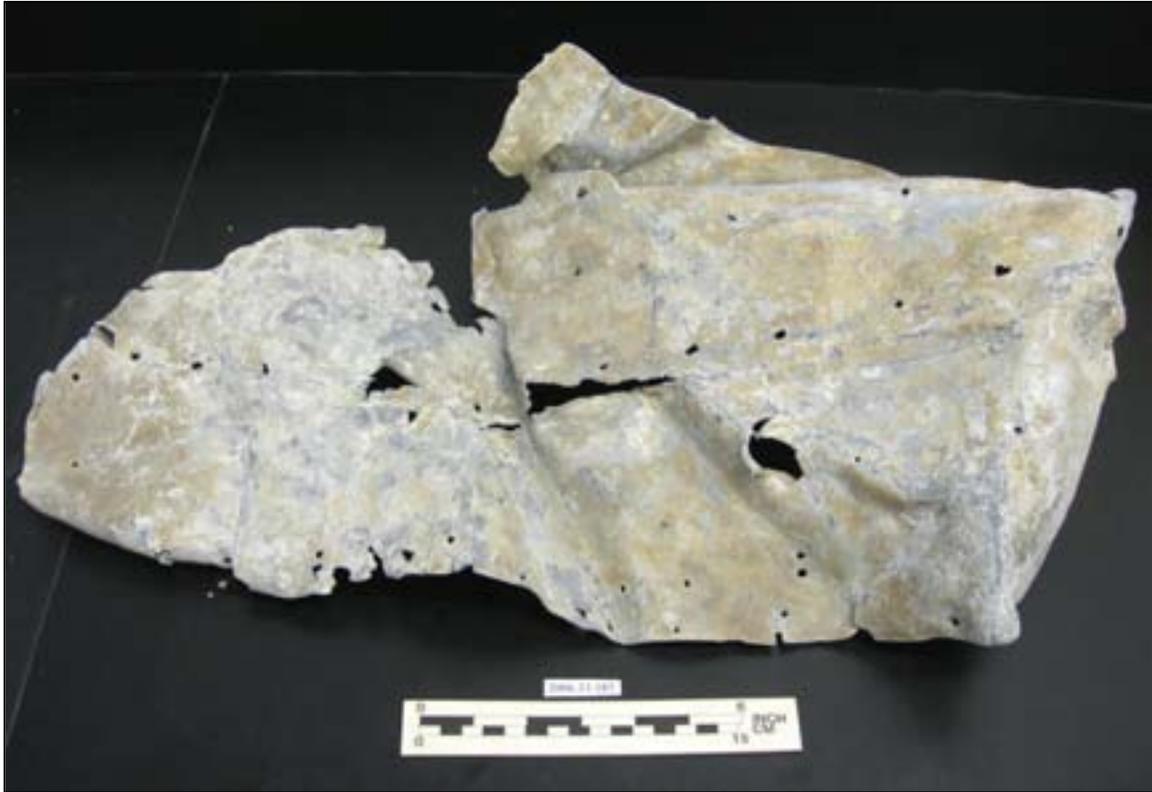
Vessel architecture in the late eighteenth century is very well understood. Plans and schematics of these ships and boats still exist, along with records from the shipwrights who built them. The difficulty in examining a shipwreck where there is little hull integrity left, as with this vessel, is in determining which of the artifacts recovered represent portions of the wreck itself as opposed to cargo or personal possessions of the crew or passengers. A few key portions of a ship are easily determined however. Exterior metal sheathing became prevalent as way of retarding the predation of worms on the wooden hulls of vessels since the fourth century BC (Bingemann et al 2000). Lead appears to be the sheathing metal of choice for the Roosevelt Inlet vessel. Four sections of lead sheathing, complete with nail holes, were recovered (see Figure 6.222). One sheath of an unidentified material was also recovered. Additionally, four lead patches and one unidentified patch were also recovered.

Figure 6.222. Lead sheathing recovered from the Roosevelt Inlet Shipwreck.

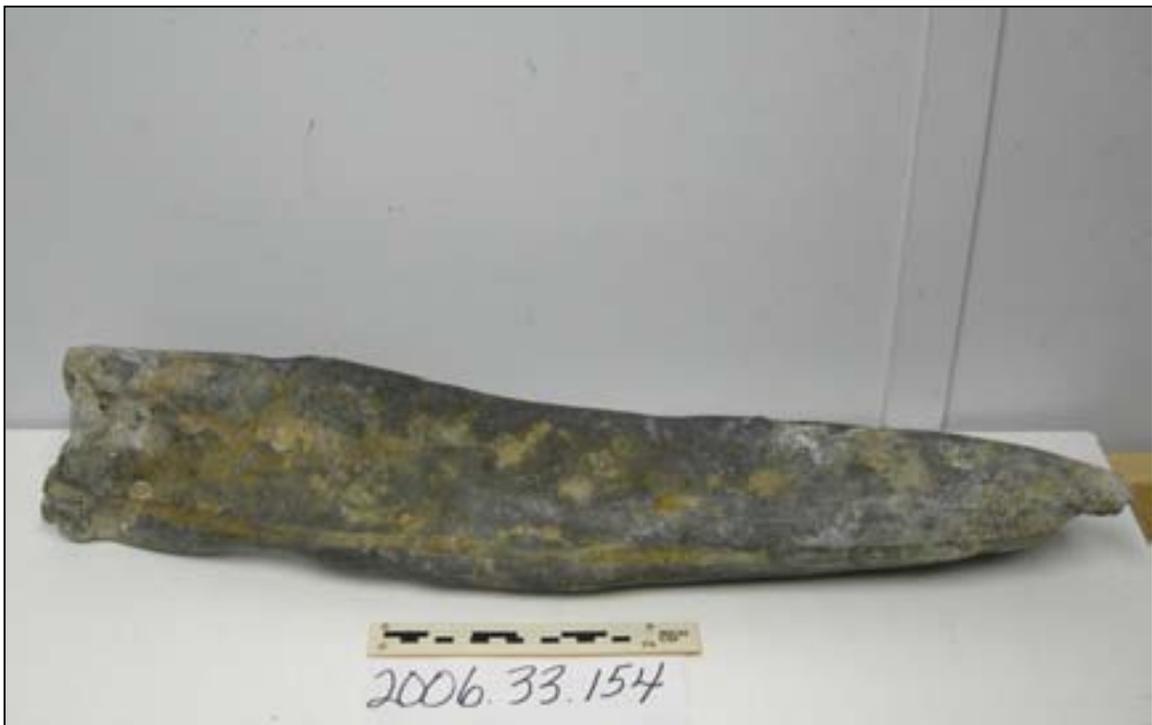
Given that vessels were prone to needing these aforementioned patches, one of the most important part of any seagoing vessel is a bilge pump. Bilge pumps can be all that stands between the sailors on board and certain death. Although pumps of one sort or another have been used on watercraft since the force pump of the Greeks, by the eighteenth century bilge pumps were constructed of wood or metal and included the use of valves and pistons. Regardless of how they were constructed they all had a single mission: get the water out the hold. This was accomplished by pushing or pulling the water up a piston tube either of wood, copper, or lead. Once the water was brought above the waterline the important job was to direct it overboard. This task was carried out by bilge tubes or dales. A dale could be as simple as a canvas or plank sheath that could be removed when not in use. A more permanent solution was the use of lead tubes. Two lead tubes with flanged collars were recovered from the wreck. Another feature common to bilge pumps was the addition of a metal sieve or screen at the bottom of the pump system. This sieve helped to ensure that no foreign bodies such as floating debris or organic material got into the mechanism and clogged it (Oertling 1996). One section of a copper sieve was recovered in the same test unit as a piece of the ship's planking, lending credence to the idea that it may represent a portion of a bilge screen. Figures 6.223 and 6.224 show bilge related artifacts.

Figure 6.223. Lead bilge pump tube recovered from the wreck.

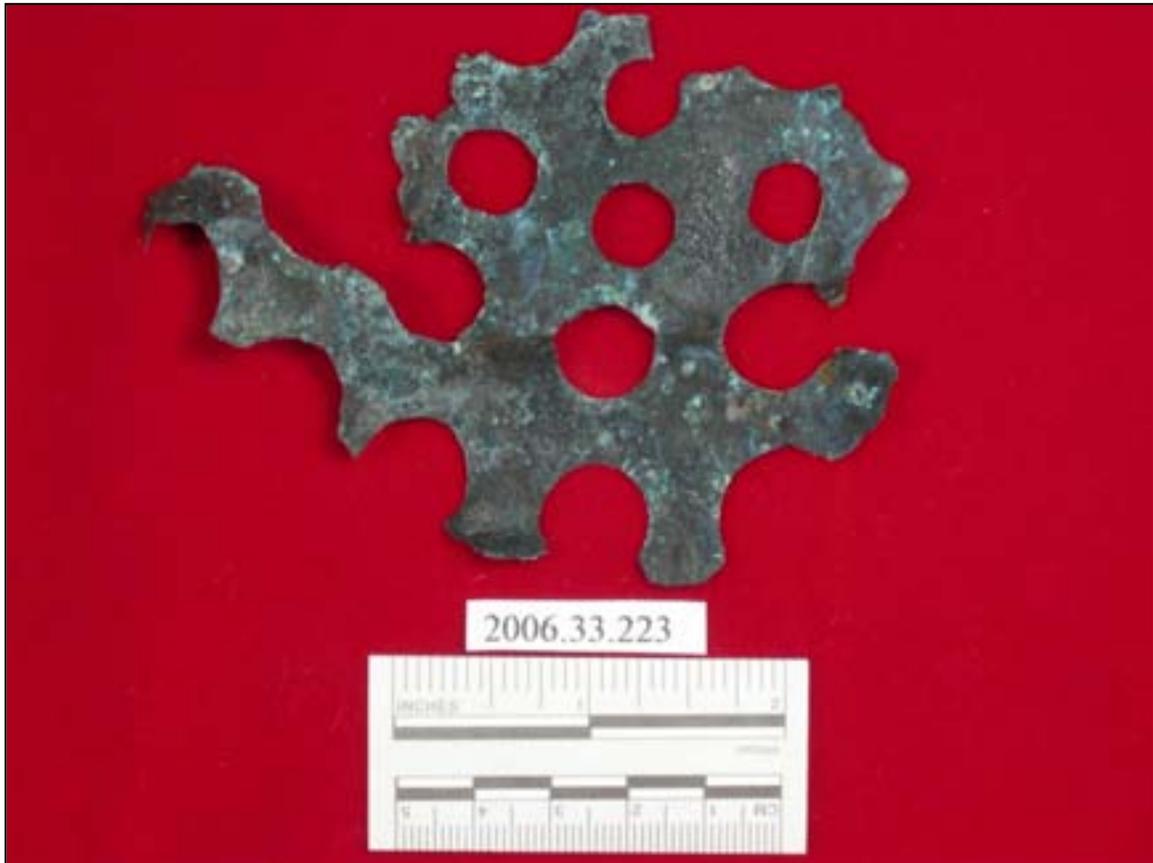
Figure 6.224. Section of copper sieve recovered from the wreck (2006.33.223).

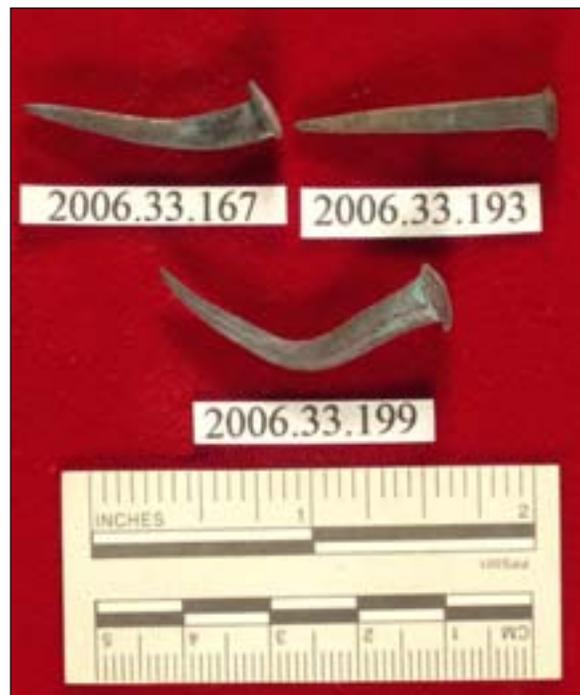
In total, twenty-three fragments of various materials were recovered from test units and identified as being related to ship architecture or fittings. Among these are three wrought copper alloy nails that appear to be bent or clinched, indicating that they are likely from the vessel itself or perhaps wooden shipping crates but not a bulk shipment intended for sale in Philadelphia. Figure 6.225 shows examples of the copper alloy nails recovered from the Roosevelt Inlet Shipwreck. Copper alloy nails were used to attach sheathing to the vessel hull and in various other applications throughout the vessel. Copper nails, not corroded by salt water as easily as other metals, were favored by shipwrights by the late eighteenth century.

Figure 6.225. Rose head copper alloy wrought nails.

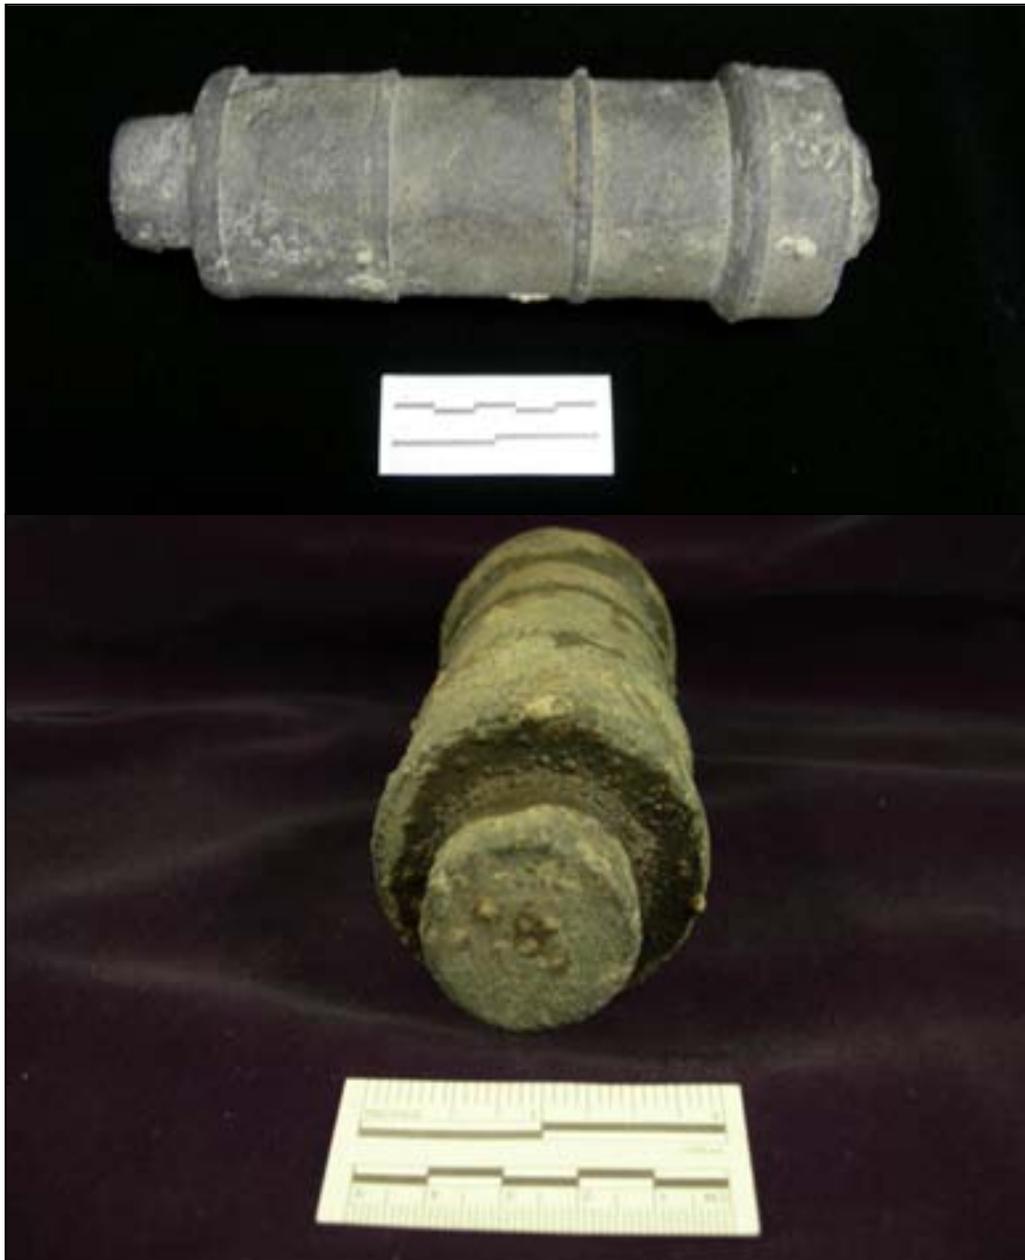
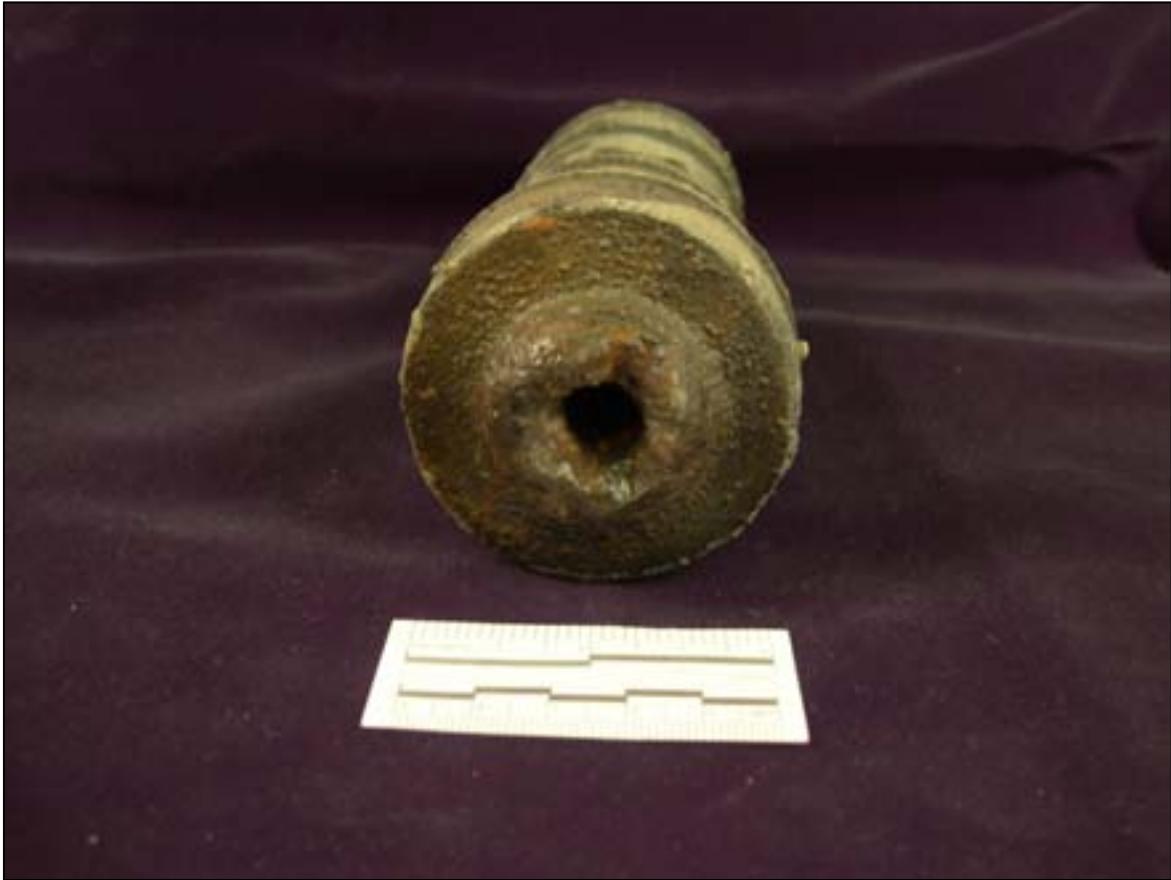
Figures 6.228 and 6.229 show three views of an object that requires further identification, for the material type and function of this object is as of yet undetermined. The object appears to be manufactured out of possible lead or pewter, and closely resembles a clyster pump in form. Clyster pumps were in common use in the eighteenth century as it was believed that frequent enemas helped to purify the body and maintain good health. Figure 6.230 is a photograph of an eighteenth-century clyster pump; note the similarity between it and the item recovered from the Roosevelt Inlet Shipwreck (Collect Medical Antiques 2010). Future research may shed greater light upon the proper identification of these and several other indeterminate artifacts.

Figure 6.228. Two views of an unidentified pewter artifact similar to a clyster pump.

Figure 6.229. Unidentified pewter artifact similar in shape to the clyster pump pictured below.

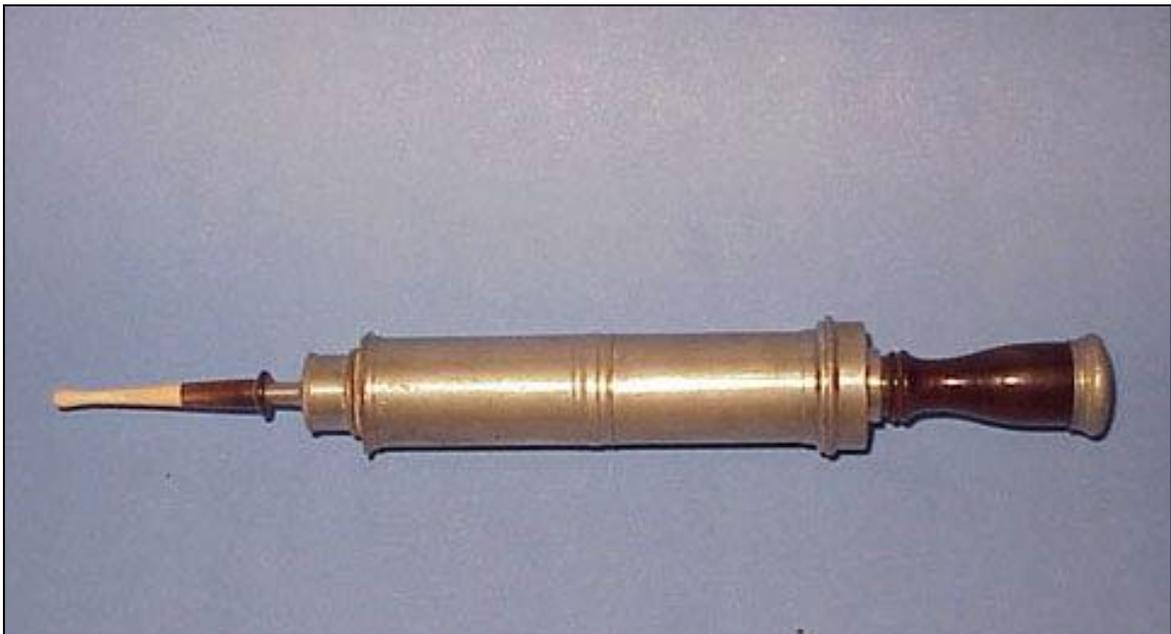
Figure 6.230. Eighteenth-century clyster pump. (Source: <http://www.collectmedicalantiques.com/potpourri2.html> January 30 2010)

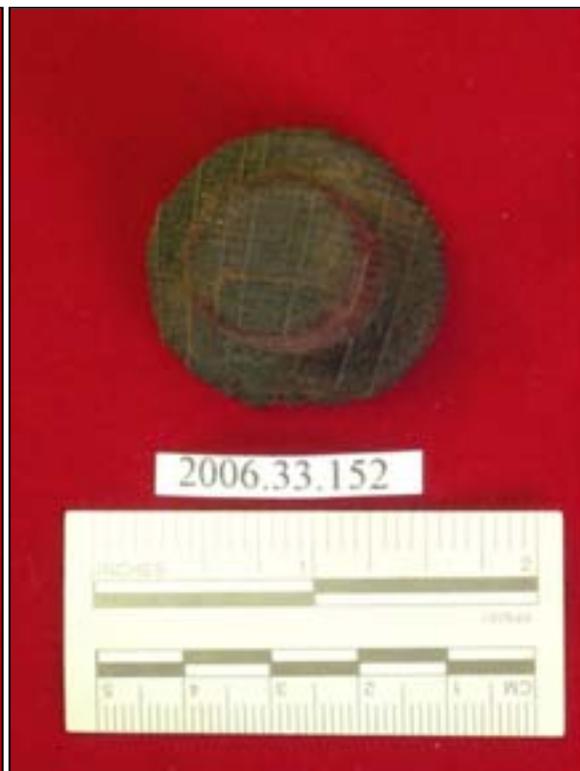
Figure 6.234. Bottom view of wooden stopper recovered from the Roosevelt Inlet Shipwreck site (2006.33.152).

Representing the second largest collection of undetermined material type recovered from the shipwreck, a total of 385 wood items were found. Most of the wooden objects retrieved could not be described further than their material type. Those that could be described, however, include items such as: one piece of molding with a squared section that may be furniture or ship-related; one section of a tapered wooden pin; one furniture or door part with a possible keyhole-shaped cutout and a possible inscribed line on one end; a perfectly preserved oak bottle stopper, and several other amorphous, worked, or undetermined pieces of timber. The wooden stopper is 31.83 mm high with a shaft diameter of 19.98 mm and a head diameter of 34.20 mm. Figures 6.233 and 6.234 show profile and bottom views of this object.

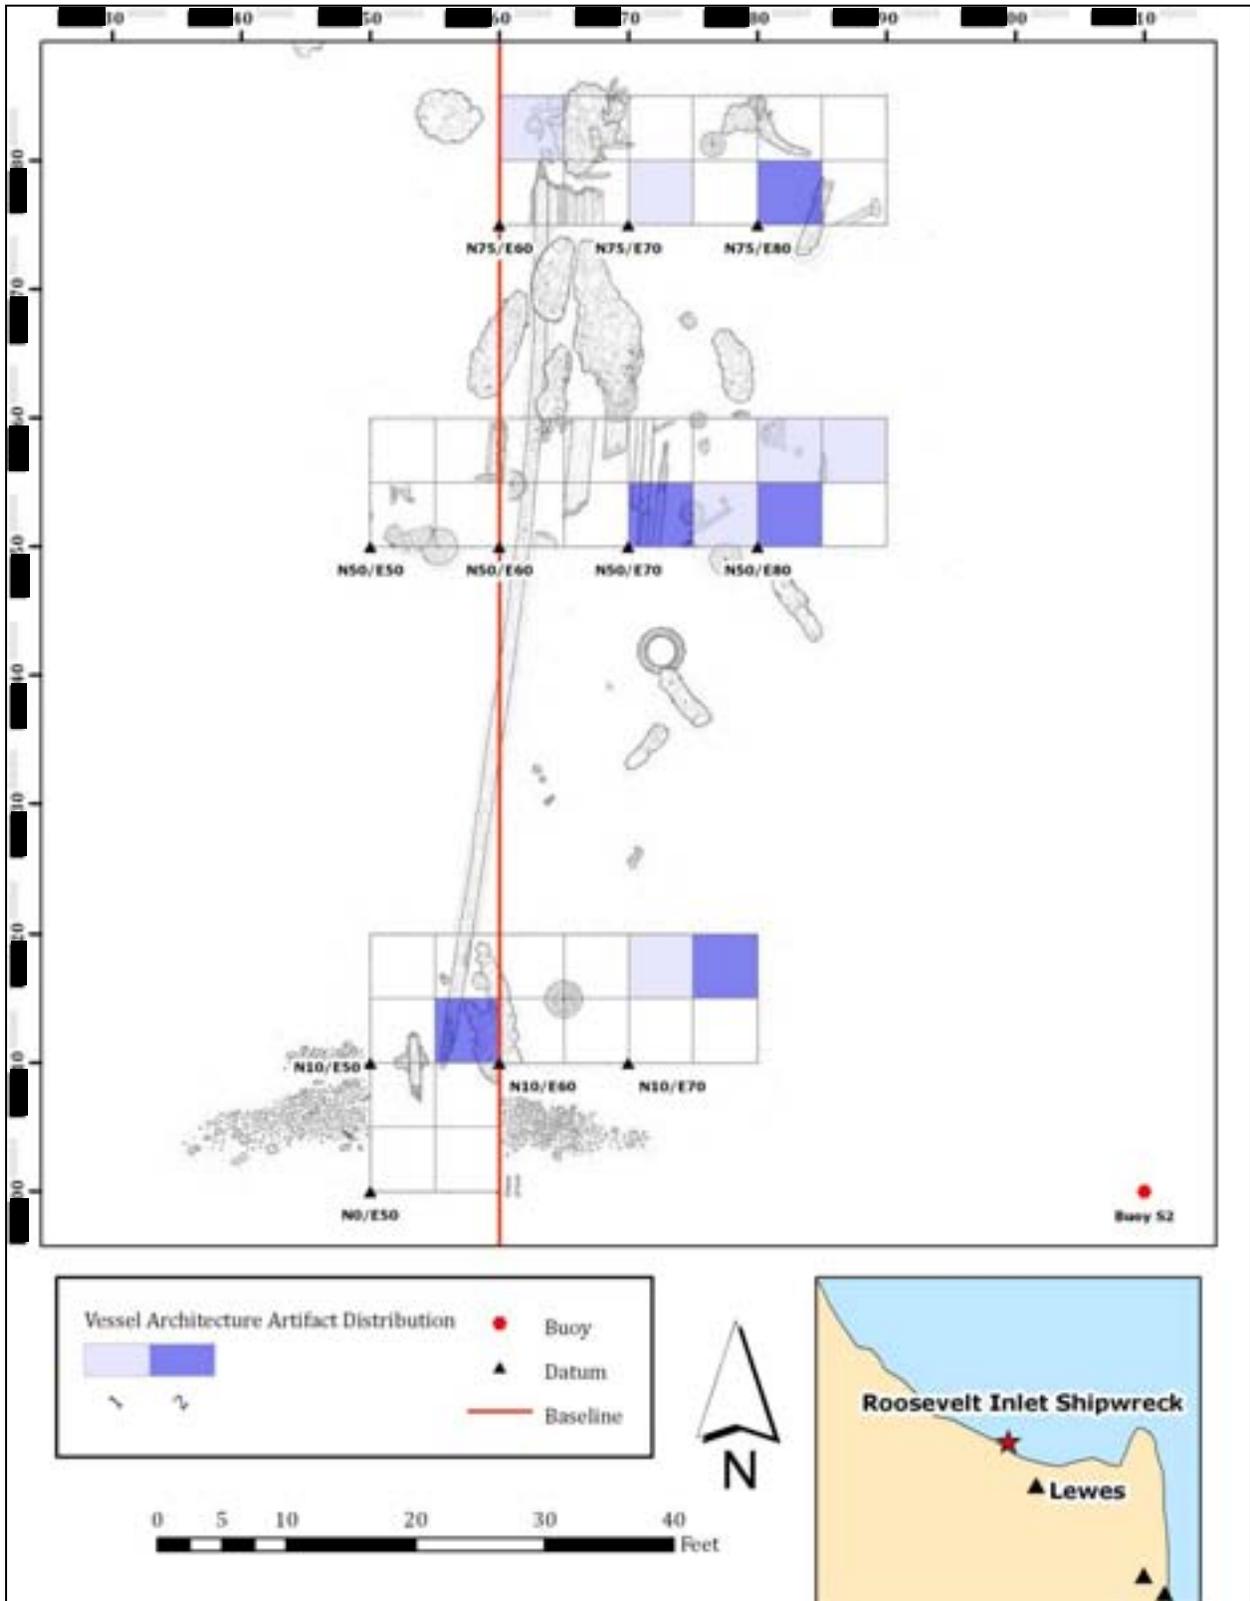
Figure 7.18. Vessel Architecture Artifact Distribution across the Roosevelt Inlet Shipwreck site.
