March 2006

**REPORT OF THE ARCHEOLOGICAL INVESTIGATIONS OF THE
NEW CASTLE COURT HOUSE PLAZA (7NC-E-105A)
NEW CASTLE, DELAWARE**

John Milner Associates, Inc.

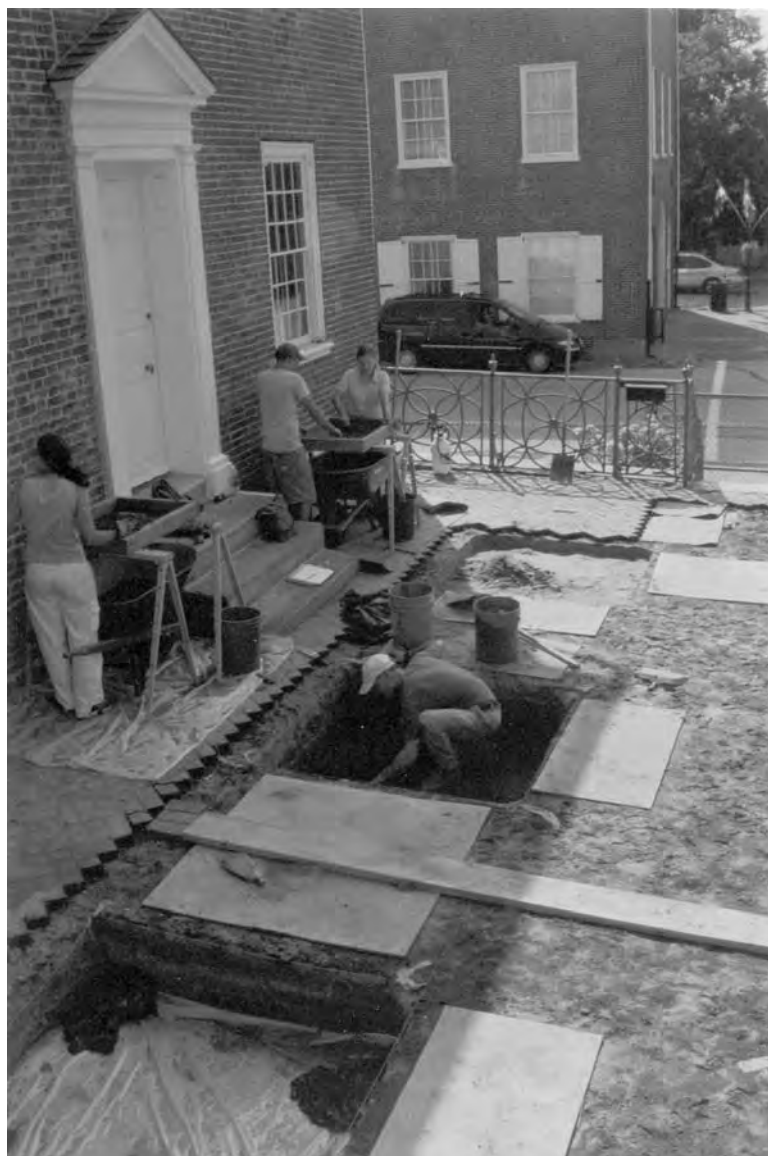
Plate 1. East plaza overview showing the initial excavation of Feature 20 (cellar hole) within EU 8 and the screening of the patio foundation sand from EU 10; view to grid northeast.

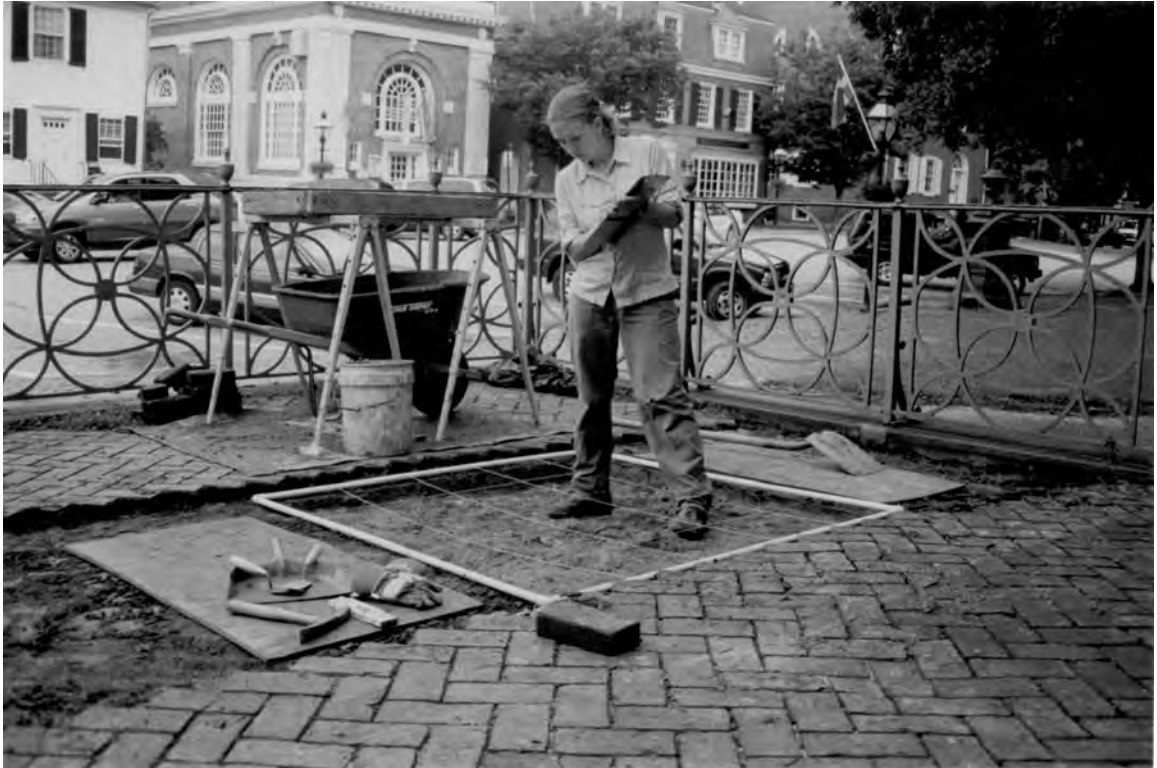
Plate 2. Plan view mapping of EU 21 located on the western plaza; view to grid southwest.

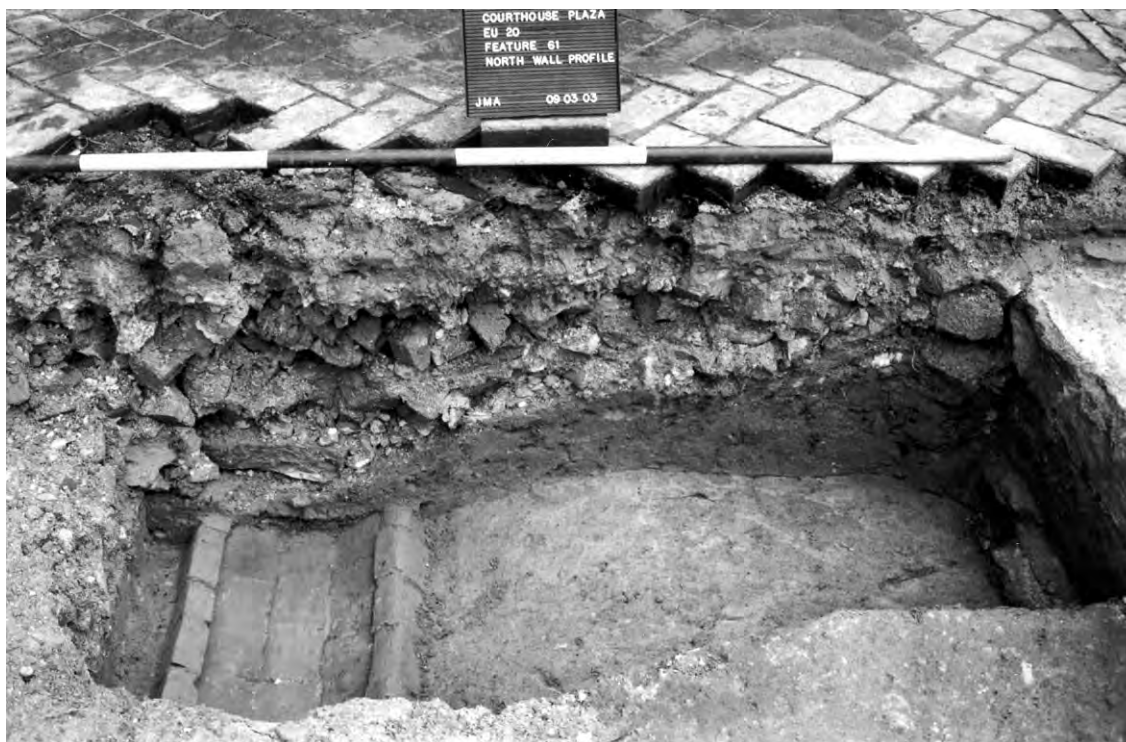
Plate 3. North profile of EU 20 showing the stratigraphic profile within the 1845 plaza extension; the location of a dry laid brick drain (Feature 61) and the edge of the ca. 1820 patio (Feature 21) are shown.

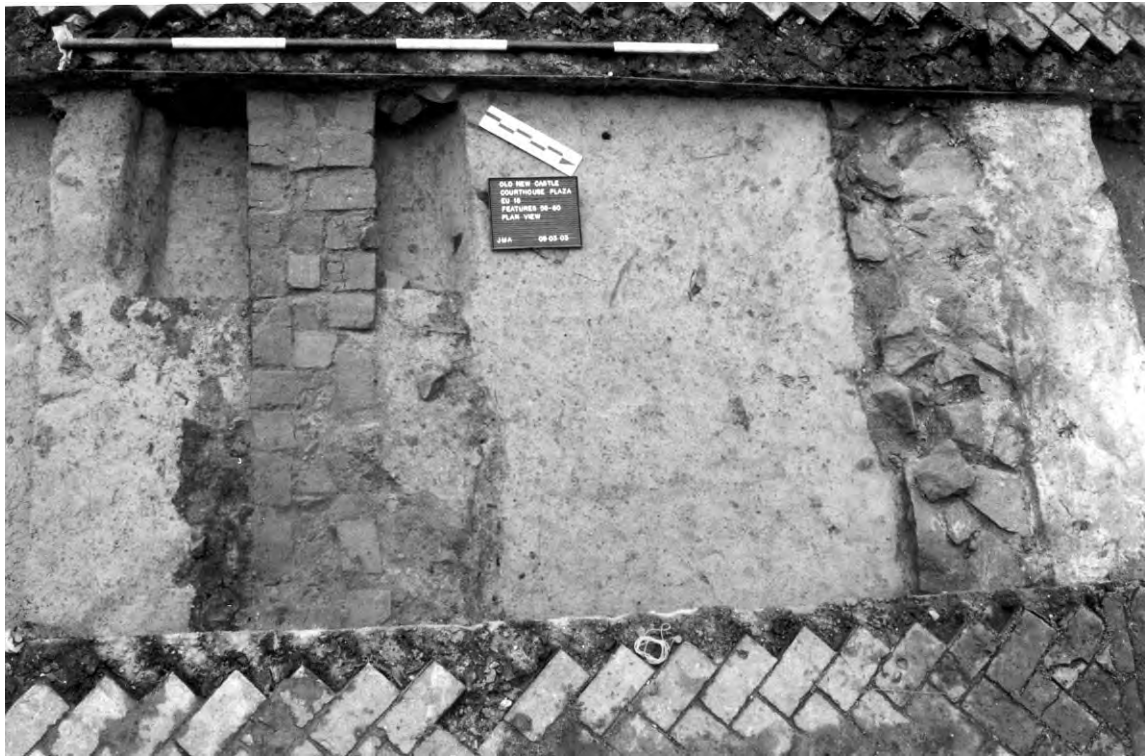
Plate 4. Plan view of EUs 18 and 19 showing the sampled builder's trenches (Features 59 and 60) associated with a brick foundation (Feature 58). The edge of the circa 1820 plaza (Feature 21) is visible on the right side of the photograph; view to grid south.

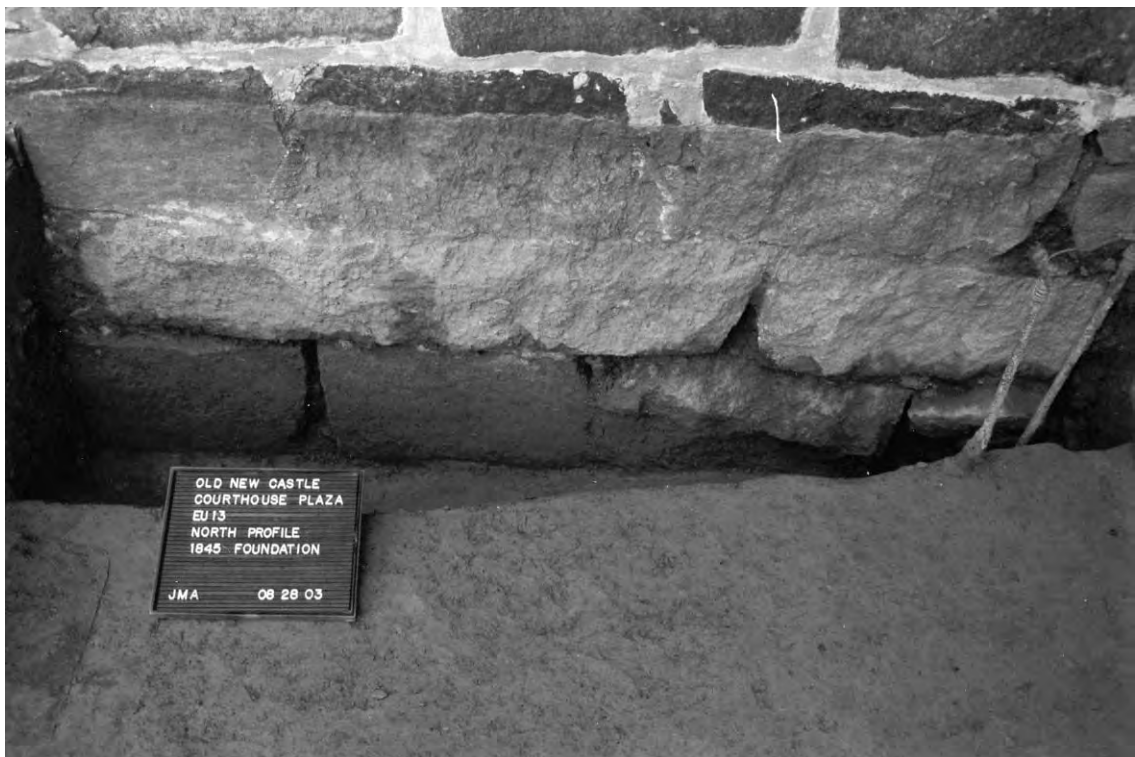
Plate 5. North profile of EU 13 showing the newly exposed 1845 Court House foundation within it associated builder's trench (Feature 49).

Feature 49 denotes the builder's trench associated with the 1845 wing addition. This feature was initially identified at the top of the circa 1820 plaza foundation sand layer within EU 13 and was fully excavated to the base of the 1845 foundation, a total depth of approximately 2.4 ft. beneath the plaza surface (Plate 5). The 1845 foundation is constructed of reused sleeper stones salvaged from the New Castle and Frenchtown Railroad and measured approximately 4 ft. in height. The full length of the feature was documented after the western plaza construction material was removed. The 1845 builder's trench extended the full length of the circa 1820 plaza within this area; extending from the western edge of the circa 1732 block across the façade of the 1845 wing and it apparently terminates beneath the 1845 front steps (Figure 6). A total of 17 artifacts, in addition to brick fragments, were recovered including one buff-bodied earthenware sherd, a redware sherd, one porcelain sherd, four bottle fragments, three cut/wrought nails, and seven pieces of window glass.

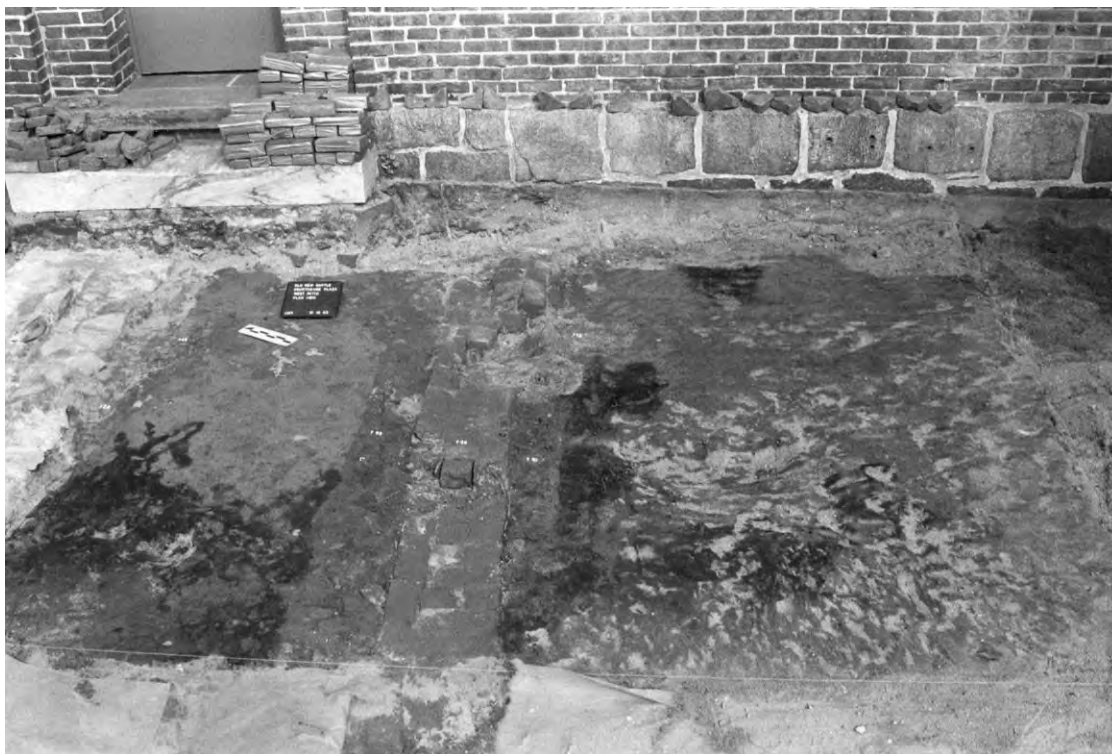
Plate 6. Plan view showing a large burnt area (Feature 93) in the north central section of the west plaza; view to grid north.

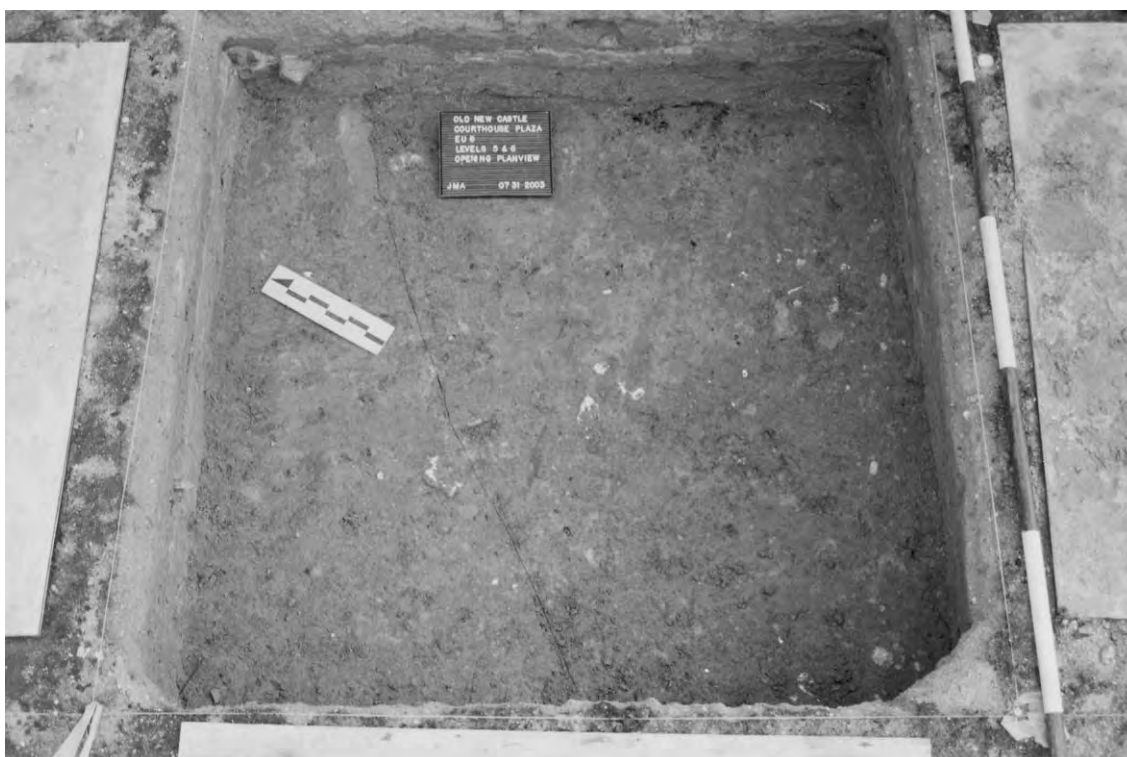
Plate 7. Initial identification of Feature 20 (cellar hole) within the right side of EU 8; view to grid north.

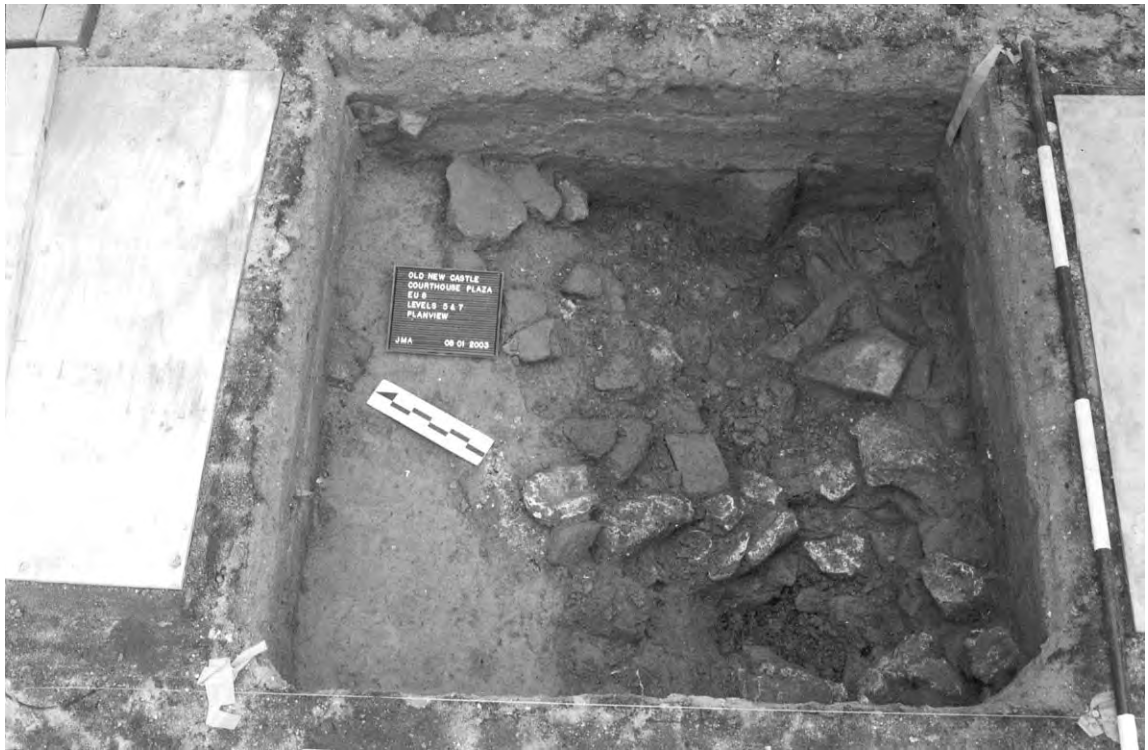
Plate 8. Opening plan view of Level 7 within the Feature 20 (cellar hole) showing high concentrations of coral, stone, and brick; view to grid north.

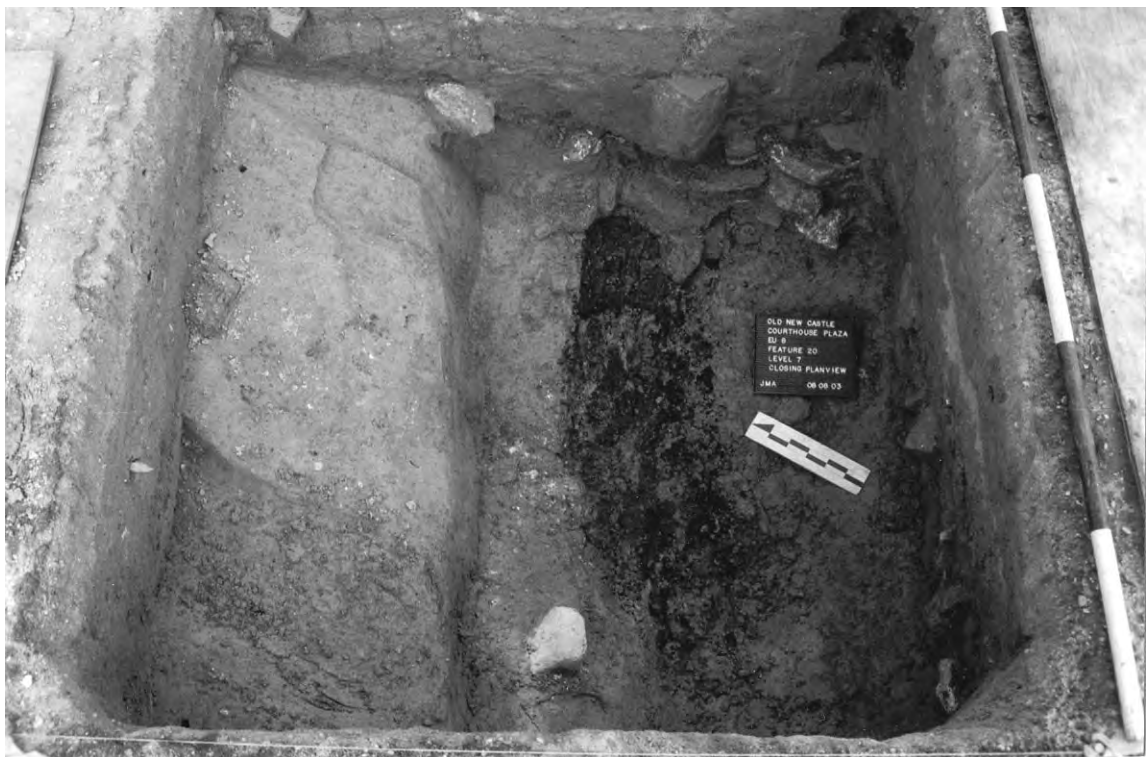
Plate 9. Closing plan view showing a burnt board at the base of Level 7 in the cellar hole (Feature 20); view to grid north.

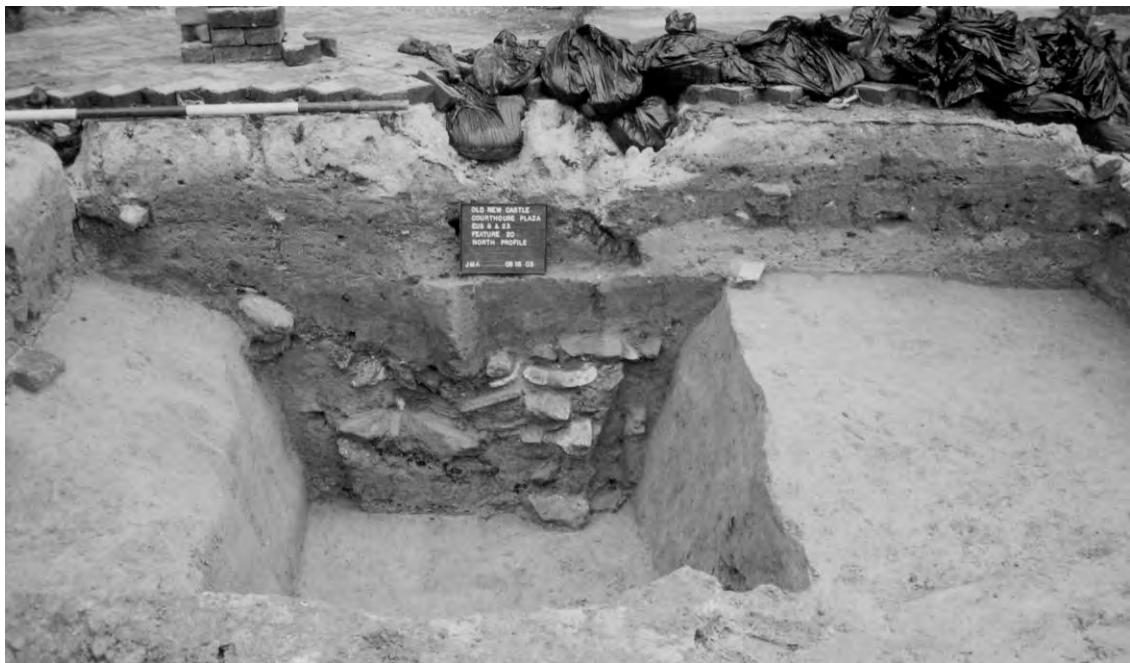
Plate 10. North profile of EUs 8 and 23 showing a fully sectioned (cellar hole).

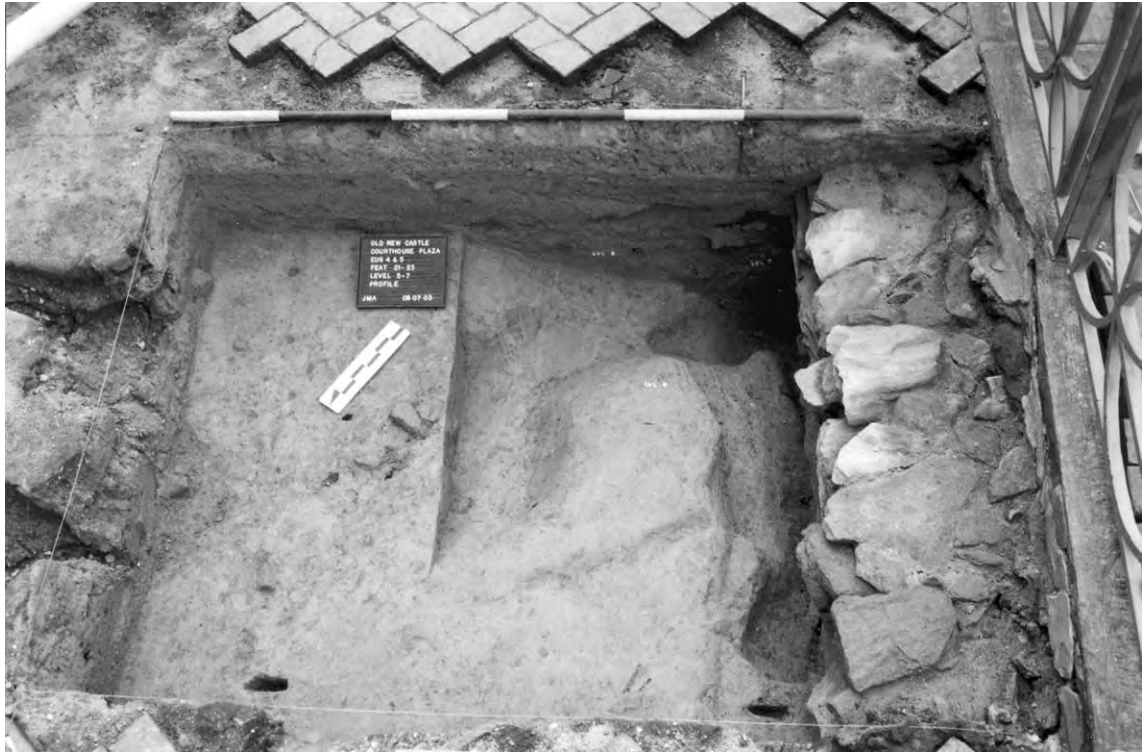
Plate 11. East profile of EUs 4 and 5 showing south bisection of Feature 23 (erosion trench) and the completed excavation of the ca. 1820 patio wall builder's trench (Feature 22).

Feature 23, identified at the base of the lower sand deposit cuts into the surrounding subsoil within EUs 4 and 5 (Plate 11). The base of this concave shaped feature measures 5.5 by 2.2 ft. with an overall depth range of 0.2 to 0.6 ft. It slopes away from the southeast corner of the circa 1732 central block, for a general orientation that is northwest to southeast. A total of 103 artifacts were recovered from this completely excavated feature and a TPQ of 1740 was assigned based on the recovery of three sherds of Jackfield-type redware (context 19). The mean artifact date was 1716.7 and the feature has an occupation date range of 1689.9 to 1743.6. The rest of the assemblage included faunal remains such as bone, coral, clam and oyster shell fragments; personal items such as a brass straight pin, ball clay pipe bowl and stem fragments; seventeenth and eighteenth-century ceramics including buff-bodied earthenware including Staffordshire and a possible Midlands yellow, North Devon earthenware with gravel temper, tin glazed earthenware, redware including possibly Red Borderware, early Buckley and Jackfield-type, imported Westerwald stoneware, and Chinese export porcelain; unidentified bottle fragments; and architectural items such as cut/wrought nails, brick, and window glass.

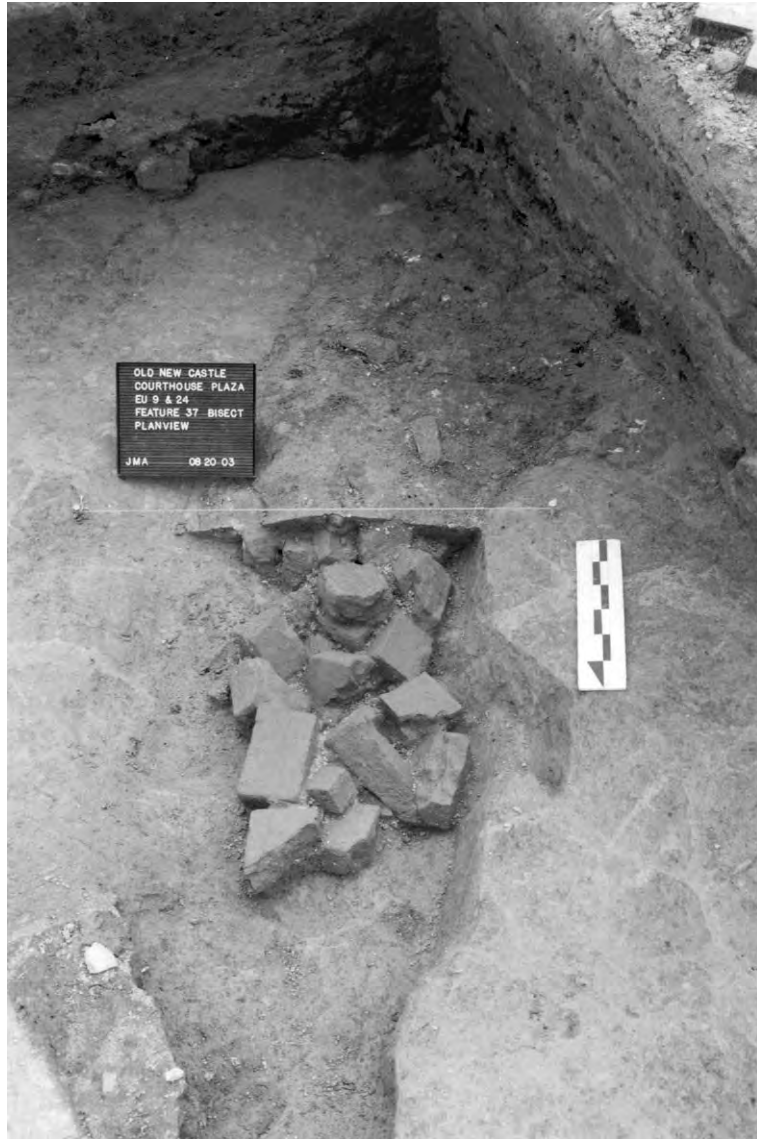
Plate 12. Plan view of Feature 37 (erosion trench) bisection within EUs 9 and 24; view to grid east.

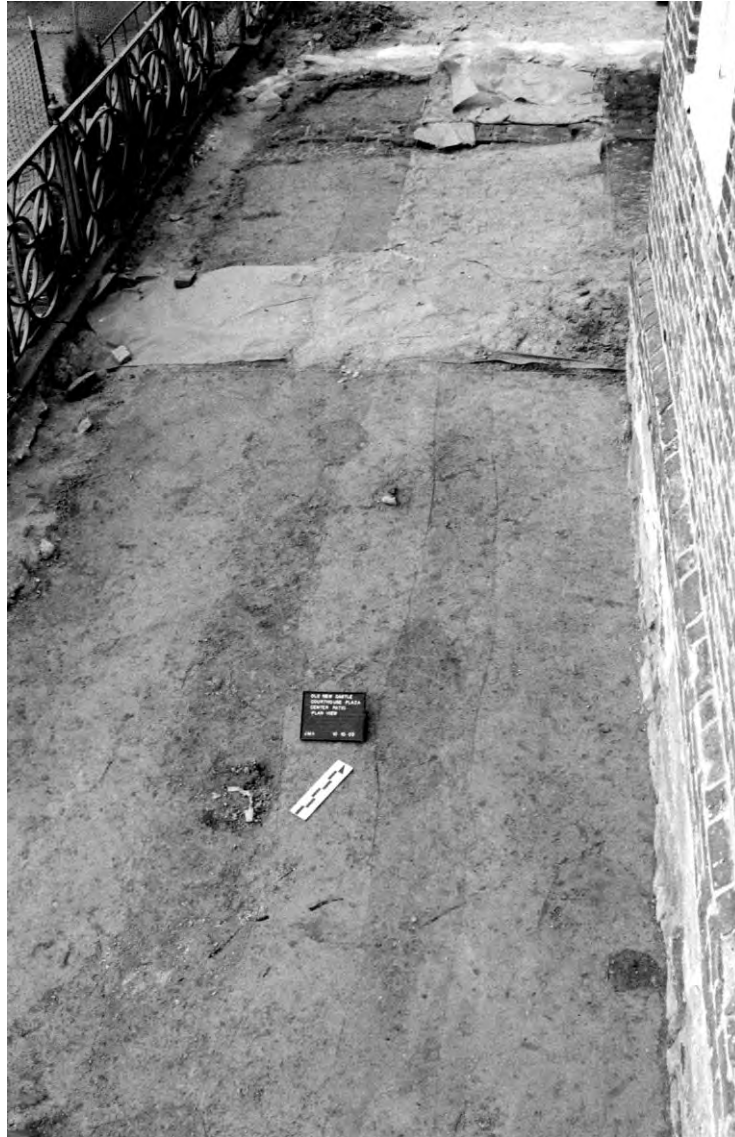
Plate 13. Western view from the main Court House steps showing the location of two parallel palisade trenches (Features 27 and 29) within the newly stripped central plaza.

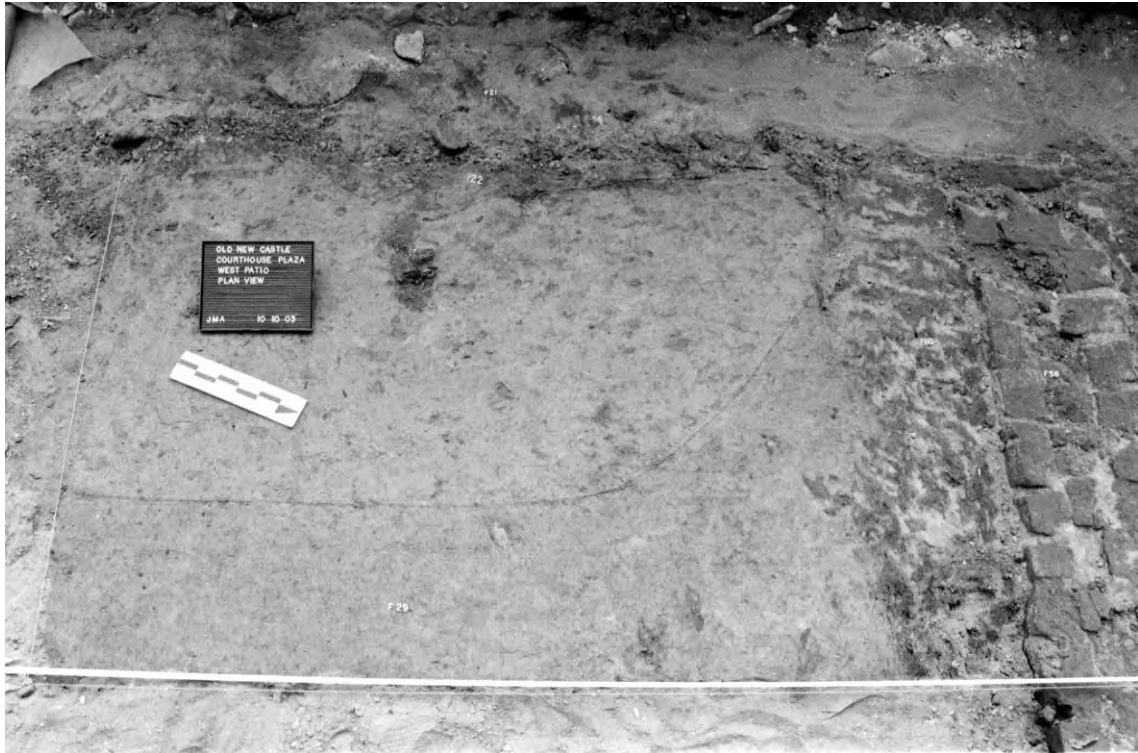
Plate 14. Plan view documenting the southern palisade (Feature 29) orientation shift within the western plaza; view to grid south.

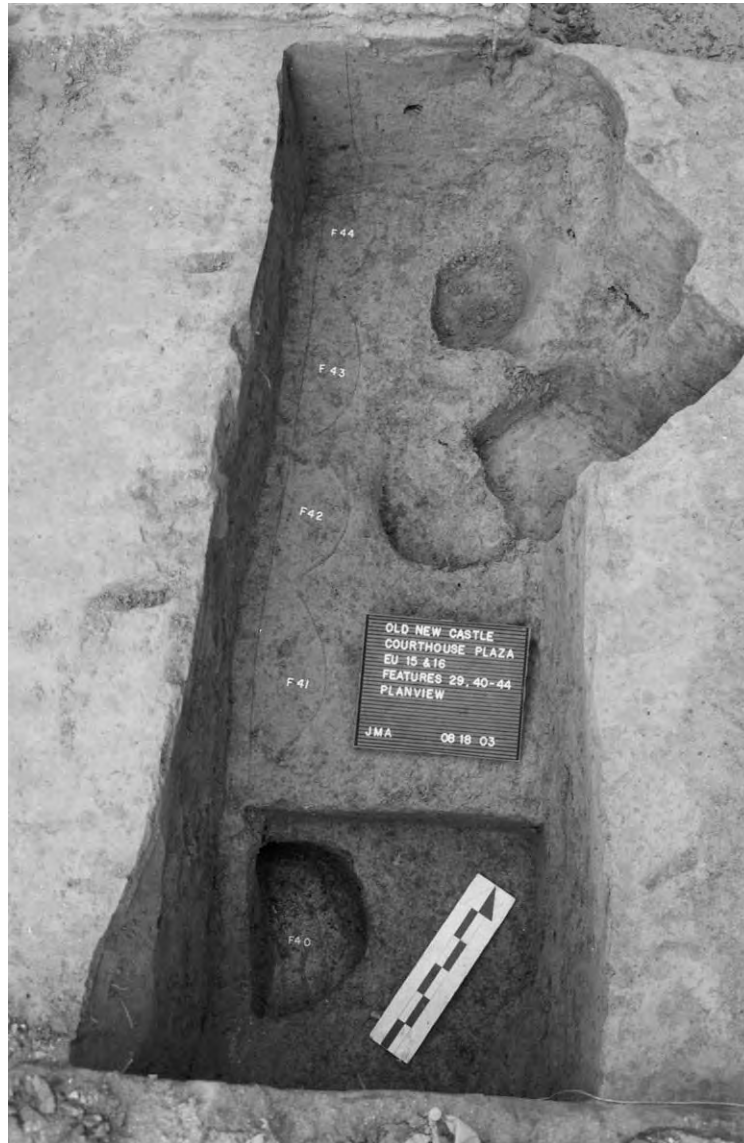
Plate 15. Plan view of excavated palisade trench post holes (Features 40 through 42) within Feature 29, EUs 15 and 16; view to grid west.

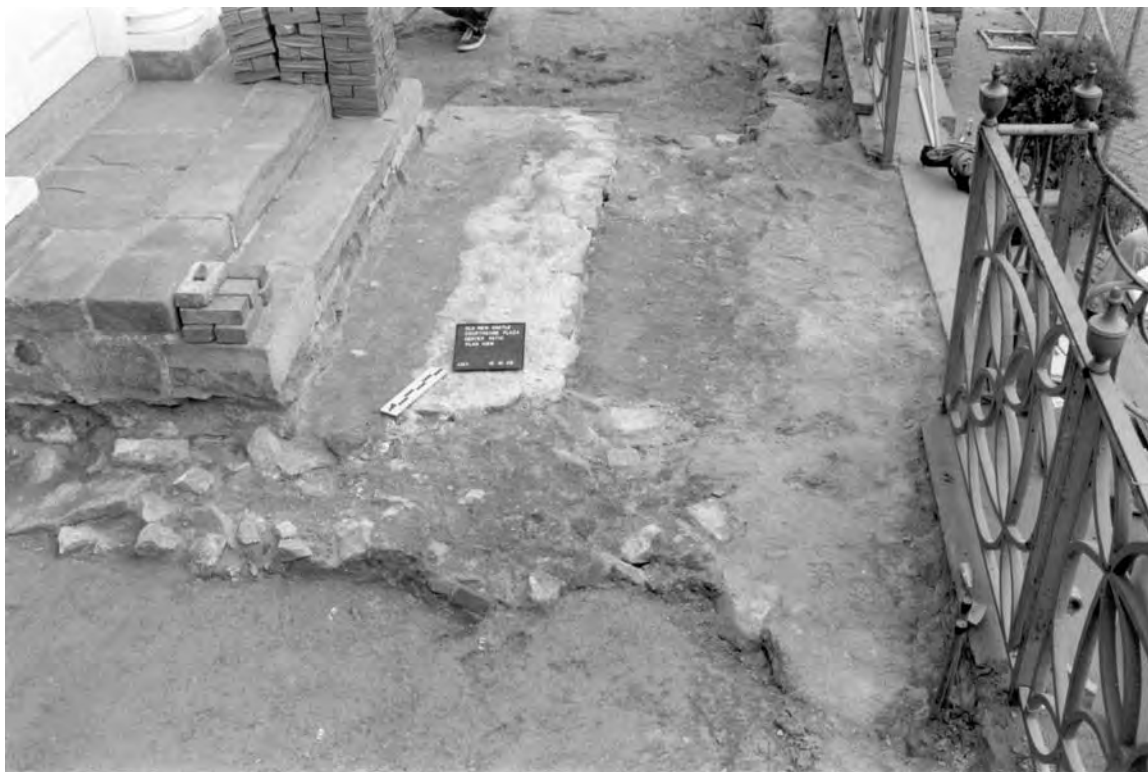
Plate 16. Plan view showing the portico foundation (Feature 78) in the central plaza; view to grid east-northeast.

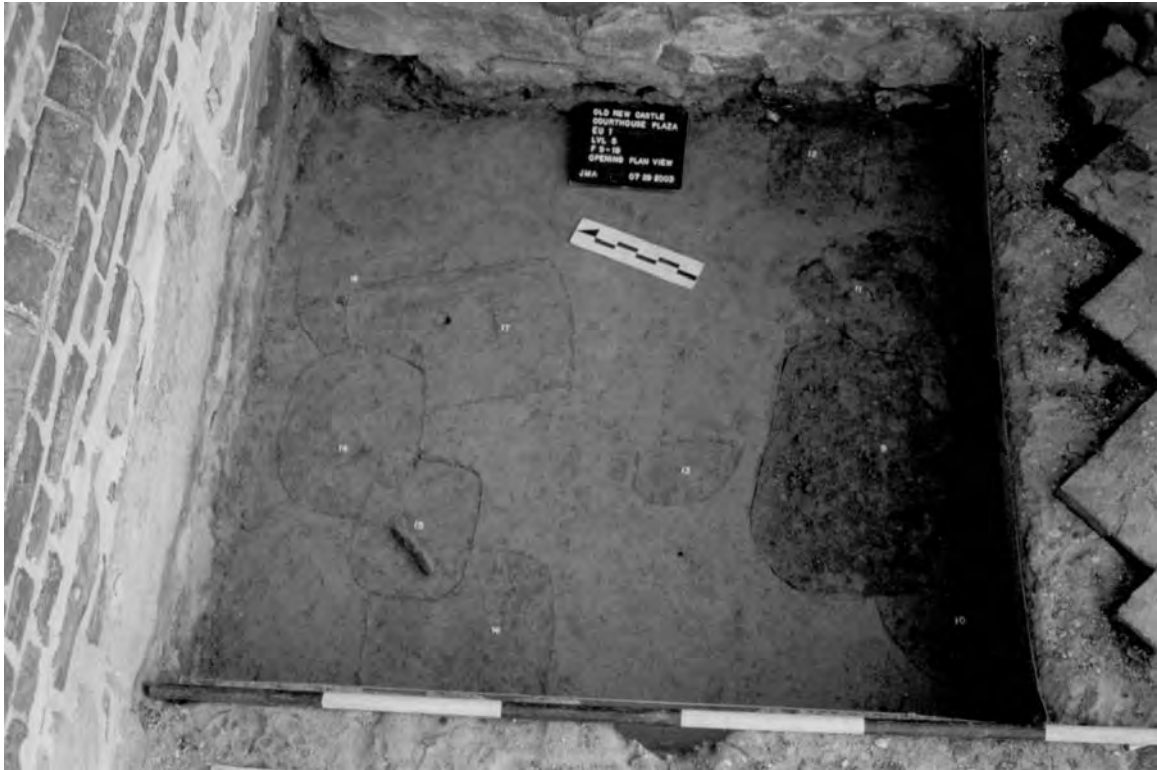
Plate 17. Opening plan view of Level 5 showing Features 9 through 16 (post holes) within EU 1; view to grid north.

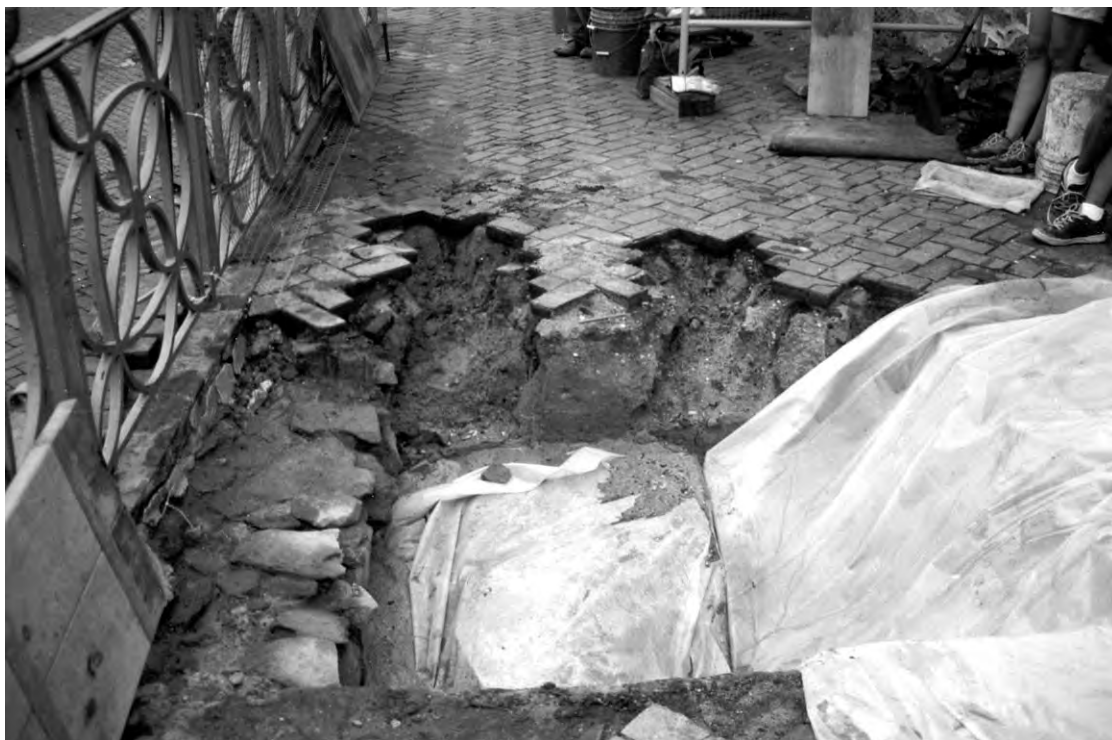
Plate 25. Plaza erosion adjacent to EUs 4 and 5; view to grid west.
